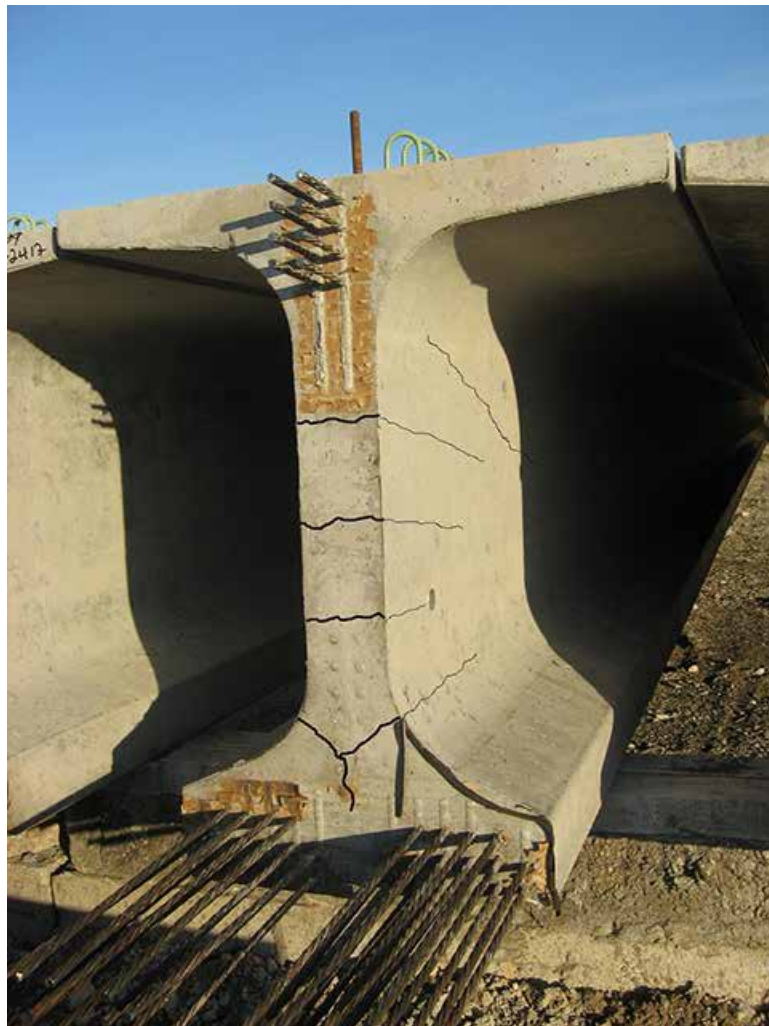
Girder end cracking that developed during the prestressing process. Photo: Wisconsin Department of Transportation.
