Observations from 30 Years of Inspecting Post-Tensioned Structures

by Bruce Osborn, Structural Technologies LLC/VSL

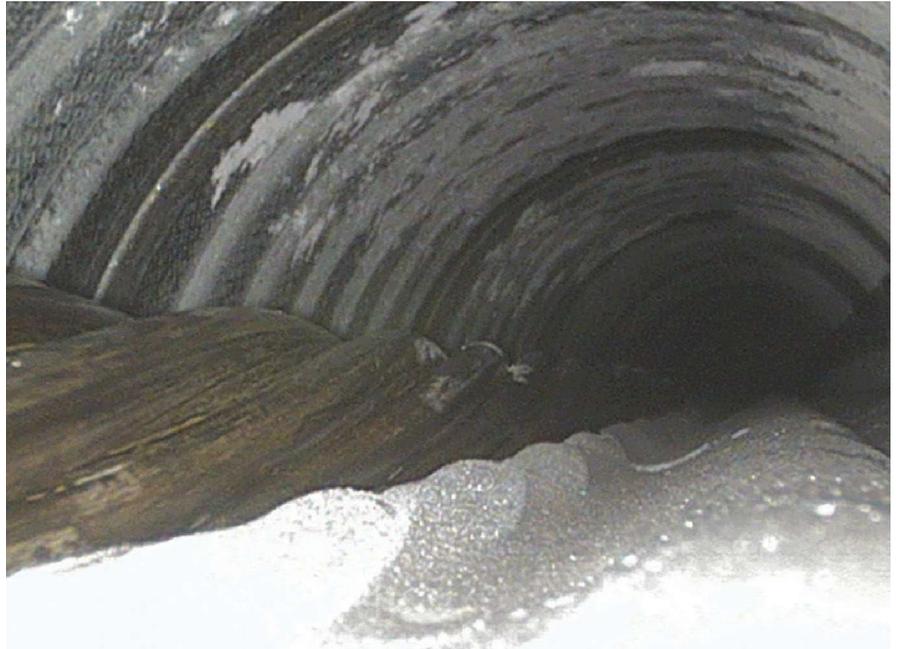
Figure 1. Bare strand in a tendon at a grout void. All Figures: Bruce Osborn.

Notably, when inspections identified voids in the grout within tendons, those voids were not always associated with significant corrosion. In most cases, voided areas could be regouted to extend the service life of the structure and the PT system within it. **Figure 1** shows a borescope picture taken from the inside of a voided tendon in a structure whose exterior condition was well maintained. The void is located at the top of the duct, and the steel within the tendon has not undergone any major corrosion. This type of void is most

often caused when improper grout venting results in air entrapment at a high point. To repair this type of condition, grout ports are drilled into the duct and vacuum grouting is used to ensure a proper seal. When there is seemingly no corrosion, this manner of repair is very beneficial.

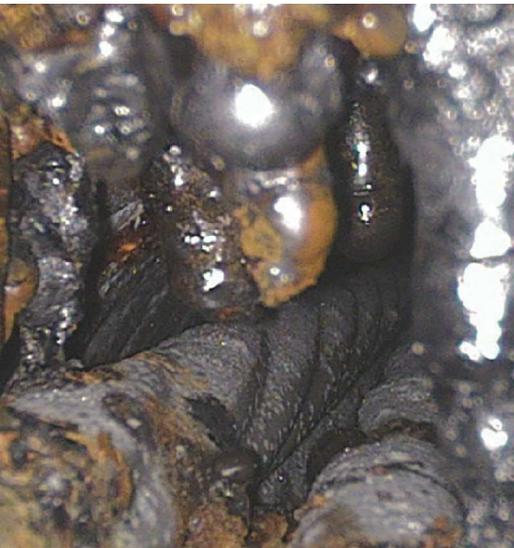
Figure 2. Bare strand with clear signs of corrosion in a tendon with a grout void.

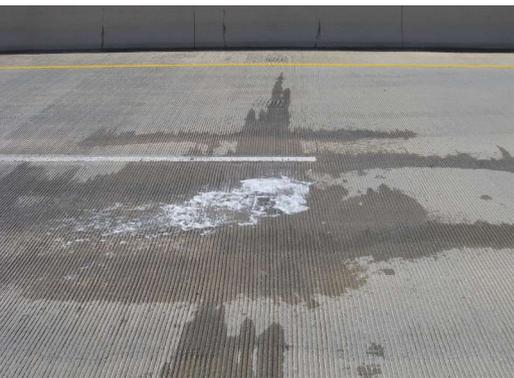
Figure 3. Operation to find cracks in the bridge that were leading to moisture in post-tensioned tendons.

Figures 3 and **4** show two photos from a structure in which large amounts of water collected in the PT ducts. It was not known how the water was infiltrating the system, but there were fears that the PT system was at fault. As part of the investigation, ports were installed into the ducts, which were then pressurized, to seek the source of the water intrusion. After reaching around 40 psi, water began discharging out of the top deck of the bridge (soap was placed around area to make any exiting air visible). This evidence demonstrated that the water-filled ducts were being recharged through cracks in the bridge deck.

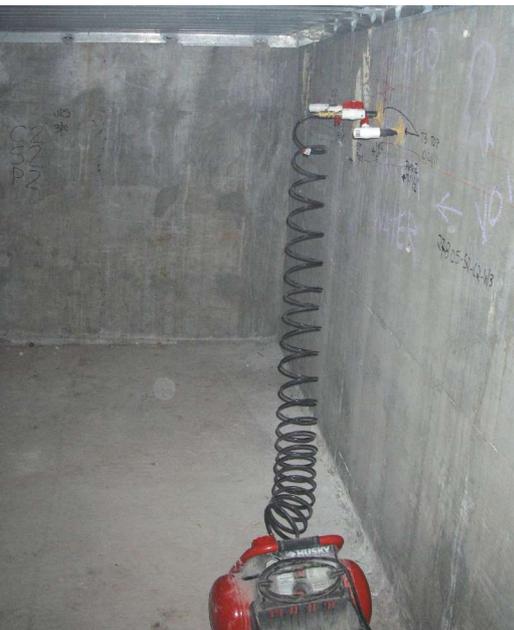
Figure 4. Equipment used to pressurize tendons and find the source of water.

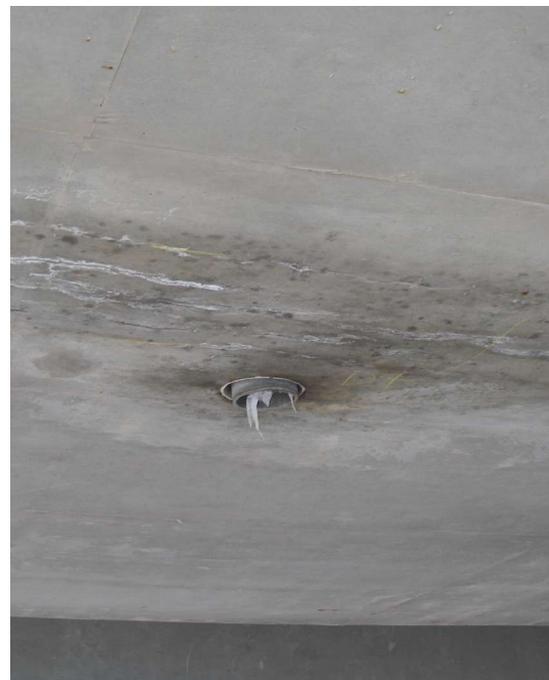
One of the most prevalent design problems in PT bridges is scuppers and deck drainage systems that run inside the structure or terminate at critical locations on the superstructure. Over time, these drains fail, transferring road deck debris and water either to the interior of the structure or

Figure 5. Signs of tendon corrosion near a bridge drainage system.

onto the superstructure (Fig. 5). Cracks consistently exposed to outside contaminants such as road salts and chlorides will grow, further endangering the tendon.

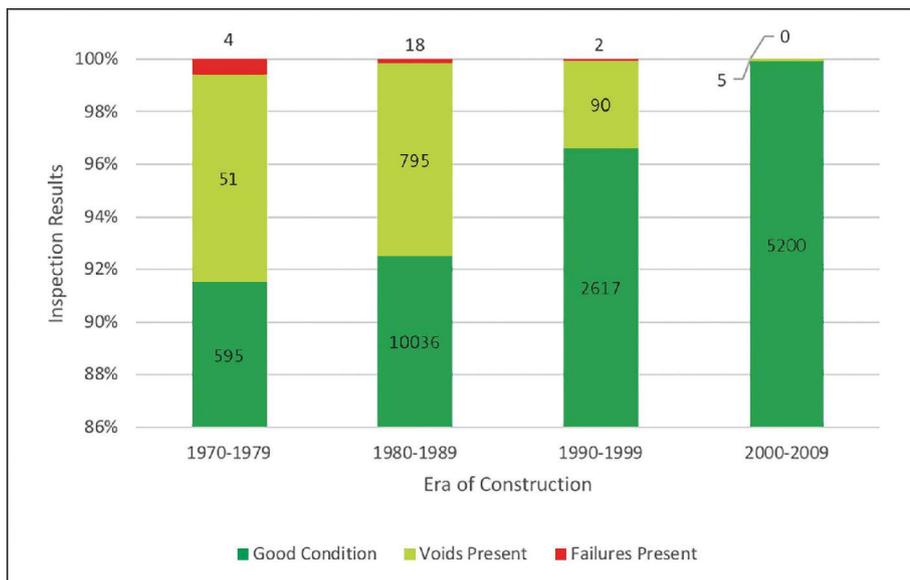
Figure 6. Condition of post-tensioning tendons inspected by the author by construction time period.

Figure 6 presents the conditions of the PT tendons investigated by the author grouped by the date of original construction. The vertical axis has been shortened to focus on the upper limits to allow the small quantities to be visible. Even though data in the figure are just for structures inspected by the author, it is evident that the condition of the structures significantly improved over time with refinement of PT systems and procedures, as indicated by the reduced incidence of voids in tendons.
