REHABILITATING MARYLAND ROUTE 195

(CARROLL AVENUE) BRIDGE OVER SLIGO CREEK

by Fred Braerman, Johnson, Mirmiran & Thompson, and Maurice Agostino,
Maryland Department of Transportation, State Highway Administration

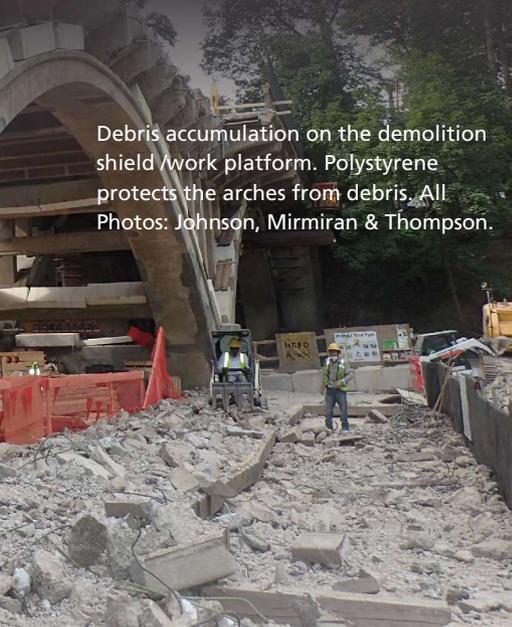
Debris accumulation on the demolition shield/work platform. Polystyrene protects the arches from debris. All Photos: Johnson, Mirmiran & Thompson.

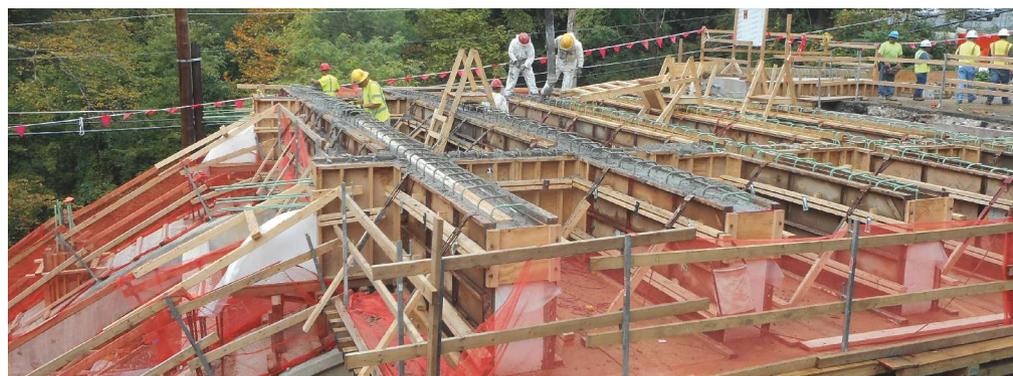
Concrete being placed for new floor beams at the top of one of the arches.
