# **When Concrete Isn't Concrete: Preserving the Dry Canyon Bridge**

by Rebecca Burrow, Oregon **Department of Transportation**

In 2017, nearly a century after it was constructed, the Dry Canyon Bridge on the scenic Historic Columbia River Highway underwent its first major rehabilitation, which included repairs to low-strength concrete, realkalization of the superstructure, application of a cementitious render, and an experimental deck overlay. With the completion of these repairs, it is expected that the bridge will have another 100 years of service life under the Oregon sun.

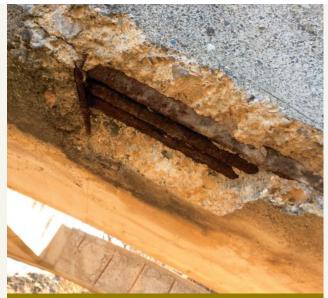
Although concrete spalling and corrosion of the reinforcement were widespread on the concrete arch, the reinforcement maintained its integrity, leading to the decision to rehabilitate rather than replace the bridge. Photo: Rebecca Burrow.

Although concerning, this low strength did not explain the sudden spalling nearly 100 years after construction. To solve that mystery, a concrete core was sent for petrographic examination. The results showed that the concrete had undergone carbonation at least 2 in. deep, and later tests found that carbonation in some locations was more than 3 in. deep. Carbonation of concrete is a chemical reaction whereby the calcium hydroxide (Ca(OH)<sub>2</sub>) in the concrete reacts with atmospheric carbon dioxide to form the more brittle calcium carbonate (CaCO<sub>3</sub>). In reinforced concrete, this means that embedded steel is no longer protected from corrosion by a high-pH environment.

Though the process of carbonation occurs in all concrete, it is typically slow enough that other deterioration mechanisms happen first. However, in the case of the Dry Canyon Bridge, the low-strength concrete was more porous, allowing the reaction to occur deeper into the concrete. Once the reaction reached the reinforcing steel, which typically had 2 in. of cover, the steel began to corrode, resulting in widespread spalling. There are three long-term solutions to this problem: (a) replace the bridge; (b) remove and replace all of the carbonated concrete; or (c) realkalization.

Spalling of the concrete was widespread on the arch, but the underlying reinforcement still had sufficient integrity despite surface corrosion. This was a factor in the decision to rehabilitate rather than replace the bridge

A life-cycle cost analysis determined that realkalization was the preferred alternative for the Dry Canyon Bridge. As a first step in the process, the already spalled concrete had to be patched. Given the extremely soft concrete, the decision was made to use masonry mortar, Type S, as the patch material for compatibility. Next, the realkalization system was applied, which involved wrapping the bridge with insulation matting to store the electrolyte, folding titanium mesh over that, and containing the system with a plastic covering. Gravity flow was used to supply the

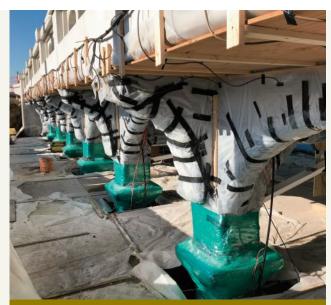
The realkalization system involved wrapping the bridge with insulation matting to store the electrolyte, folding titanium mesh over that, and containing the system with a plastic covering. Photo: Rebecca Burrow.

anode mesh that is temporarily applied on the surface of the concrete. The anode is surrounded by an alkaline electrolyte, typically sodium or potassium carbonate, which is pulled into the concrete surface by the electrical current. Over the course of a week, the process reverses the carbonation, repassivates the steel, and densifies the concrete, slowing the carbonation process for the future.

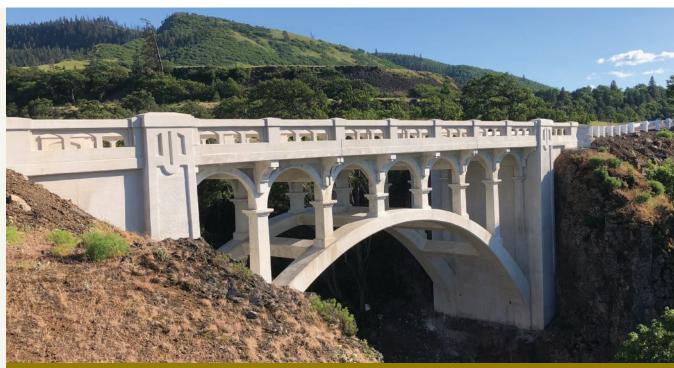
After being coated with a cementitious render and silane sealer, the rehabilitated bridge looks almost brand new. Photo: Rebecca Burrow.

electrolyte to the entire bridge. Because of the historic and scenic requirements of the site, the bridge was also coated with a cementitious render and silane sealer following the realkalization to restore its appearance. Overall, the work on the bridge took three months and never closed the roadway for longer than 20 minutes.
