Inspection and Repair of a Fire Damaged Prestressed Girder Bridge

RICHARD STODDARD, Washington State DOT, Olympia, WA

IBC-04-17

DAMAGE INSPECTION REPORT 12/12/02

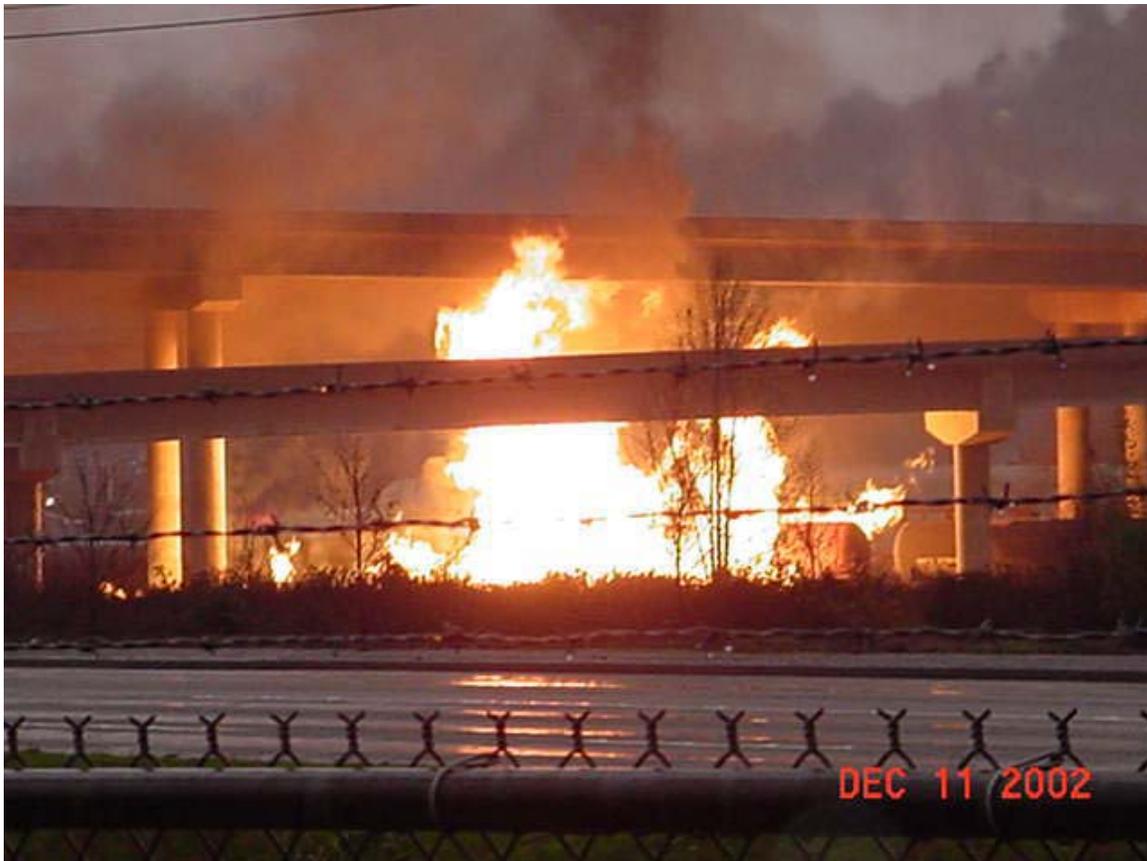
On December 11, 2002, at approximately 4:00 pm, a railroad tanker collision caused a fire under a prestressed girder bridge that consumed 30,000 gallons of mythanol, (photo 1). This section of the bridge was a relatively new continuous three span frame constructed in 1997. The girders had a span length of 146 feet, a 28 day concrete strength of 7000 psi, and 0.5” diameter 270 ksi steel strands. The bridge deck and columns were constructed using 5000 psi concrete and 60 ksi mild steel. Confinement reinforcement in the columns was provided by tightly wound spiral cages.

Photo 1. Puyallup River Bridge Railroad Tanker Fire

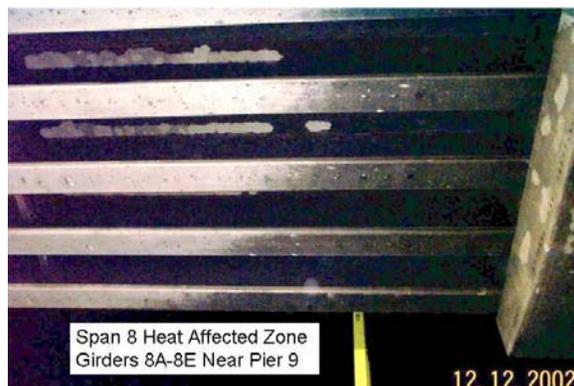
All 15 lines of girders in Span 8 were damaged by the fire. The color of the bottom flange soffit was a whitish-gray, (photo 2). The whitish-gray concrete at the corners of the bottom flange could be easily removed to expose the outermost prestressing strands for a length of more than 94 feet, (photo 3). There were 0.5 inch deep concrete spalls in the top flange and webs of girders.

Photo 2. Span 8 Heat Damaged Flanges

- Maintain truck weight restrictions placed on the bridge on December 12, 2002.
- Remove the loose concrete that presents a safety hazard to BNSF and the public.
- Conduct detailed inspections to verify findings and document extent of damage.

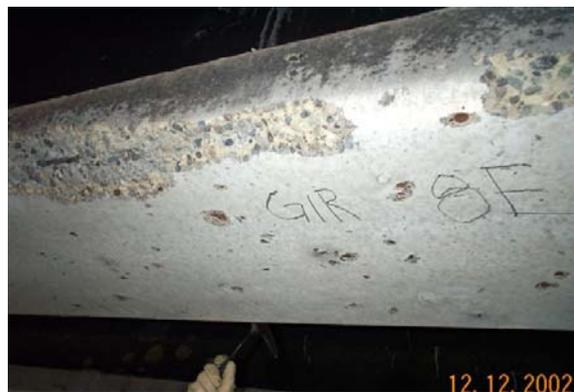
Photo 3. Girder 8E Flange Soffit

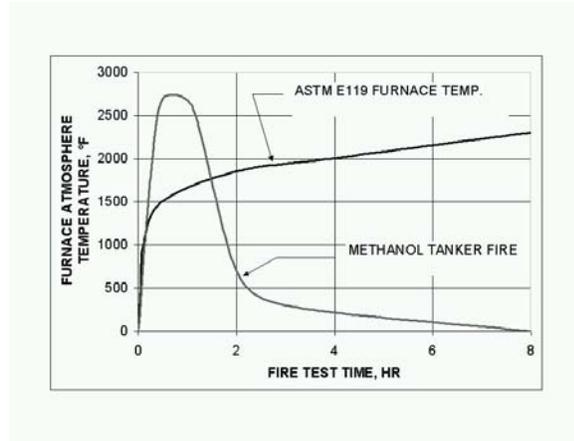
Calculations were made to estimate the heat energy released by the methanol fire. A comparison of the intensity of this fire to ASTM E119 fire tests was helpful in determining the probable heat penetration and concrete damage within the girders. PCI publication MNL-124-77, *Design for Fire Resistance of Precast Prestressed Concrete*², provides the temperature and heat energy applied during the ASTM fire tests as well as graphs for establishing isotherms within concrete beams. Furnace temperatures for the ASTM fire test reach a maximum of 2300° F after eight (8) hours of exposure. It is likely that the methanol tanker fire projected temperatures of 2700° F to the bottom of the girders after only one-half (1/2) hour and temperatures fell below 1000° F after two (2) hours. Figure 2 compares the ATSM furnace temperatures to a possible heat time history for the methanol tanker fire. Differences can be seen in temperature and duration. The tanker fire was hotter but temperatures subsided more quickly than prescribed for the ASTM test.

Figure 2. Temperature vs Time

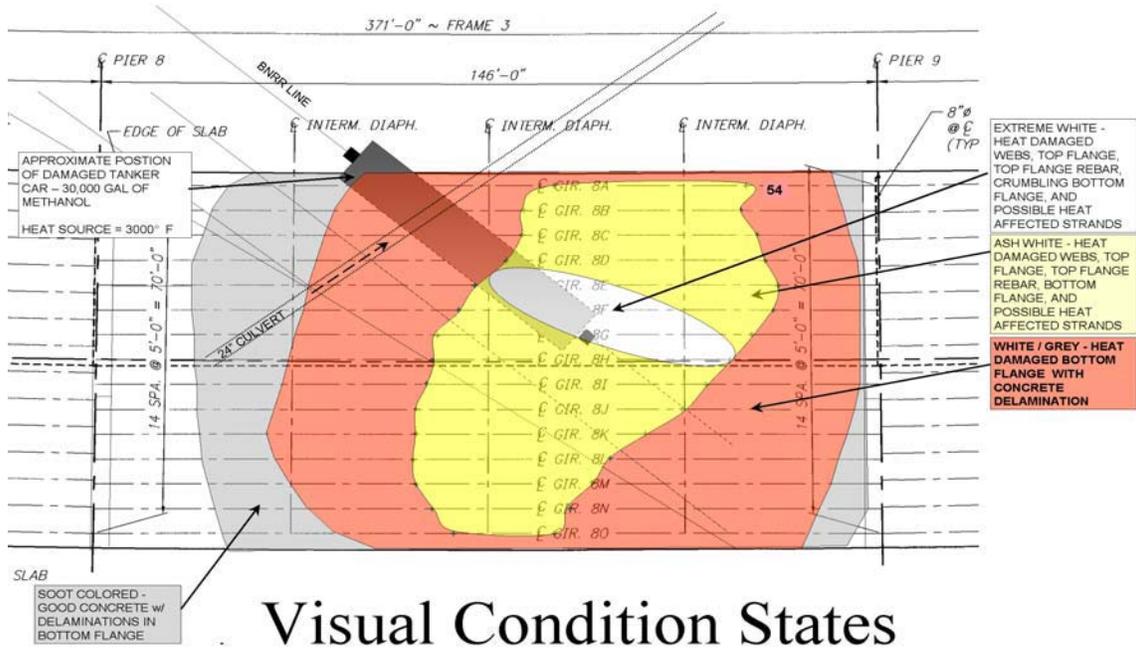
Visual inspections of the damage in Span 8 made note of concrete color variations on the soffit of the bottom flanges that corresponded to changes in concrete condition states. Figure 3 contains a map that was produced to display the boundaries of four fire induced color regions. The color regions were described as Extreme-White, Ash-White, White-Gray, and Soot.

Figure 3. Bottom Flange Visual Condition States

The Ash-White bottom flange region encompassed approximately 30% of the Span 8 area and included all fifteen (15) girders. The North and South boundaries were relatively easy to see from the ground. Their position was measured from the center of Pier 9. Concrete on the soffit of the bottom flanges crumbled or spalled when tapped with a rock hammer. Prestressing strands on the edges of the bottom flange were easily exposed. Concrete spalls were noted in the webs and the top flanges. Web spalling occurred only on the side facing the heat source, due to shadowing effects from the adjacent girders. The density and extents of spalling on the webs appeared to increase with distance from the heat source. This is probably another demonstration of shadowing effects that occurred near the heat source. The girder webs furthest away from the fire were actually more exposed to the radiant heat than were the webs nearest to the fire. Web spalling and top flange spalling did not occur outside of this color region. The nylon reinforcing chairs in the girders had melted with some indication of being burned during the fire. Melted nylon formed stalactites and pockets of charred nylon were visible.

The White/Gray bottom flange region encompasses approximately 30% of the Span 8 area and included all fifteen (15) girders. This region was characterized by obvious delamination sounds in the bottom flanges when struck with a rock hammer. Concrete spalling could be produced with forceful strikes using a rock hammer. The concrete did not crumble and the spalled pieces were 6 inches to 12 inches in size. Prestressing strands on the edges of the bottom flange were difficult to expose using a rock hammer. The web and top flanges were covered with soot but appeared to have sound concrete. The nylon reinforcing chairs in the girders had melted during the fire leaving long nylon stalactites.

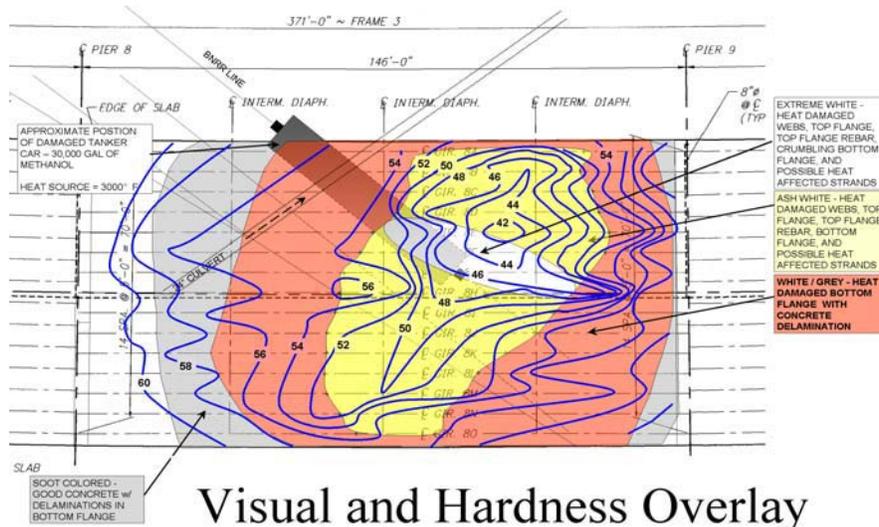
Two locations in Span 9 were tested to provide an expected hardness value for concrete not affected by the fire. The average rebound hammer reading for the soffit of the bottom flange in Girder 9N was 61.4. The rebound hammer readings for the soffit of the bottom flanges in Span 8 ranged from a low of 42.0 to a high of 60.9. The minimum hardness reading was found to be directly over the heat source and in general, flange hardness increase with distance

Figure 4. Visual Condition States and Flange Hardness Contours

away from the heat source. A contour map overlay was added to the flange color variations to check for correlations. As can be seen in Figure 4, the hardness measurements were consistent with the visual damage assessments.

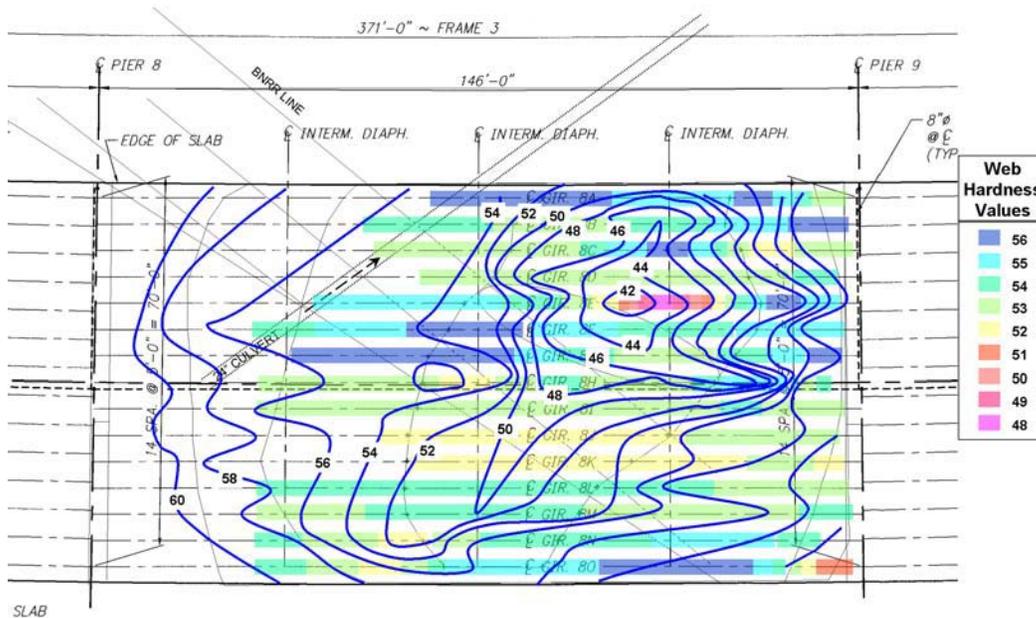
The average rebound hammer readings for Girder 9N was 54.4. The rebound hammer reading in the webs of Span 8 ranged from a low of 47.9 to a high of 57.4. The web harness reading proved impossible to represent with a contour map because values did not follow a pattern of regular change. Color bands were developed as a method to display the hardness changes on a map. Figure 5 overlays the Web Hardness Color Bands and the Flange Hardness Contours to show that the location of the lowest web hardness values corresponds with the lowest flange hardness values. In general, web hardness increases with distance from the source of the fire but shadowing affected the distribution of web damage. Webs lying outside of the small circle in the center of the heat source were damaged by heat if they were not shadowed and if their angle of exposure to the heat source was less than 40 degrees. One could see how the shadowing occurred by standing at the location of the tanker during the fire. Webs directly above and near that location could not be seen because they were blocked by the bottom flanges. Webs of the exterior girders became more visible resulting in a greater exposure to radiant heat. The web damage (reduced hardness) outside of the Extreme White color region actually increased with distance from the fire.

Figure 5. Flange Hardness Contours and Web Hardness Color Bands

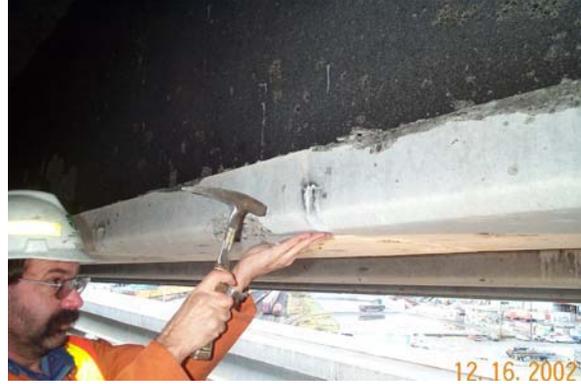
Concrete in the bottom flanges surrounding the straight prestressing strands was easy to remove with the use of a light rock hammer, (photo 4). A small hand held air powered impact hammer was used to remove concrete to exposed prestressing strands in Girder 8F directly above the tanker fire, referred to as location F2. The concrete around strands labeled as number 2, 8, 16, and 18 was removed without difficulty. The color of the exposed concrete varied from ash-white at the surface to light tan (buff color) to a depth of about 0.25 inches, and then a normal gray concrete color on the interior. Beyond a depth of about 1 inch, the concrete became difficult to remove with the rock hammer but remained very easy to remove with the air hammer.

Photo 4. Crumbling Concrete Girder 8E

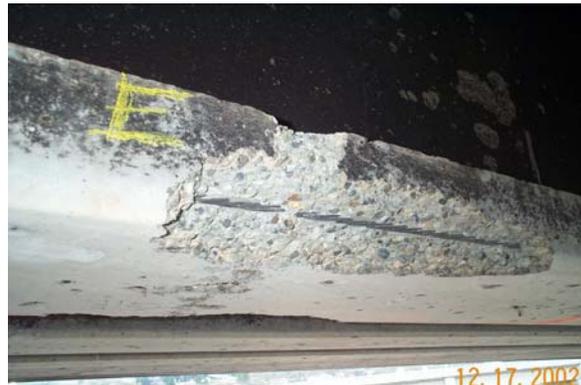
Photo 5. Buff Color Concrete Girder 8E

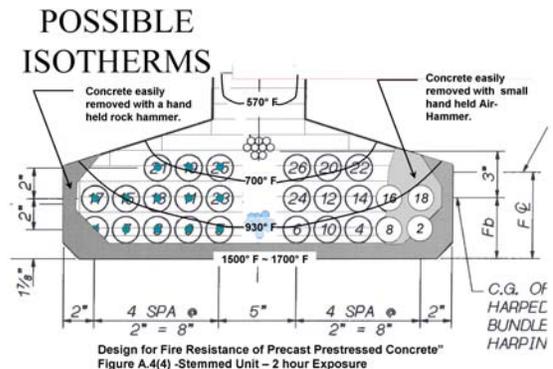
Possible temperature isotherms shown in Figure 6, were developed by combining visual observation of the concrete color, estimated flame temperatures, ease of concrete removal, and the use of Figure A.4(2) on page 77 of PCI Publication – *Design for Fire Resistance of Precast Prestressed Concrete*.² The buff colored 0.25 inch shell indicates possible temperatures of 1700°F. The ease of concrete

Figure 6. Possible Isotherms in Bottom Flanges

removal indicates that concrete temperatures surrounding the lower row of prestressing strands and the exterior strands of the second row exceeded 900°F (strands 1 thru 10 and strands 17 and 18). Contract plans also revealed that the bottom flange soffit provided only 2 inches of cover for the lower bundle of harped strands. Additional observations of warped mild steel reinforcement in the top flanges supported the concern for a temperature induced relaxation of the prestressed strands.

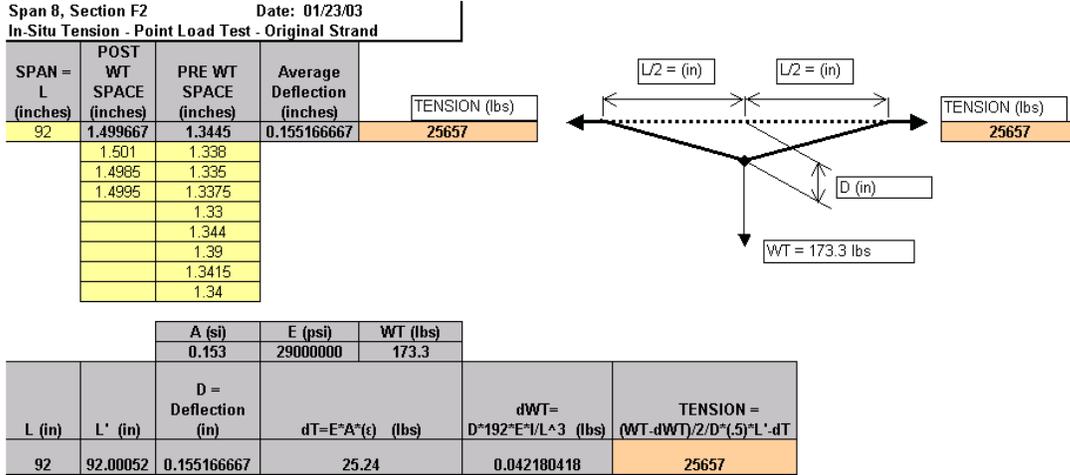
probable accuracy of 5% and was certainly accurate to within 10% of the actual tension force. Figure 7 shows the calculations used in the deflection tests.

Conclusions: The prestressed strand force in girders 8F and 8N appeared to be unaffected by the heat of the fire. Strands within the hot zone at locations F2 and N2, (Figure 8), appeared to have retained 100% of their design force despite high temperatures in the surrounding concrete. We have theorized that the steel strands were able to conduct heat to cooler concrete away from the hot zone and prevent a substantial reduction in the yield stress. Transmission of heat away from the hot zone through the steel strands provides an explanation for the delaminations that have been detected in bottom flanges in the Soot colored region shown in

Figure 7. Calculation of Strand Tension from Displacement Test

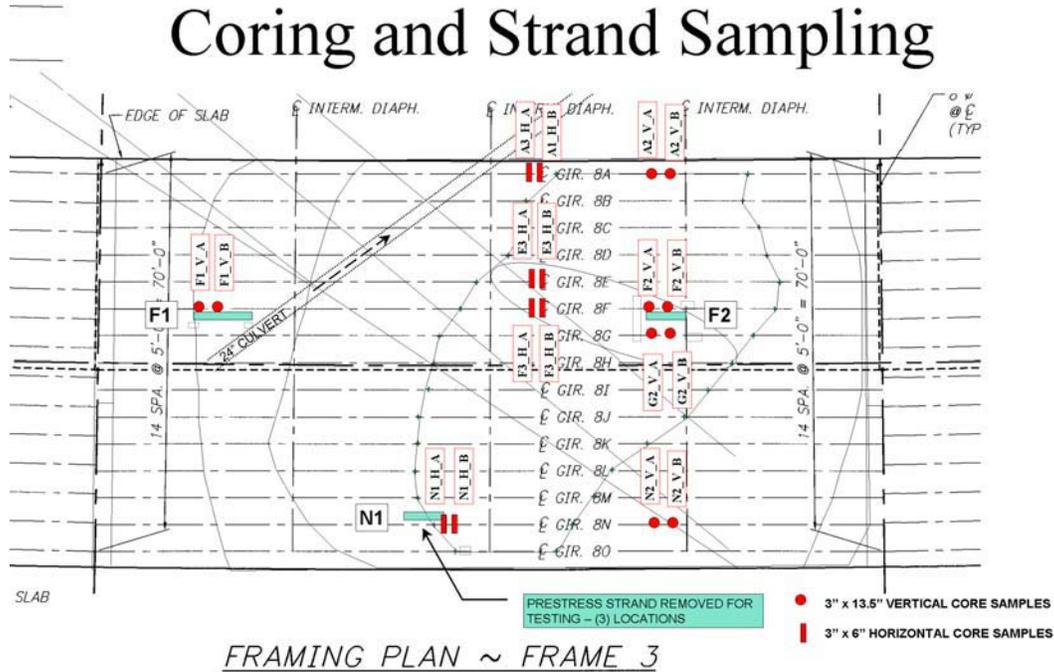
Three samples of the prestressing strands in Span 8 were removed for lab testing to determine their material properties, Figure 8. Two samples of strand number 2 were removed from Girder 8F. Sample F1 was located near Pier 8 at the boundary of the Soot colored region well away from the hot zone, (Figure 3). The concrete in this region displayed very little damage from the fire. Sample F2 was located directly above the tanker fire in the Extreme-White color region, (Figure 3). Concrete in this region crumbled when tapped with a hand held rock hammer and could be crushed with finger pressure. One sample from Girder 8N, labeled N1, was taken at the eastern edge of the Ash-White color region, (Figure 3). Concrete in this region spalled when struck with a hand held rock hammer resulting in 6 inch long chunks that were difficult to break with hand pressure. The material and strength tests were performed by Smith-Emery Laboratories in Los Angeles, California. The report⁶ concluded that the material and strength properties of the strands samples met the requirements for 0.5 inch diameter uncoated seven wire prestress strands as described in ASTM A 416-96 and ASTM A370. Test results are shown in Table 2.

Figure 8. Concrete Core Sample and Prestress Stand Sample Locations

Conclusions: The prestressing strands retained the original material properties and design prestress force despite being surrounded by concrete that was significantly degraded by the heat of the fire.

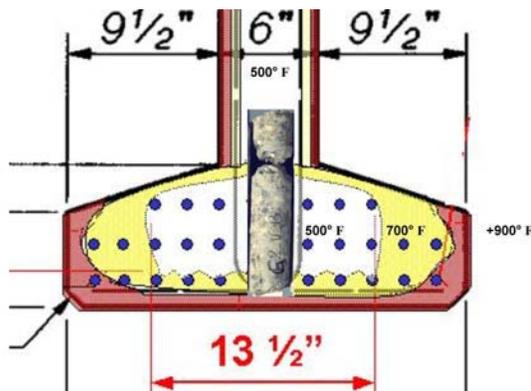
Core No. G2-V-B: Outer 3½ inches fair condition (up to ±500°F); remainder appears sound.

Figure 11. Core Sample G2-V-B – Taken from Extreme-White Color Region

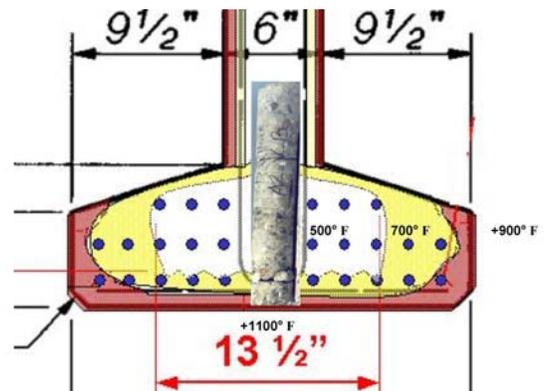
Core No. A2-V-B: Outer 2 inches poor condition (±700°F-900°F); remainder appears sound.

Figure 12. Core Sample A2-V-B – Taken from Ash-White Color Region

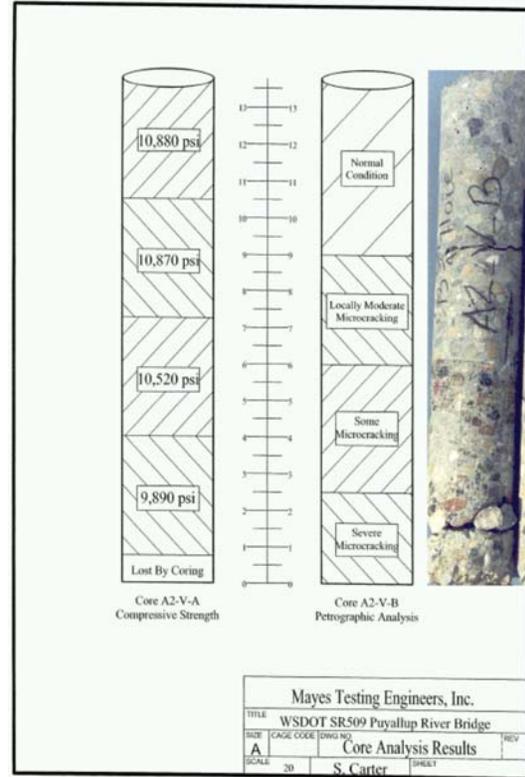
Compression tests⁸ performed on the core samples indicated that much of the girder core has excellent strength with compressive strengths that exceed 9000 psi. Figure 13 shows the strength test profile and petrographic analysis profile for location A2. However, concrete core samples taken from Girders 8A, 8F, and 8G showed numerous physical signs of concrete degradation. For example, the drilling operation was easier to perform than in regions away from the hot zone. The cores were missing 0.75 inches of concrete from the flange soffit, (Figures 11 and 13). They fractured during the drilling process at the bottom row of strands and at the interface of the web and the flange, (Figures 11 and 12). The cores broke at additional locations if not handled with care. Core samples taken at location F1, in the Soot colored region away from the hot zone, were exceptionally difficult to drill and were very

durable when handled. These differences indicated significant heat damage, but the compression tests did not indicate much change or a performance problem.

Figure 13. Compression Test Profile Core A2-V-A⁸, Petrographic Profile Core A2-V-B⁸, Photo Core A2-V-B⁷.

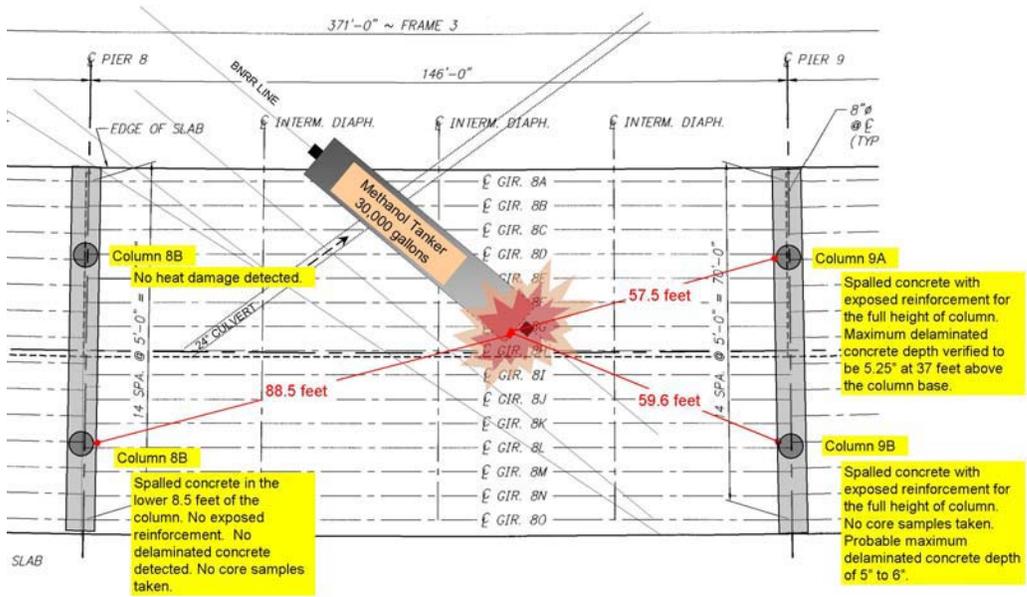
Column 8B was approximately 88 feet from the source of the fire at the railroad tanker, (Figure 14), and showed no significant effects on the side facing the tanker. However, the east face was exposed to methanol flames emanating from the adjacent drainage ditch. Concrete spalling occurred in the bottom 8.5 feet of the column, Photo 8. The concrete spalls were found to be less than 1 inch in depth. No reinforcement was exposed and no concrete delaminations were discovered. The remaining concrete was not discolored and appeared to have serviceable strength.

Columns 9A and 9B were approximately 60 feet from the source of the fire, (Figure 14). Concrete spalling occurred for the full height of the columns on the south face of Column 9A and the southwest face of Column 9B. The spalled concrete thickness frequently exceeded 1½ inches resulting in areas of exposed spiral reinforcement. The remaining concrete was not discolored and appeared hard but delaminated. Exposed aggregate appeared to be in good condition except for one specific type of red rock. This rock was found in many locations to be highly fractured and could be crumbled between a person's fingers. The rock was similar in appearance to red brick and contained a white colored mineral or granule. Efforts were made to remove all of the delaminated concrete from the columns with the use of air hammers but the removal process was stopped at the outer edge of the vertical reinforcement at a depth of approximately 2¼ inches. Many areas of the remaining concrete in both columns sounded hollow indicating that delamination fractures continued inside the column reinforcement cage. A core sample taken from Column 9A at 37 feet above the base of the column (12.92 feet below the top of the column) showed concrete delamination had occurred at a depth of 5¼ inches from the original surface of the column.

Figure 14. Pier 8 and Pier 9 Heat Exposure and Damage

The recommended repair strategy for the damaged area of Column 8B is to perform a simple concrete pour-back with dry concrete mix to provide environmental protection for the column reinforcement. The concrete repair must be performed according to WSDOT repair procedure, ie;

The recommended repair strategy for Column 9A and Column 9B is to perform a seismic column retrofit using a steel confinement shell and grout to fill the annular space between the steel shell and the column. The delaminated concrete in Column 9A and 9B present a concern for the performance of the columns during a seismic event. Providing a steel shell will assure confinement of the column core and assist with the placement of grout or concrete to protect the exposed reinforcement.

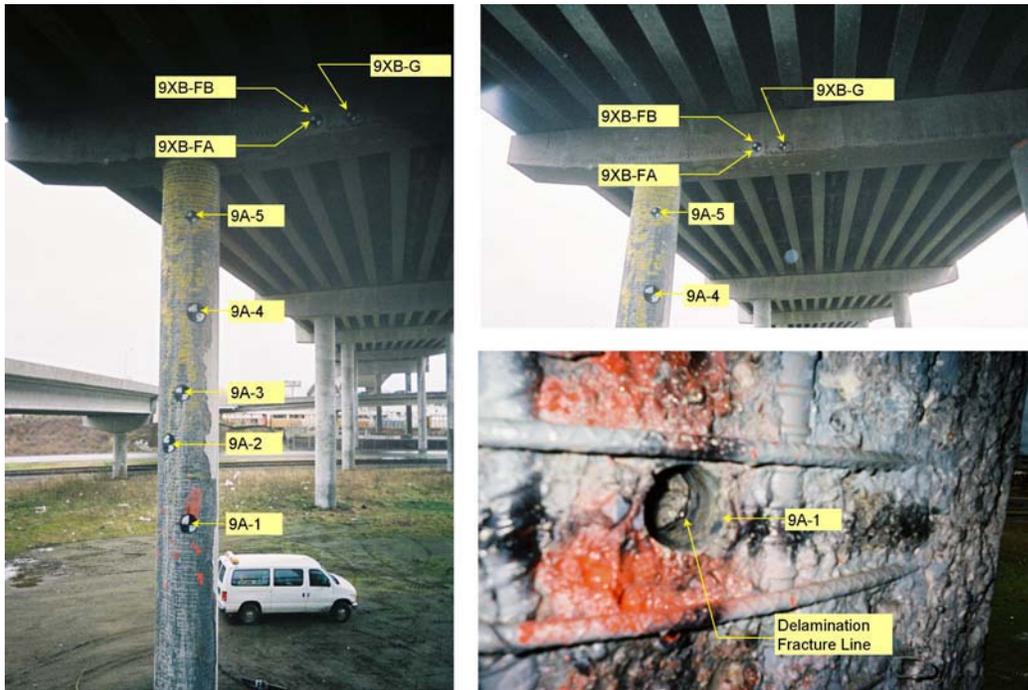
Photo 9. Pier 9 Core Sample Location

Core samples from Column 9A confirmed the existence of delamination fractures in the interior core of the column. The maximum depth of a delamination fracture was found to be 5” from the original surface and more than 1inch inside of the vertical column reinforcement, Photo 12. Aside from the delamination fractures, the concrete remaining on Column 9A appeared to have very good strength.

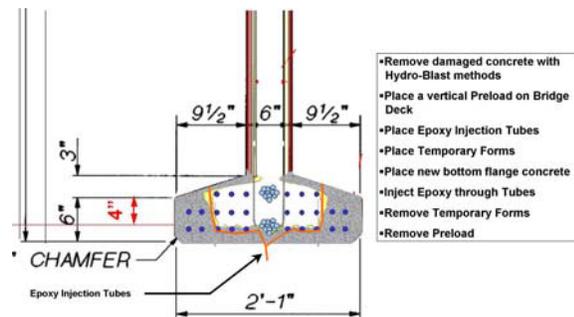
Figure 15. Hydro-Blast / Preload / Pour-Back

HYDRO-BLAST / PRELOAD / POUR-BACK: The objectives of this alternative is to safely remove and replace all damaged concrete, (Figure 15). Pre-compression would be added to the bottom flange by adding a vertical preload to the bridge deck prior to placing the concrete. Epoxy grout would be injected into the cold joint between the new concrete and remaining girder concrete. The pre-load would be removed to compress the pour back concrete.

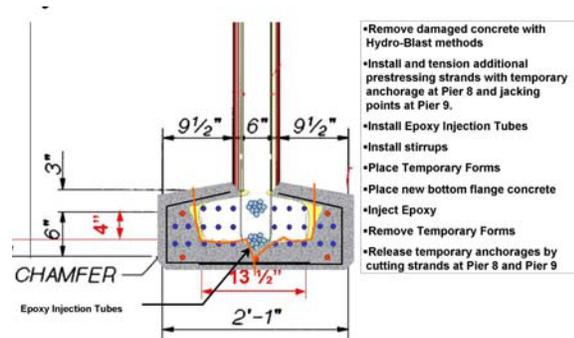
Figure 16. Hydro-Blast / Prestress / Pour-Back

HYDRO-BLAST / PRESTRESS / POUR-BACK: The objectives of this would be similar to the previous alternative but prestress would be used instead of a pre-load, (Figure 16). Compression in the new bottom flange concrete would be established by installing bonded prestress strands. The damaged concrete would be removed with hydro-blast methods. The prestress strands would be installed above and below the existing bottom flange. A

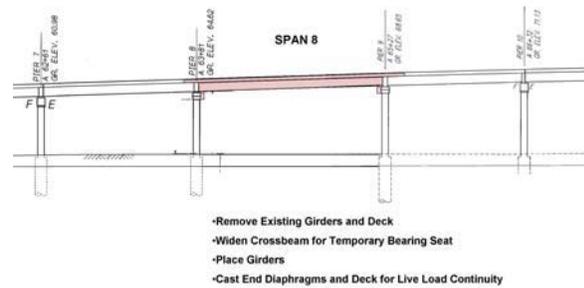
Figure 17. Span 8 Replacement Profile

Objectives of the replacement strategies are to restore the service life and ultimate moment capacity by replacing all 15 girders in Span 8, (Figure 17). The demolition and construction sequences must minimize disruption to highway and railway operations. Three alternative design concepts were considered. Alternative 1, replace “In-Kind” with 15 lines of W74G girders using the As-Built specification for concrete strength and strand diameter. Alternative 2, replace with 10 lines of W74G girders using 9000 psi concrete and 0.6 inch diameter prestressing strands. Alternative 3, (Figure 18), replace with 8 lines of WF74G girders using 9000 psi and 0.6 inch diameter prestressing strands. The WF74G girder section is a new long span section with greater capacity than the W74G girders.

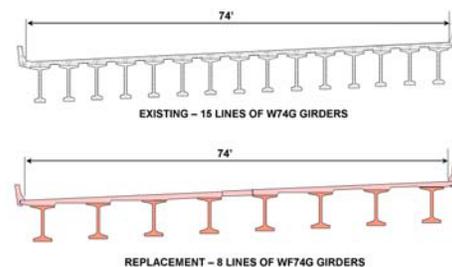
Figure 18. Span 8 Replacement Section
