Segmental Bridges: Case Studies and Lessons Learned

by Chris Davis, Scott Greenhaus, Eric Sommer, and Bob Sward, Structural Technologies; Bob Gensel, Pullman Services; Craig Finley and Jerry Pfuntner, COWI

Case Study: West Seattle High-Rise Bridge Emergency Repairs

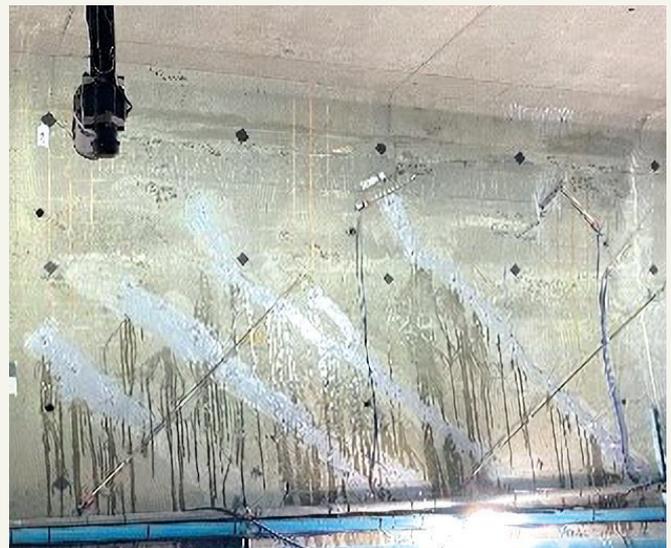
Electronic crack monitors and epoxy injection repairs in December 2020 on the West Seattle High-Rise Bridge. This photo shows four of the previously installed crack monitoring devices and electronic data cables along with one of numerous cameras (visible in the upper left corner of the photo), installed throughout the bridge to allow visual monitoring of cracking. Photo: Pullman Services.

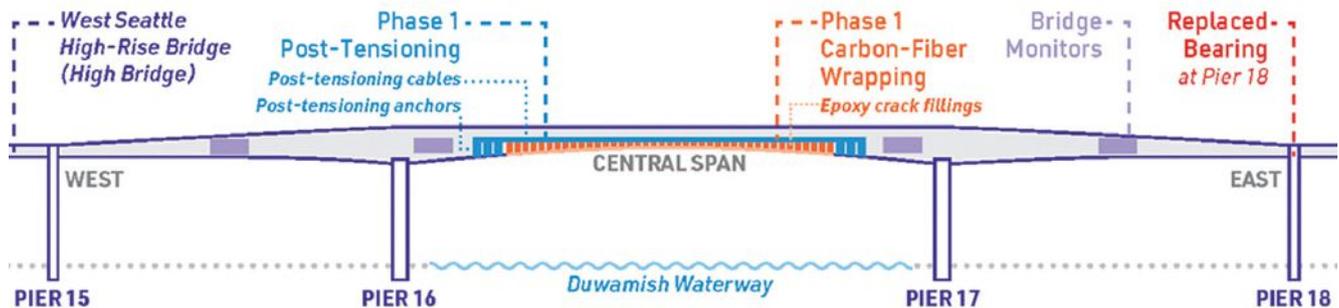
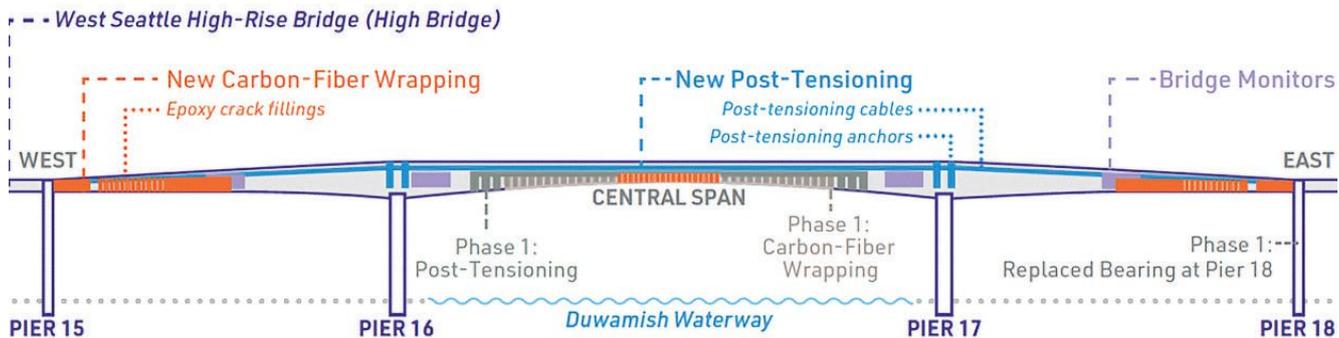
Schematic elevation views of the West Seattle High-Rise Bridge showing activities and locations for Phase 1 stabilization and Phase 2 rehabilitation projects. Figure: Seattle Department of Transportation.

Following the 2020 bridge closure, a two-phase approach to stabilization and repair was developed. Phase 1 focused on stabilizing the main span to mitigate concerns regarding potential collapse, whereas Phase 2 would complete repairs necessary to fully reopen the bridge to traffic.

Phase 1 repairs commenced in late 2020 and required the use of custom platforms to access the bridge's exterior. To stabilize the structure and to allow subsequent Phase 2 repairs to be performed, the project team implemented a repair scope that included epoxy injection at crack locations, installation of an external longitudinal post-tensioning system within the concrete box girders, and the installation of carbon-fiber-reinforced polymer (CFRP) at selected locations along the superstructure.

Phase 2 commenced early in 2022 and again included CFRP and external longitudinal post-tensioning, as well as more comprehensive epoxy injection at the remaining cracks located throughout the superstructure. The West Seattle High-Rise Bridge is currently expected to be reopened to traffic in July 2022.

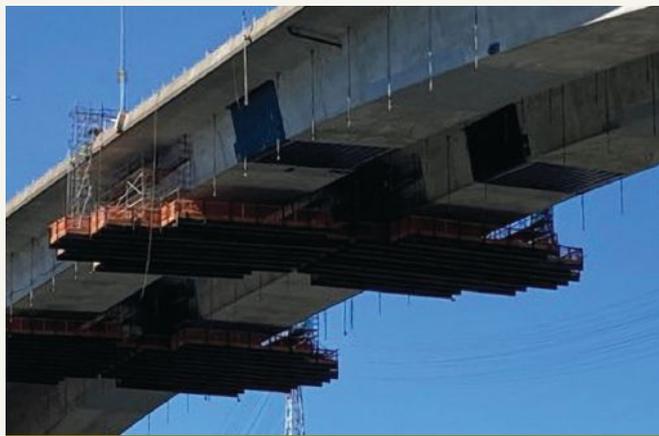
Access platforms for initial repairs to the exterior of the West Seattle High-Rise Bridge. Photo: WestSideSeattle.com.

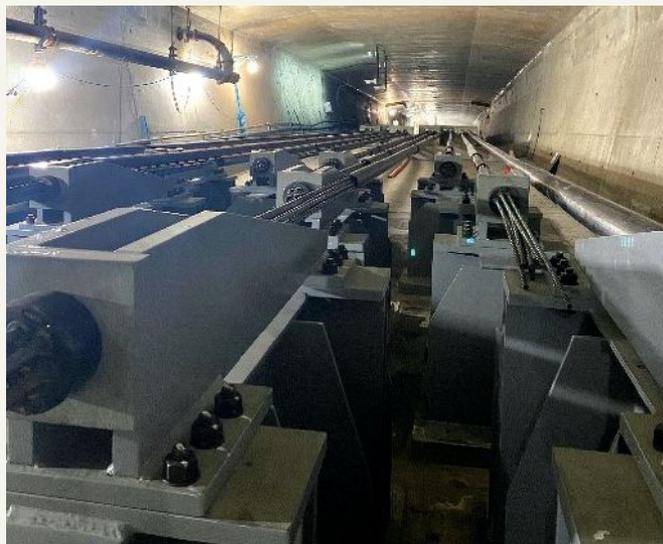
One aspect of the rehabilitation of the West Seattle High-Rise Bridge was the installation of new external post-tensioning tendons and anchorages inside the bridge. Photo: Pullman Services.

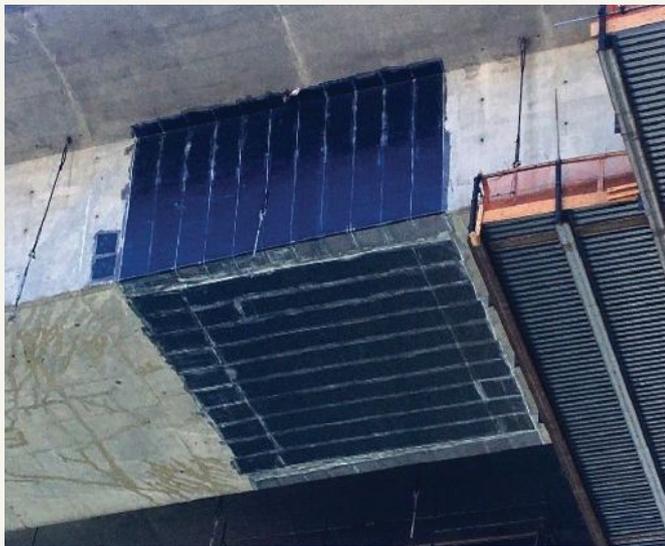
As part of the rehabilitation of the West Seattle High-Rise Bridge, carbon-fiber-reinforced polymer was installed at selected locations. Epoxy-injected cracks are visible on the bottom slab of the box girder. Photo: WestSideSeattle.com.

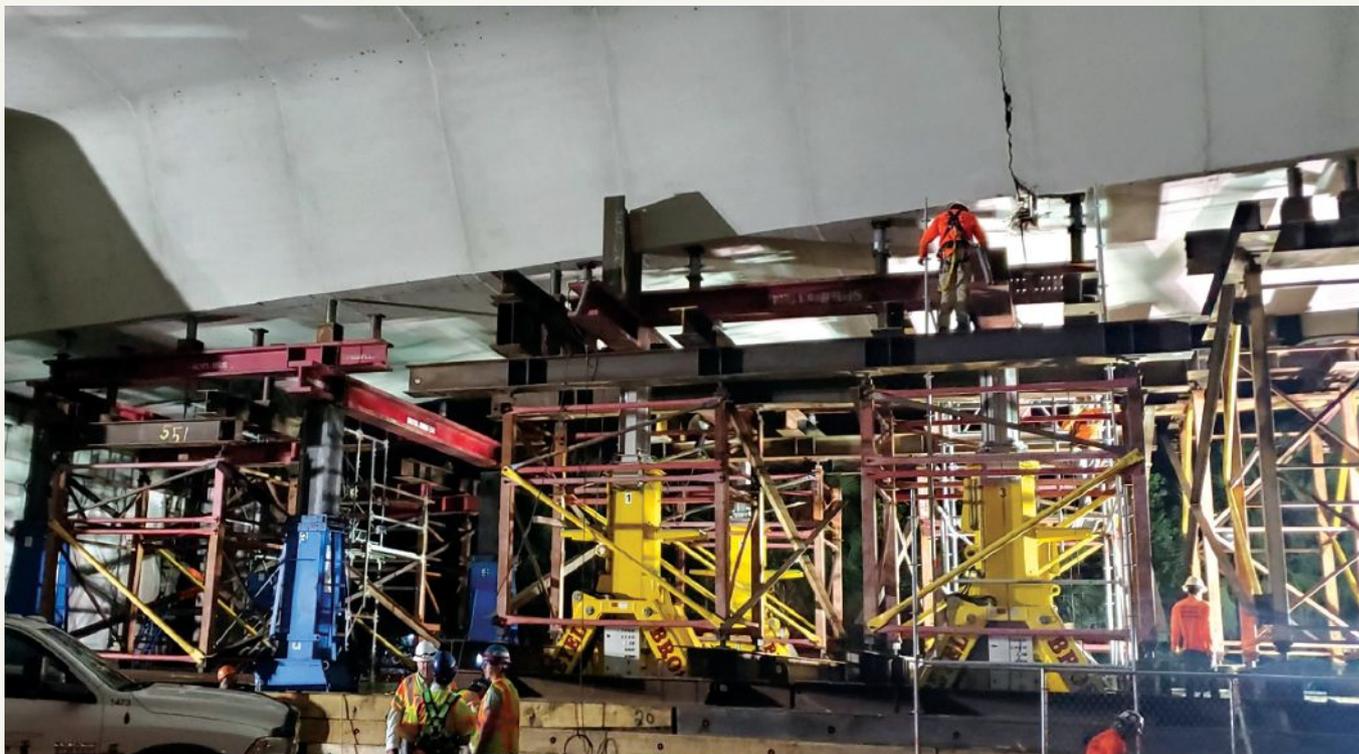
In June 2020, the Florida Department of Transportation (FDOT) closed portions of the bridge to address emergent repair needs identified during a routine inspection. Cracking was discovered in the bottom slab of southbound span 1 over Dixie Highway, and out of an abundance of caution, both bridges and Dixie Highway were immediately closed to traffic.

FDOT quickly assembled a team of consultants to determine the extent of the issue because it could compromise the life safety of the traveling public. They determined that the crack was caused by five post-tensioning tendons that had failed in the bottom slab due to excessive corrosion. The corrosion was attributed to water that migrated from the bridge deck through segment joints and bottom slab tendons, and leakage through fiberglass storm drainage pipe joints inside the bridge. The consultants further determined that the immediate issue was isolated to the southbound structure, and the northbound structure could be reopened to traffic. As the northbound bridge was being reconfigured to accept both north- and southbound traffic, an emergency shoring system was installed beneath southbound span 1, which would allow the reopening of Dixie Highway.

To facilitate repairs on the southbound span 1 of the Roosevelt Bridge, additional 100-kip-per-leg shoring towers were added around the initial emergency shoring. In the upper right of the photo, a vertical crack is evident in the outside web of the box girder. Photo: Structural Technologies.

Once the construction phase began, supplemental shoring was added to southbound span 1. The emergency shoring was adequate in capacity; however, it could not be moved to facilitate the support and adjustment of each precast concrete bridge segment during repairs. During the construction phase, the remaining bottom slab continuity tendons on southbound span 1 had to be detensioned, and their associated concrete anchorage blocks had to be removed from inside the box section to clear the way for the installation of the new post-tensioning system. The supported segments of southbound span 1 also needed to be raised and lowered during the repair process to avoid cracking in the webs as existing tendons were detensioned and to reinstate the original geometry and ride quality of the bridge deck.

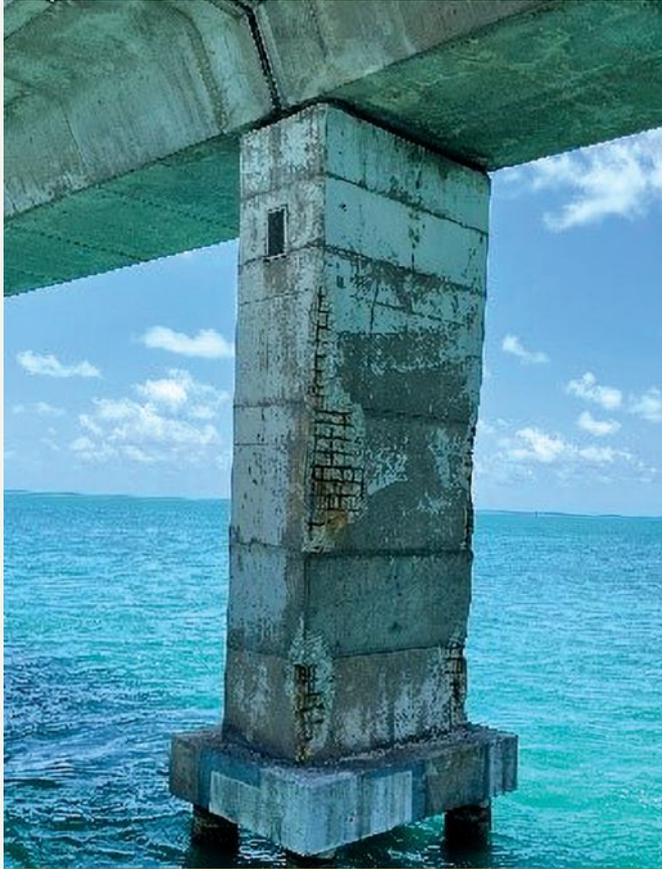
Chloride had penetrated to the outer layers of the substructure's reinforcement and had infiltrated defects in the segment joints and post-tensioning bar blockout pourbacks, which initiated corrosion in the mild reinforcement and vertical post-tensioning bars, leading to spalling of the exterior concrete cover on the precast concrete segmental box piers. An engineering evaluation of the bridge in its current state was performed, and the substructure load demands that are imposed on the bridge as it sits today were determined. It is critical to understand where this bridge is relative to the imposed deformations from creep and shrinkage, which will have largely already occurred at this time. The theoretical calculations can be generally confirmed from observations of the bearing deformations after correction for thermal movement. However, after more than 40 years, the structure has already experienced the long-term movements, and this process is far from an exact science.

A typical segmental box pier of the Channel Five Bridges in the Florida Keys has experienced daily exposure to saltwater from tidal, wave action, and seawater spray for more than 40 years. This had led to spalling of the exterior concrete cover. Photo: COWI.
