Texas Replaces Washed-Out Cow Creek Bridge in 29 Days

by Biniam Aregawi and Michael Hyzak, Texas Department of Transportation

COW CREEK BRIDGE / NORTHWEST TRAVIS COUNTY, TEXAS

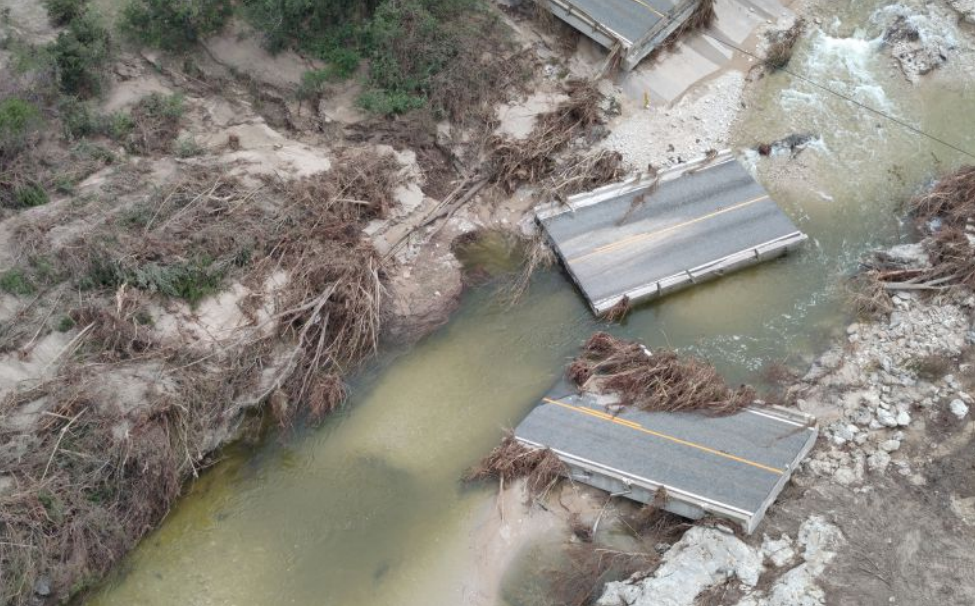
The original bridge was overtopped by Cow Creek, and segments were displaced some distance away. All Photos: Texas Department of Transportation.

As soon as the floodwaters receded on July 6, engineers from the TxDOT Austin District conducted a field assessment. They confirmed the total failure of the structure and discovered entire bridge spans scattered up to 100 yards from their original location.

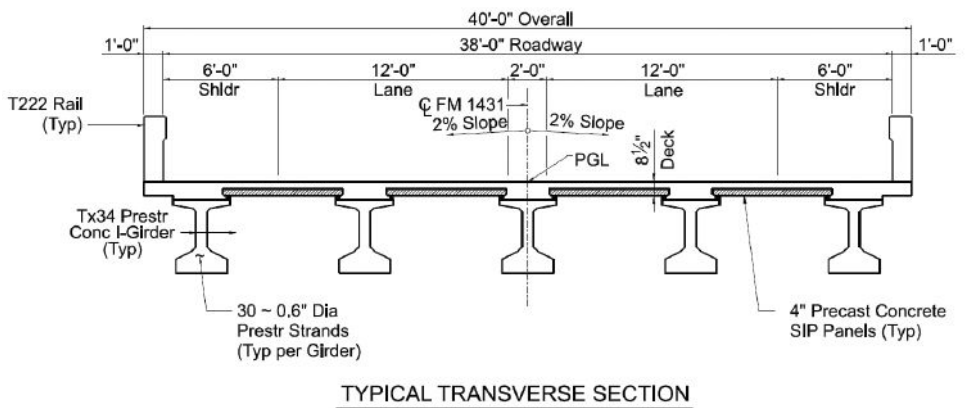
Cross sections of new Cow Creek Bridge. The new bridge was widened a nominal amount. Figure: Texas Department of Transportation.

Compared with the bridge that washed away, the new bridge includes several structural improvements to enhance resistance to extreme flood events. The diameters of the round columns were increased from the typical 36 in. to 49 in., and the cross sections of the rectangular bents were also increased in size. Whereas the original bridge had six span lengths of 40 ft, the new structure's three spans are 80 ft to improve the hydraulic flow. Enhanced concrete shear keys were incorporated at the substructure-to-superstructure interface at all bents to enhance lateral and overturning force resistance.

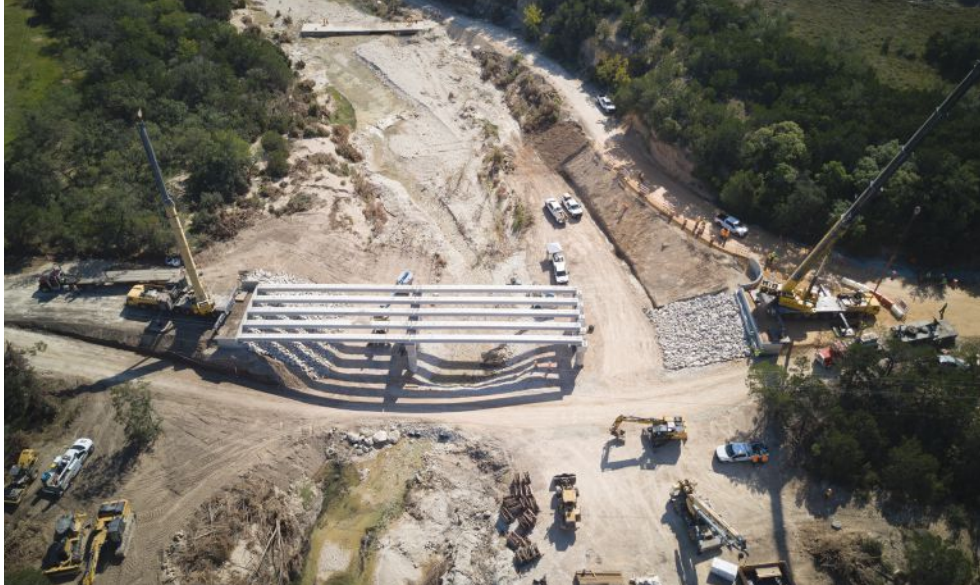
Installation of the 79.5-ft-long precast, prestressed concrete TX34 bulb-tee girders is complete on two of the three spans. The creek typically only carries a small amount of water, but with high-intensity rainfall events, the hydraulics can change immensely.

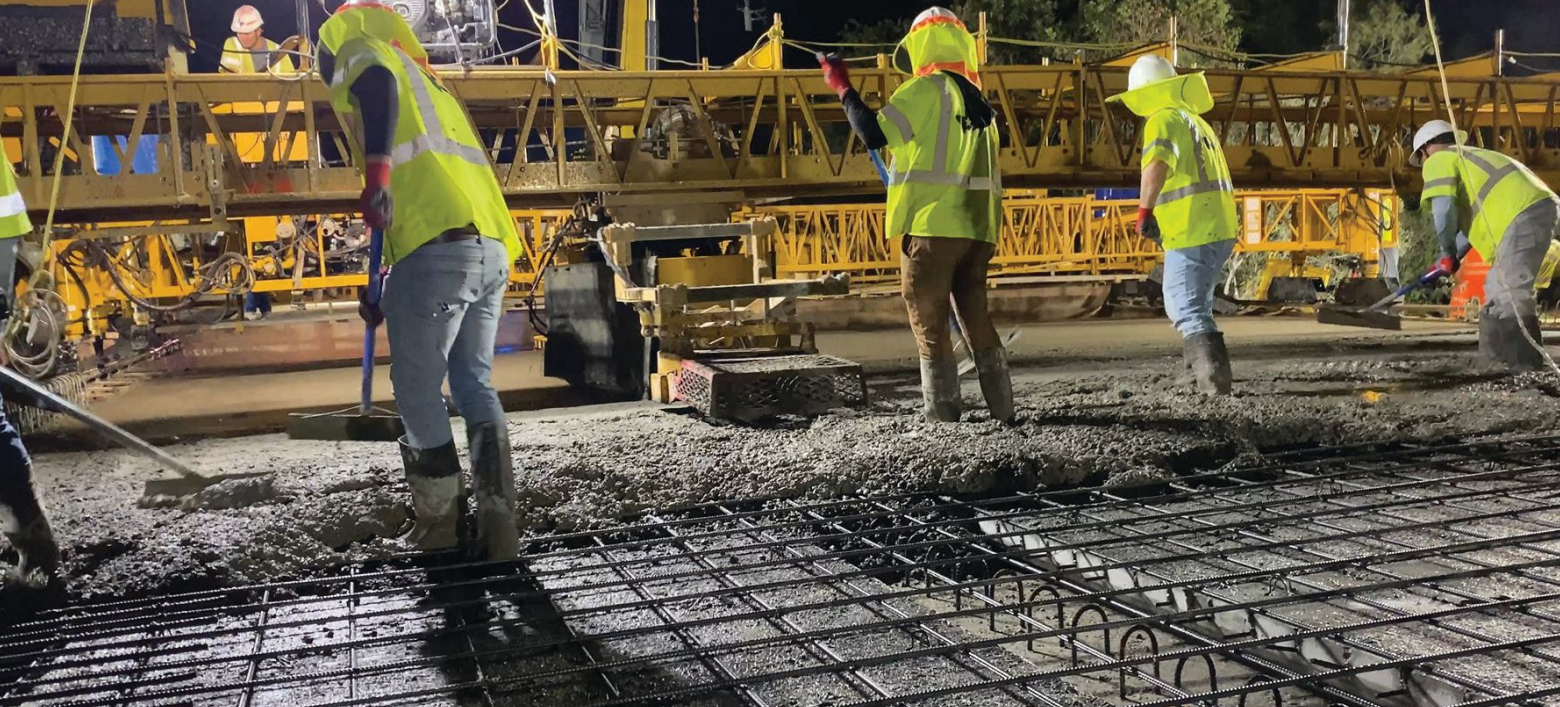
The cast-in-place concrete deck is placed at night to accommodate the project schedule. However, it is common to cast concrete decks at night during the summer months in Texas.
