PARTNERSHIP PAYS OFF

PRESERVING HISTORY

SETTING THE STANDARD

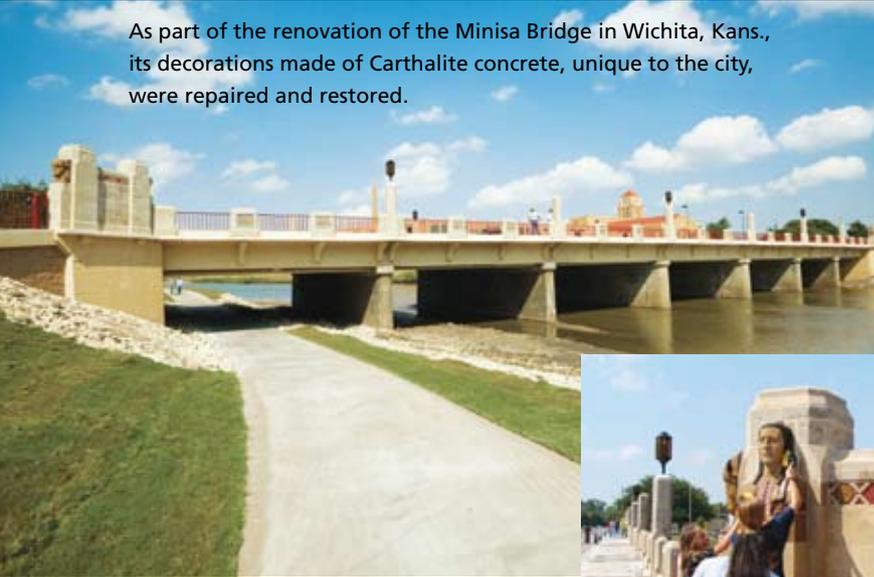
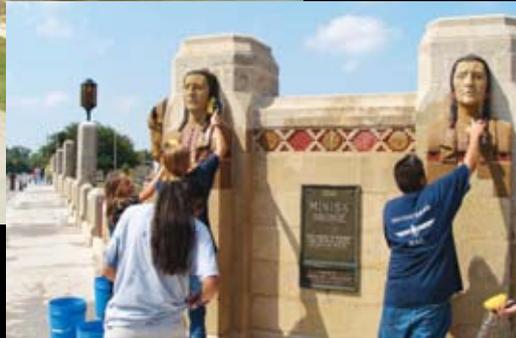
Community residents helping to restore some of the decorative sculptures on the Minisa Bridge.

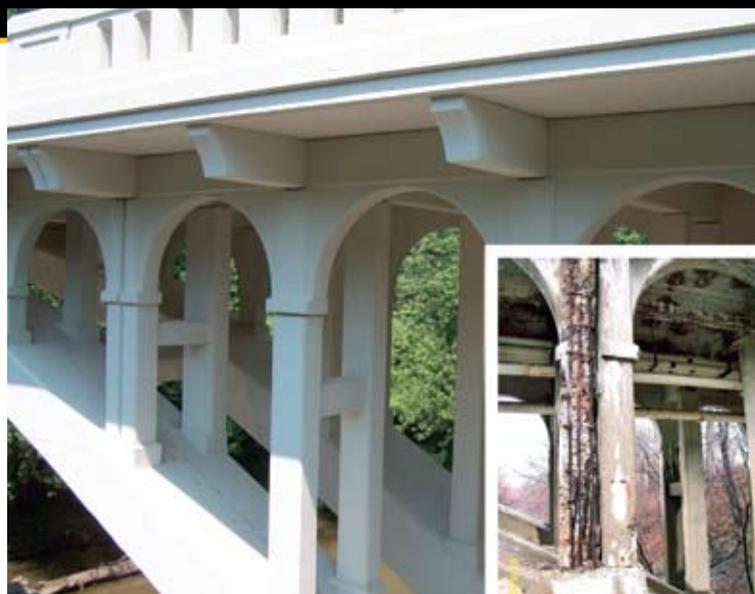
Precast concrete components, including columns and spandrel walls were carefully fabricated to replicate the look of the original concrete pieces replaced on the historic Spring Street Bridge in Floyd and Clark Counties, Ind.

This detailed coordination was required to ensure that any removed structural elements were reconstructed to match the existing elements' sizes and shapes. Precast concrete components were used extensively to save construction time and eliminate the need for additional formwork and bracing. It also eliminated any extra construction dead loads applied to the arch ribs.

Precast columns were attached to pedestals on the arch ribs with grouted NMB splice sleeves. These sleeves also were used to tie the floor beams to the tops of the columns. The precast spandrel walls were constructed to the same size and shape as the existing ones, as

these were the most visible elements from below the bridge. The spandrel walls were attached to the columns using a Halfen anchor channel cast into the column and a Halfen tee-head bolt cast into the spandrel wall.

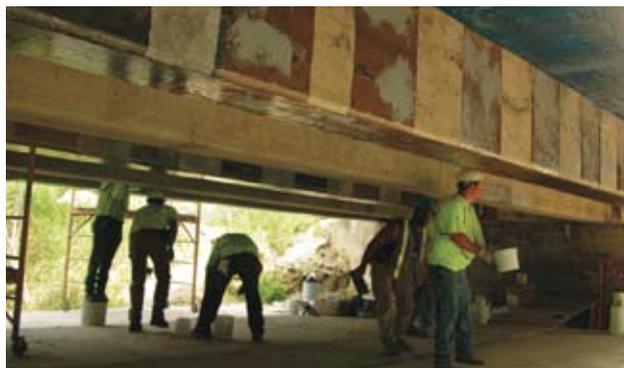
The bridge, built in the 1940s, consists of a 48-ft-long span using six reinforced concrete tee beams. By 2008, the bridge was showing signs of corrosion damage and could not support the loads required for modern truck traffic. PennDOT officials worked with researchers at Penn State University and West Virginia University to evaluate the bridge's condition and investigate repair options.

Repairs to the bridge on State Route 4012 in Pennsylvania, which used carbon-fiber reinforcement and cementitious repair mortar, will serve as the standard by which other bridges will be repaired in the state.

The strengthening system consists of carbon-fiber sheets that are applied to the surface of the concrete structure to restore or increase its strength without changing the dead load. After the extent of the deterioration in the concrete was determined, each area to be addressed was prepared by sandblasting the surface. Then a two-part epoxy coating was applied with a roller. The MBrace sheets, which have the thickness and texture of denim, were cut to size and applied to the affected area. Another layer of epoxy was then added over the sheets.

The repair mortar was applied to damaged concrete areas and to the cross section of the bridge beams where needed. A special corrosion inhibitor also was included in the mix to provide additional protection.
