Hurricane-Damaged Span Replaced in 156 Days

by Stanley W. Woods

CSX TRANSPORTATION RAILROAD BRIDGE / BAY ST. LOUIS, MISSISSIPPI

AASHTO TYPE IV PRESTRESSED CONCRETE BEAMS WITH CAST-IN-PLACE SLAB / CSX TRANSPORTATION, OWNER

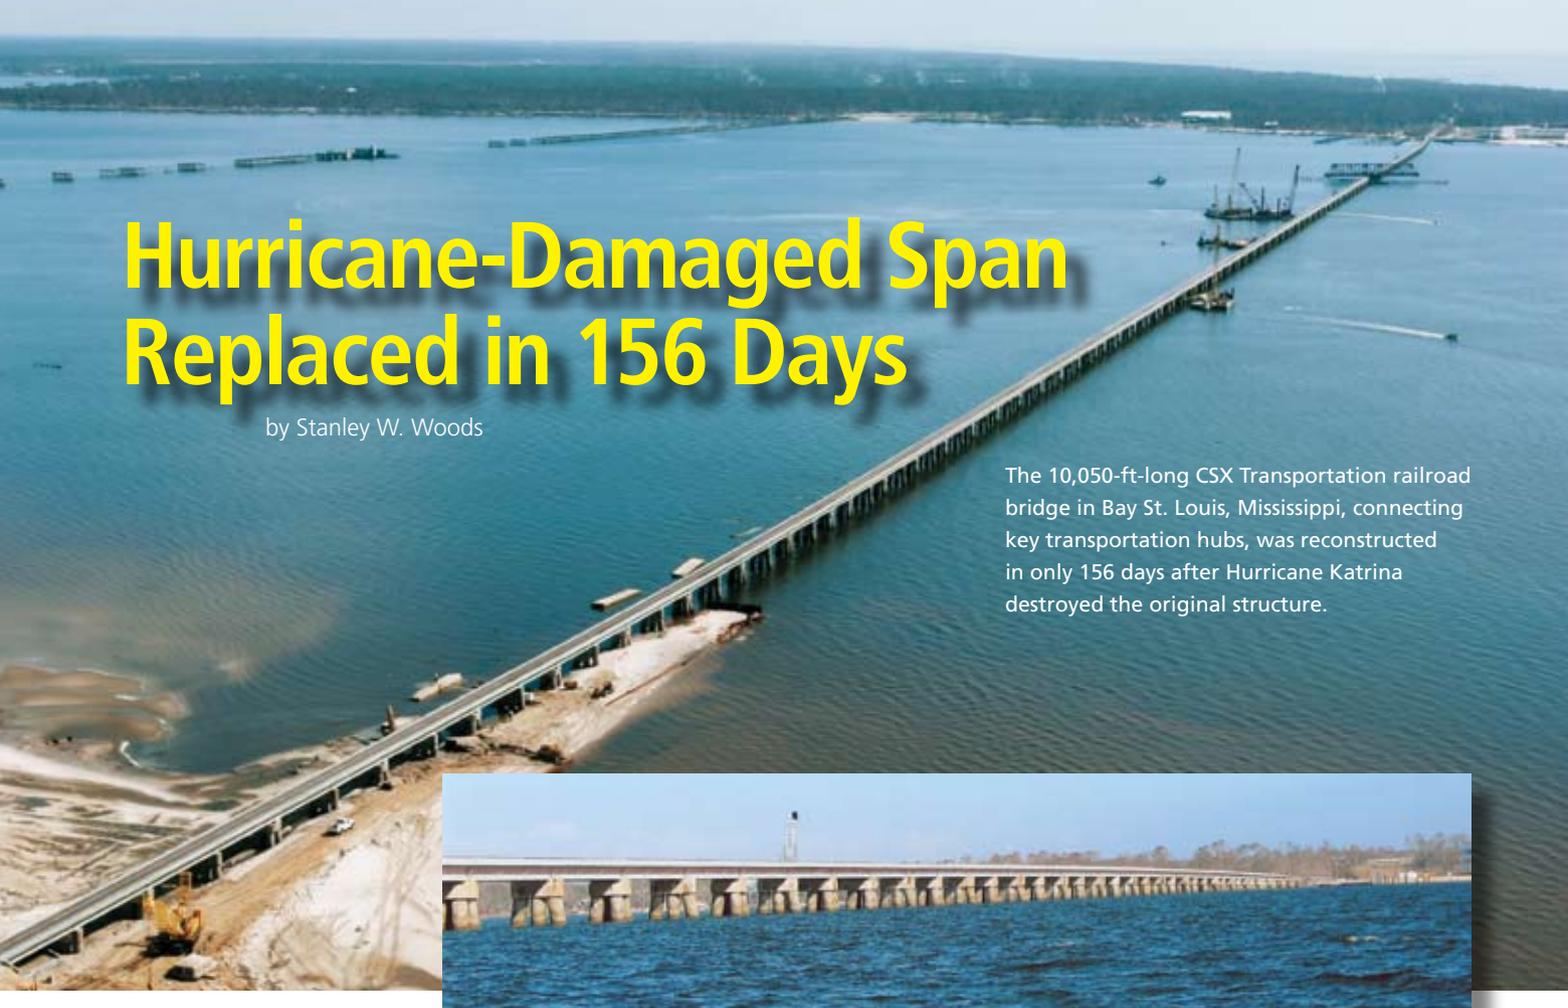
The 10,050-ft-long CSX Transportation railroad bridge in Bay St. Louis, Mississippi, connecting key transportation hubs, was reconstructed in only 156 days after Hurricane Katrina destroyed the original structure.

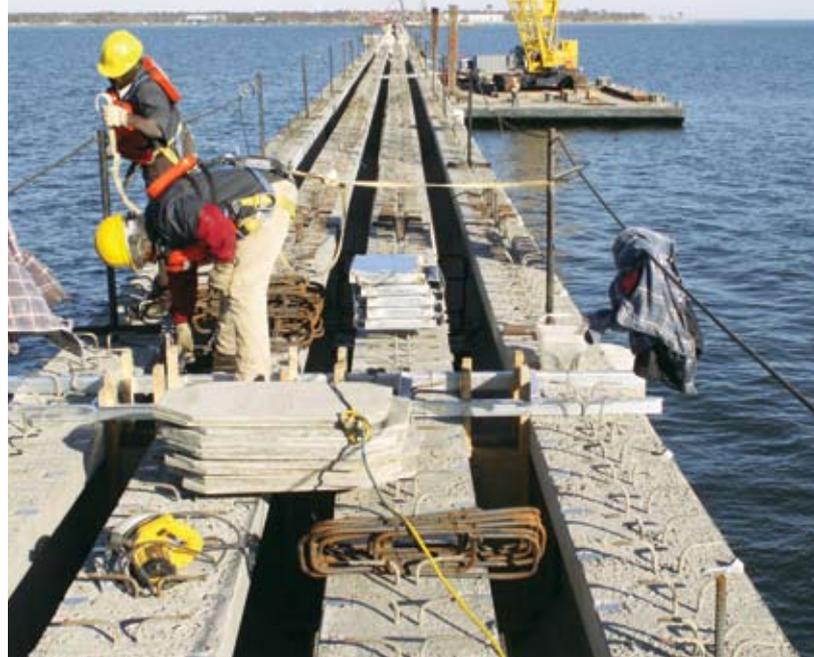
After the beams were erected, diaphragms, composite deck, and ballast curb were cast.

After the beams were delivered, they were loaded on barges and moved to the spans being erected. Beams were erected at an average rate of about 15 beams per day. Once the beams were set, stay-in-place metal forms were placed between the girders, and plywood forms were placed for the overhang soffits. The concrete deck and curbs were then placed. A pump truck was set on a sand causeway to supply concrete for the new superstructure. Replacement of the superstructure took only four months and was completed in early January 2006. The rock train arrived on January 14, 2006, when laying track and ballast operations began. The bridge was opened to rail freight traffic on February 1, 2006.

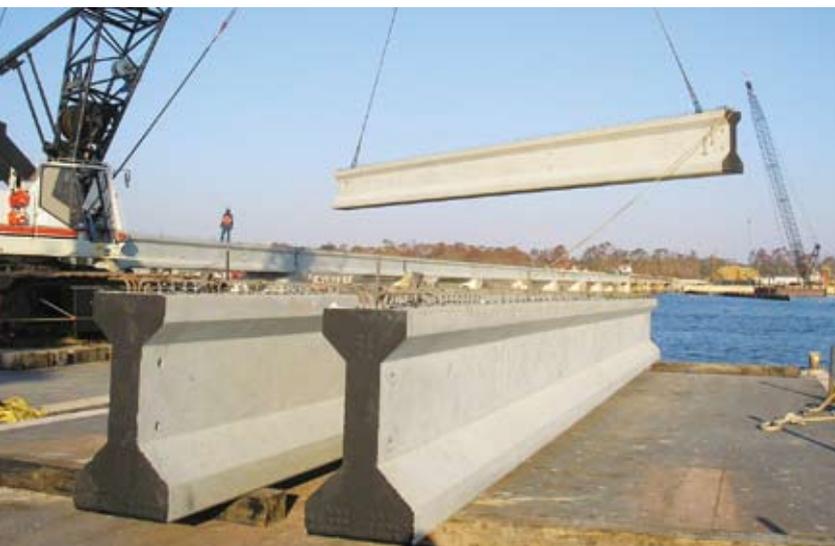
The AASHTO Type IV precast, prestressed concrete beams were erected at an average of 15 beams per day.
