Minimizing REPAIR IMPACT

by Craig A. Shutt

Fabric Repairs **HISTORIC ARCHES**

A PERFECT MATCH

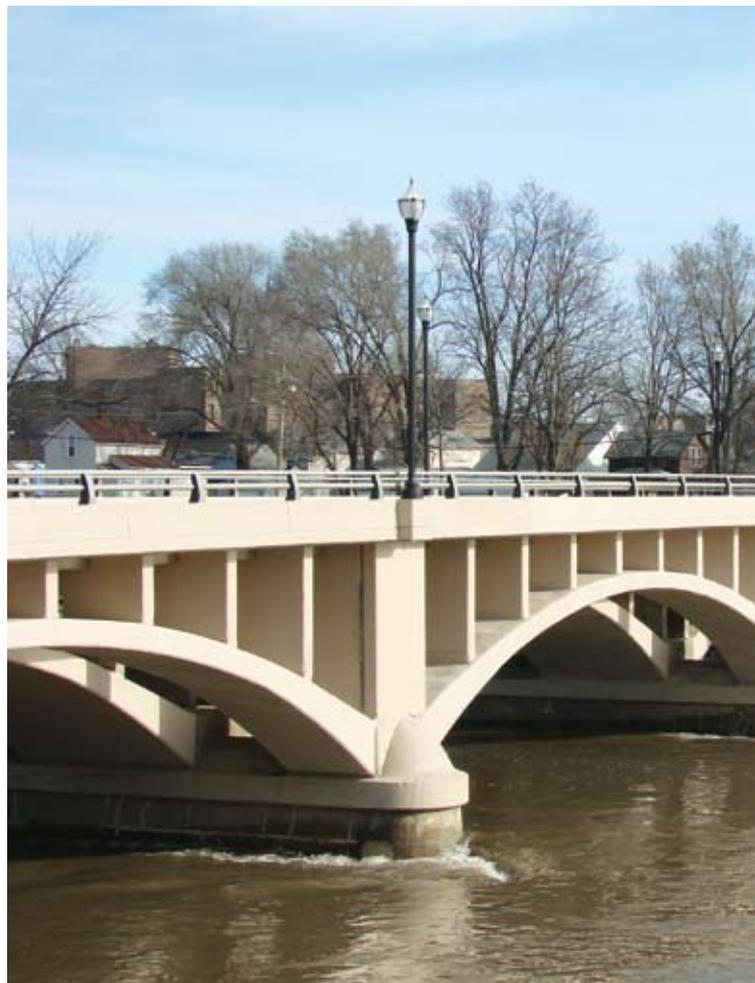
The 379-ft-long Station Street Bridge in Kankakee, Ill., had its five cast-in-place concrete, open-spandrel arches repaired with fiber-reinforced polymer composite wrappings. The repair was accomplished for less than original cost estimates.

Conventionally formed concrete and shotcrete were used for repairs, after which the arches were wrapped with the fiber-reinforced polymer composite. They were then painted to protect the composites and to give the repaired concrete a like-new appearance. To provide a consistent look to the entire bridge, the existing concrete not wrapped was painted to match the repaired substructure. All work on the bridge was performed under the direction of the prime contractor, Kankakee Valley Construction, Kankakee, Ill.

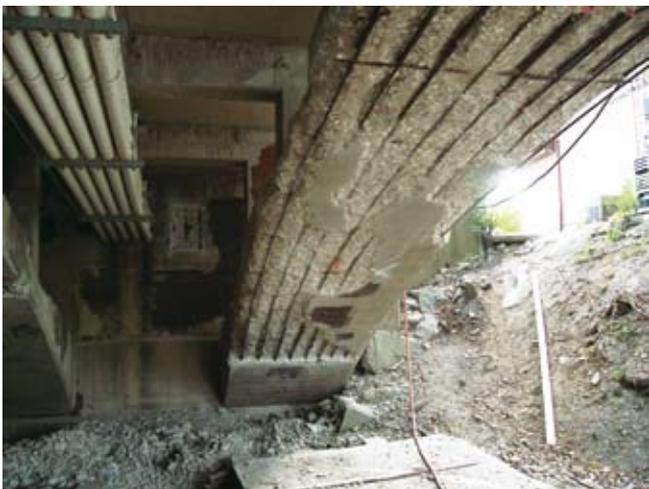
The arches on the bridge, which is listed on the Illinois Historic Bridge List and eligible for the National Register of Historic Places, needed to be repaired so that its historic nature was not disturbed.

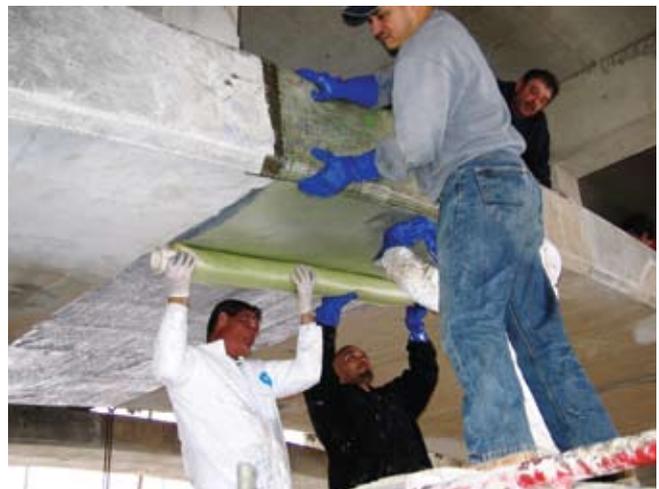
The contractor's low bid on the project allowed city officials to extend the wrapping work to include the center arch and still have the total cost come in below the original engineering estimate.

The fabric had been used in Illinois to strengthen existing columns in high-seismic areas, but it had not been used before to strengthen a spandrel arch bridge. Initially, engineering estimates had limited the project to wrapping only the two exterior arches, which were significantly more deteriorated. However, the low bid also allowed the center arch to be wrapped and the project to be completed for \$1.9 million or \$600,000 below the original estimate.

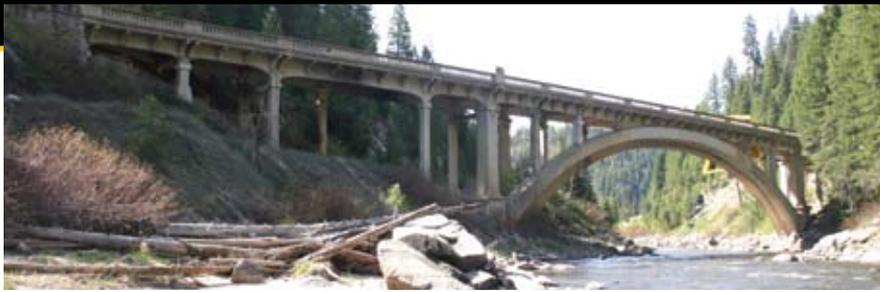
The historic Rainbow Bridge near Smiths Ferry, Idaho, had its deteriorating rails replaced with precast concrete units that were match-cast in color and texture to provide a consistent look for the entire structure.

The main focus at the deck level was replacing 841 ft of rail using precast concrete sections. This approach was taken to ensure the bridge could remain open avoiding traffic next to an unprotected edge. The key to success was finding the proper concrete mixture to ensure the new components would exactly match the shape, color, and texture of the original rails.

On the assumption that the original concrete mix comprised local aggregates, considerable scouting was done to find suitable sources. Concrete cores were taken from the existing bridge, and these were compared to cores taken from new samples cast with different aggregates. Tinting wasn't an option, as it would begin to weather and create a disparity. It was determined that some local aggregates were totally unsuitable, but ultimately a close match was created. The new concrete is expected to weather over the next few years to closely match the existing components.
