PROJECT / THE BRIDGE AT PITKINS CURVE

Improvements to Highway 1 at Pitkins Curve and Rainrocks

EA 05-0E9600

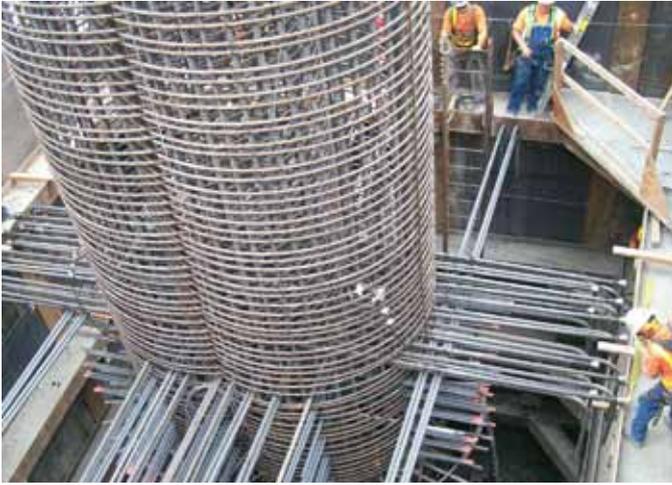
Main bent column reinforcement with partial main bent footing reinforcement being lowered into footing forms.

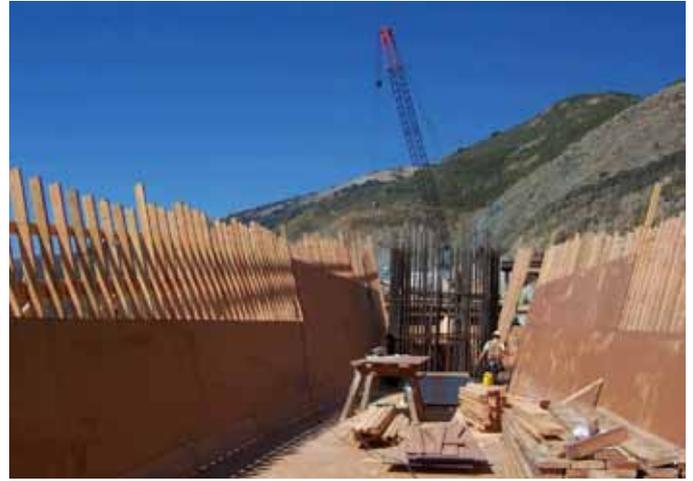
Girder and soffit forms for the first end span are supported on falsework.

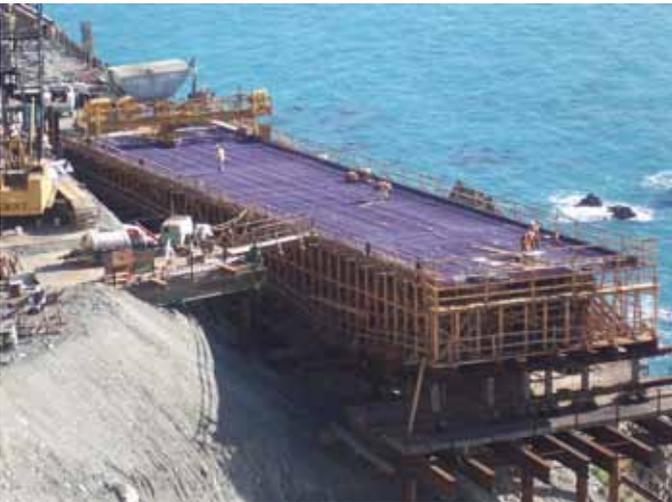
Epoxy-coated reinforcing steel in the deck of the south end span is readied for placement of the concrete. The end spans were formed on falsework.

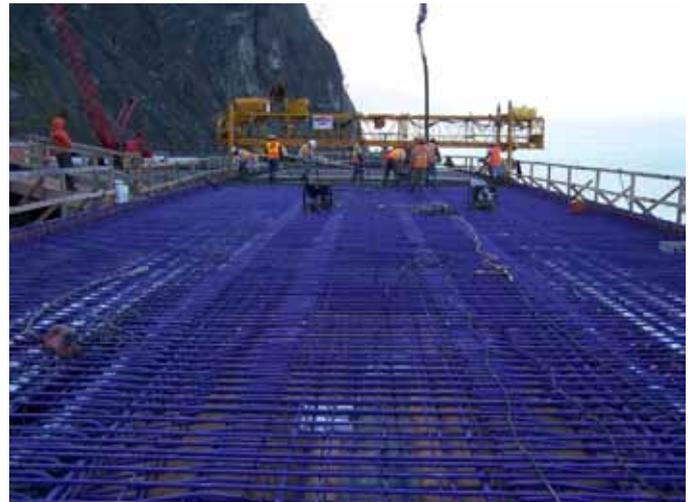
Epoxy-coated reinforcing steel in the deck prior to concrete placement.

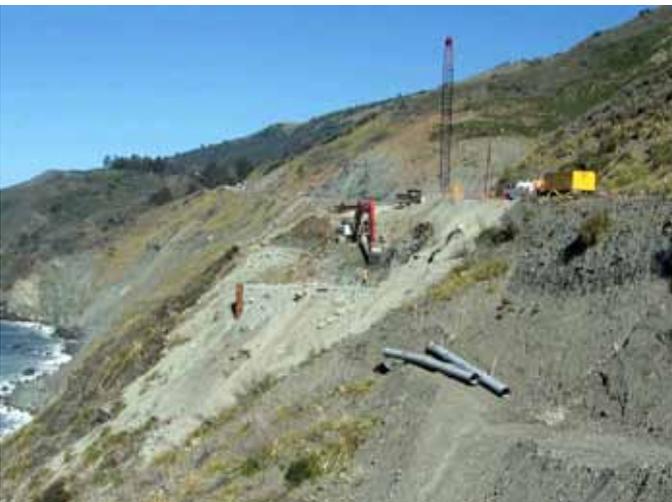
Falsework construction is started for the north end span looking north toward Big Sur, Calif.

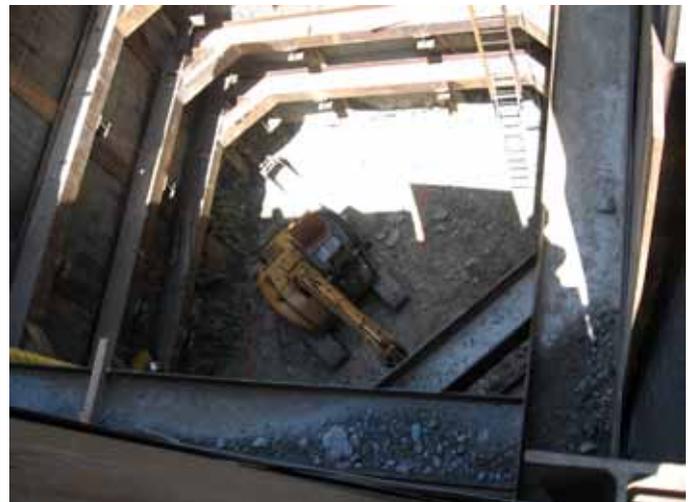
Shoring is in place in the excavation for the foundation of a bent. Drilling for the bent piles will take place at the bottom.
