# Investigating Existing Grouted Tendons

by Miroslav Vejvoda, Post-Tensioning Institute

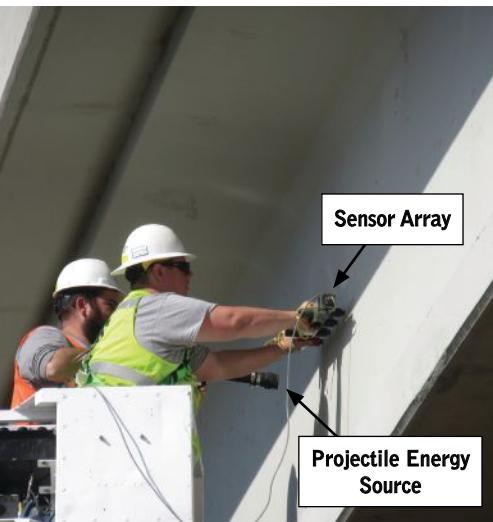
Impact-echo testing. See Reference 2.

The most recent of the three *PTI Journal* articles is "Nondestructive Testing for Voided and Soft Grout in Internal Post-Tensioning Ducts," by Paul Fisk and Benson Armitage.<sup>2</sup> This July 2019 article investigates the use of two nondestructive testing methods that can be used in detecting grout defects in tendons. The ground-penetrating radar (GPR) method is used to accurately locate the internal ducts to a precision of  $\frac{1}{2}$  in. Then, sonic/ultrasonic impact-echo testing can be used to detect voids or soft grout. Once a defect location is identified, workers can drill into the duct and use a borescope to document the tendon condition. The impact-echo system uses a projectile impact-energy source, a sensor array, and a computer to achieve quality display of data. If a

duct is fully grouted, the compression wave velocity generated and recorded by the impact-echo system remains constant. When voids or soft grout exist in the tendon, the resonant frequency is significantly lower or not measurable, indicating anomalies along the wave path.

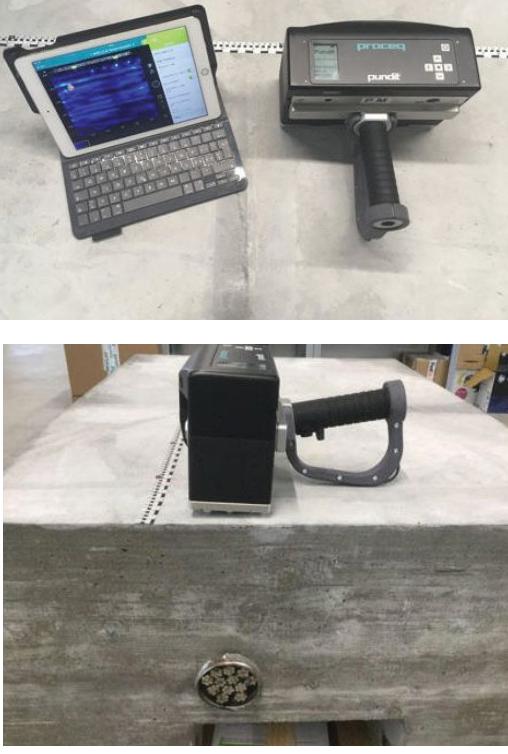
Pulse echo instrumentation includes a transducer and an indicating device (upper photo). The lower photo shows the transducer directly above a duct. See Reference 3.

The second article is "NDT Investigation of PT Ducts," by David Corbett.<sup>3</sup> This December 2018 article also describes how GPR is used to locate tendons; once they are located, potential grouting defects are identified through an ultrasonic pulse and echo (UPE) method. Objects in concrete are detected through reflections that occur at the boundary between two materials with different properties. GPR works with reflections occurring when the two materials have different dielectric properties, whereas UPE works with reflections occurring when the two materials have differing acoustic impedance. GPR waves are totally reflected at a concrete-steel boundary and partially reflected at an air or plastic boundary. UPE waves are totally

reflected at a concrete-air boundary and partially reflected at a steel or plastic boundary. Because of that, UPE enables PT duct detection through reinforcing bar configurations that would limit GPR. More significantly, the total reflection from air may make detection of voids in the duct possible. A comprehensive evaluation using the amplitude and phase analysis techniques of the pulse-echo technology is now possible as three-dimensional imaging is available in commercial equipment used on site.
