PROJECT

Rapidly Restoring a Vital Transportation Route in Nebraska

HIGHWAY 281 OVER THE NIOBRARA RIVER EMERGENCY RESPONSE / BOYD AND HOLT COUNTIES, NEBRASKA

BRIDGE DESCRIPTION: A 1050-ft-long, seven-span, continuous, prestressed concrete I-girder bridge

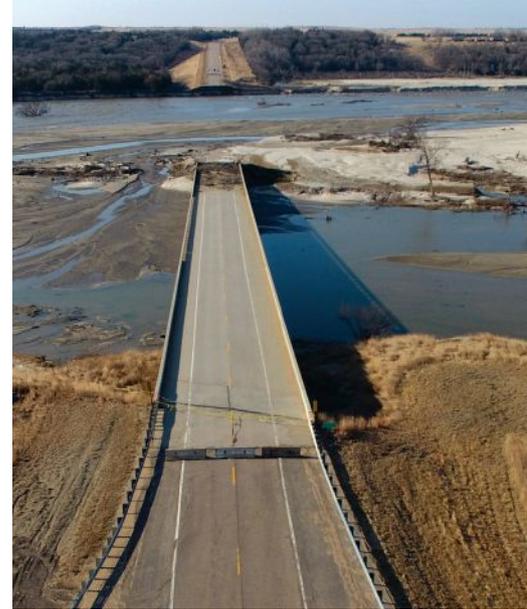
A rare bomb cyclone that hit Nebraska on March 12, 2019, caused the failure of the Spencer Dam in north-central Nebraska. The resulting flood damaged the existing U.S. Highway 281 bridge over the Niobrara River and created a new channel of the river that destroyed 1000 ft of pavement south of the bridge. Until a temporary bridge was installed, users had to endure a two-hour detour.

roads were either damaged or destroyed. One of the damaged roadways spanned the Niobrara River on U.S. Highway 281 (U.S. 281) in north-central Nebraska. Massive ice floes in the Niobrara River to the west of an existing bridge resulted in failure of the Spencer Dam, which

subsequently and dramatically created a brand-new path for the Niobrara River. The flooding left a wide path of destruction, including damage to the existing bridge and 1000 ft of pavement at the south end of the bridge.

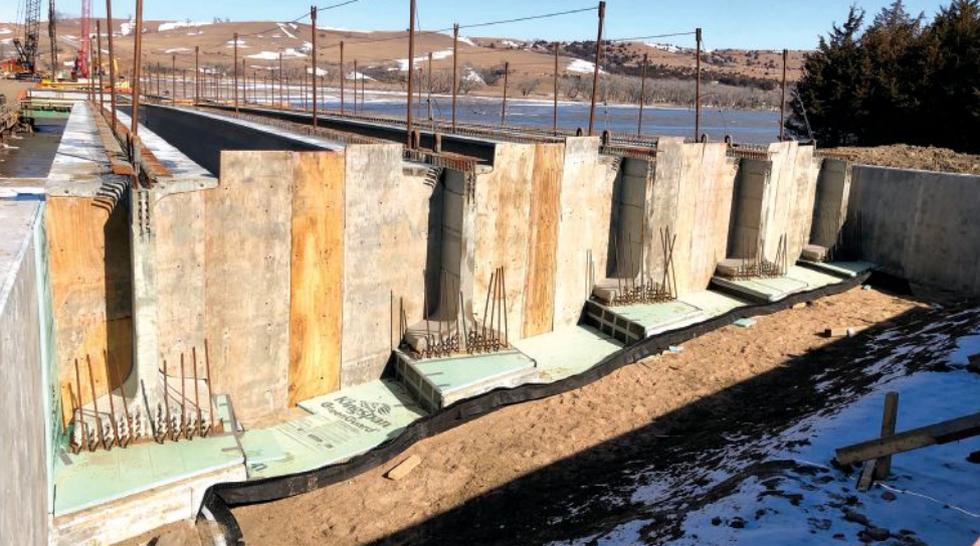
A view of the skewed ends of the NU1800 prestressed concrete girders at an abutment. This photo was taken before the semi-integral abutment turnout placement and before the deck forming and concrete placement. This bridge featured a jointless deck system across the length of the structure. Expansion joints were placed at the end of the approach slabs, which were founded on pile-supported grade beams placed 20 ft beyond the abutments.

load with a 20-degree skew with respect to the girders and consisting of 155-ft central spans and 140-ft end spans was determined to be structurally and hydraulically optimal. The bridge was jointless across the length, with expansion joints provided at a pile-supported grade beam at each end of the approach.

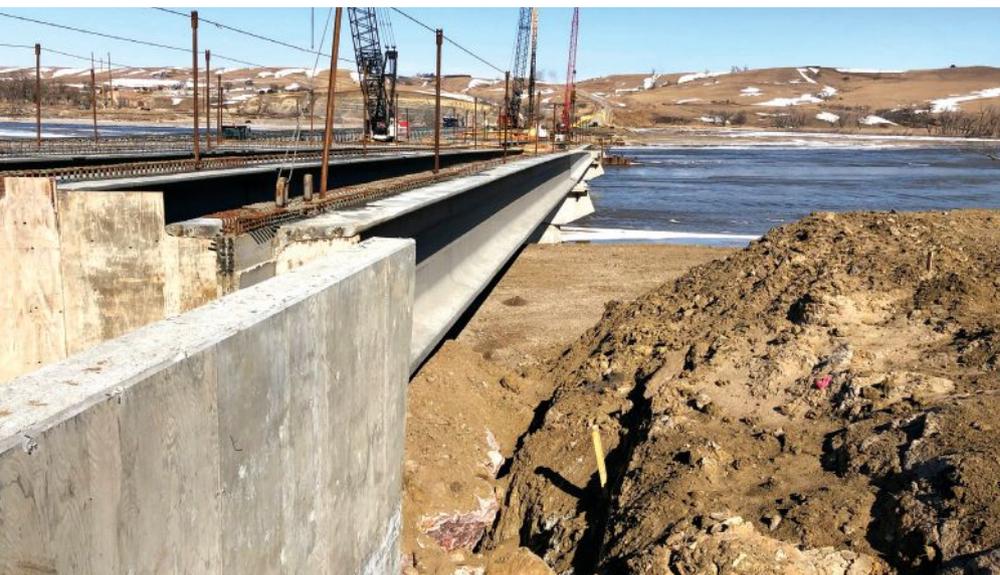
Girders are set and are being prepared for concrete deck placement on the U.S. Highway 281 Bridge over the Niobrara River. This photo is taken from the south bridge abutment looking along the bridge span over the new river channel. A temporary crossing for contractor access was constructed adjacent to the permanent bridge to allow cranes to access the jobsite and place girders. Multiple cranes were on site during construction, and space was generally limited between the temporary bridge and the permanent bridge.

The project encountered fabrication challenges that were mostly centered around availability. Girders were being cast for bridges across the state, and the girder fabrication timeline drove the construction schedule. Erection required a temporary crossing between the permanent and temporary bridges to enable the contractor to deliver and place the girders.

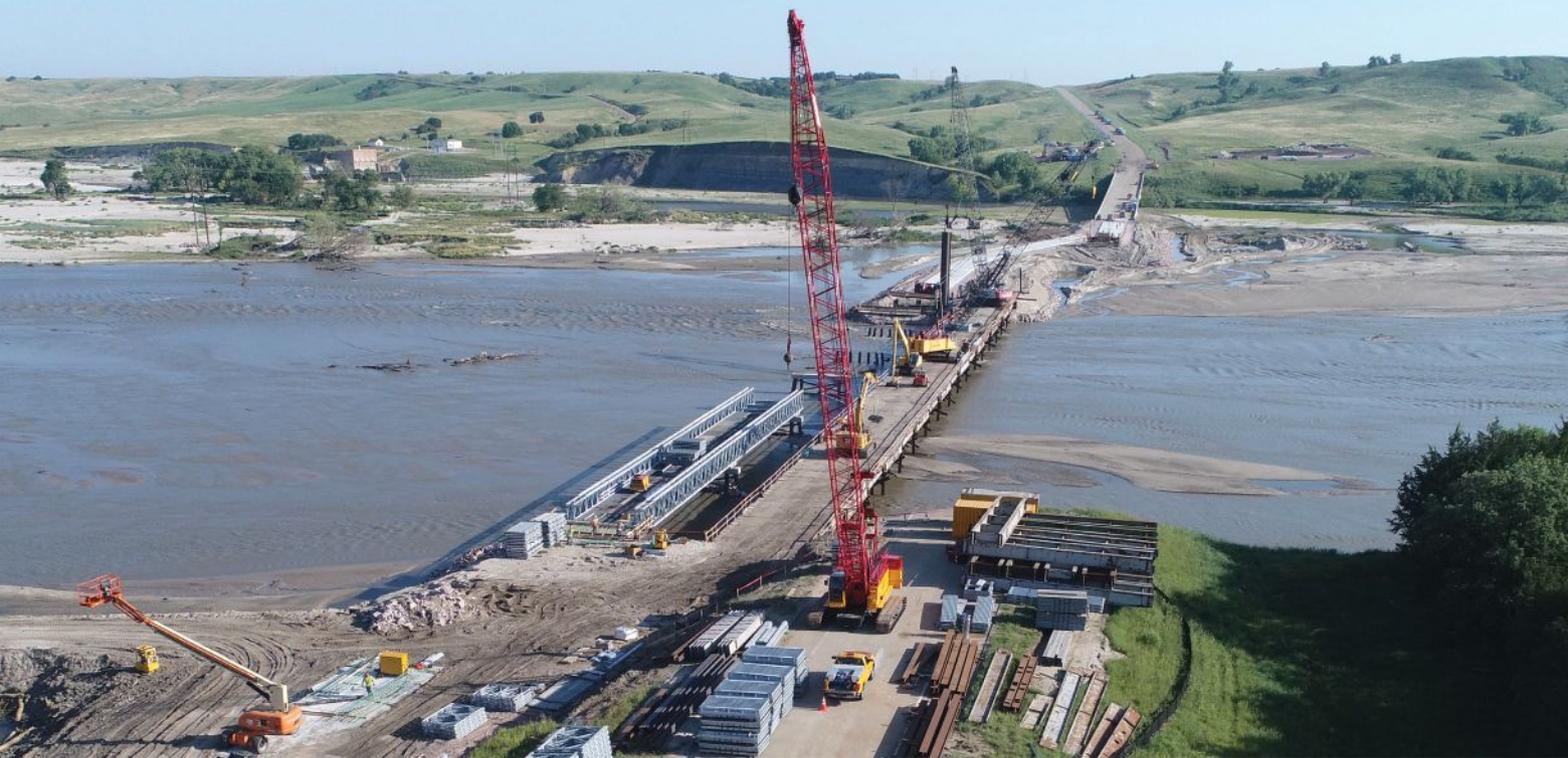
Aerial view of the new bridge location from the south abutment, with the existing bridge in the background. The hydraulic analysis and bridge design considered the current and future conditions of the new river channel, including the potential for the braided channel to shift and the channel bottom to lower significantly over time. The new bridge was constructed on the original alignment to the right of the temporary work bridge, which was also used to construct the temporary modular bridge used to restore traffic.

The permanent bridge design crossing the new river channel was not a simple task. The hydraulic analysis considered the current and future conditions of the new river channel, including the potential for the braided channel to shift significantly over time, and showed that a 1050-ft-long bridge would be necessary to span the new river channel. For economy, simplicity, and durability reasons, a prestressed concrete girder superstructure was selected as optimal for the site. A seven-span bridge using NU1800 girders made continuous for live

One of the key challenges for designing the permanent bridge was developing an understanding of how the new channel of the Niobrara River would evolve over time and the role the flow-line elevation and scour would play in the stability of the bridge foundation. The failure of the dam upstream would lead to aggradation for a time. Judging from the upstream and downstream conditions, it was clear the channel would eventually normalize to a
