Condition Evaluation of the JFK Causeway Post-tensioned Segmental Bridge

by Brian D. Merrill, Wiss, Janney, Elstner Associates Inc.

The John F. Kennedy (JFK) Memorial Causeway Bridge, completed in 1973, carries Texas Park Road 22 over the Gulf Intracoastal Waterway (GIWW), connecting Corpus Christi to North Padre Island, Tex.

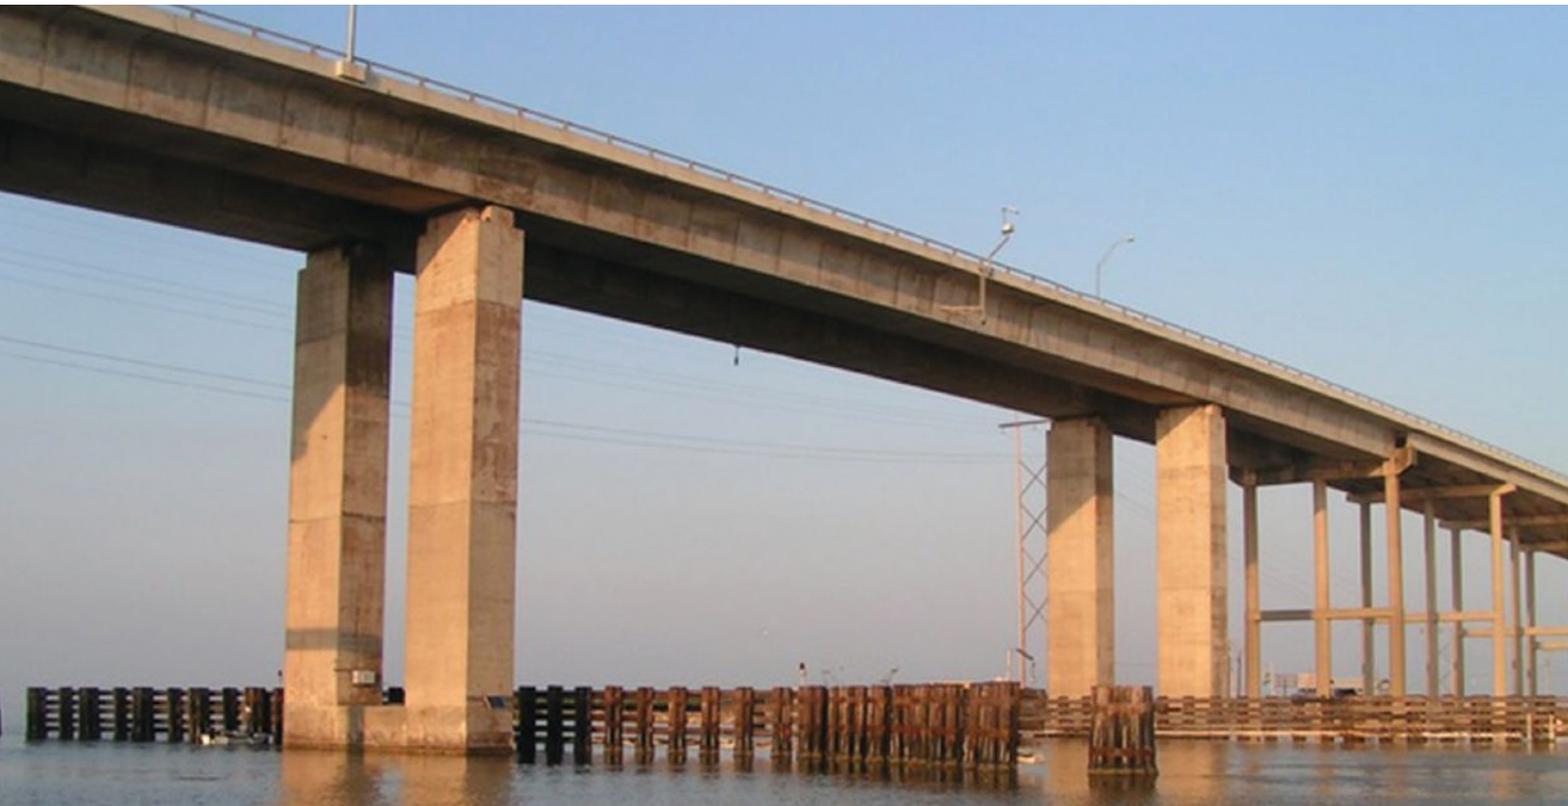
The John F. Kennedy Memorial Causeway Bridge over the Gulf Intracoastal Waterway was completed in 1973. The 400-ft-long (200 ft main span with 100 ft back spans) continuous main unit was the first precast concrete post-tensioned segmental box-girder bridge built in the United States. Photo: Texas Department of Transportation.

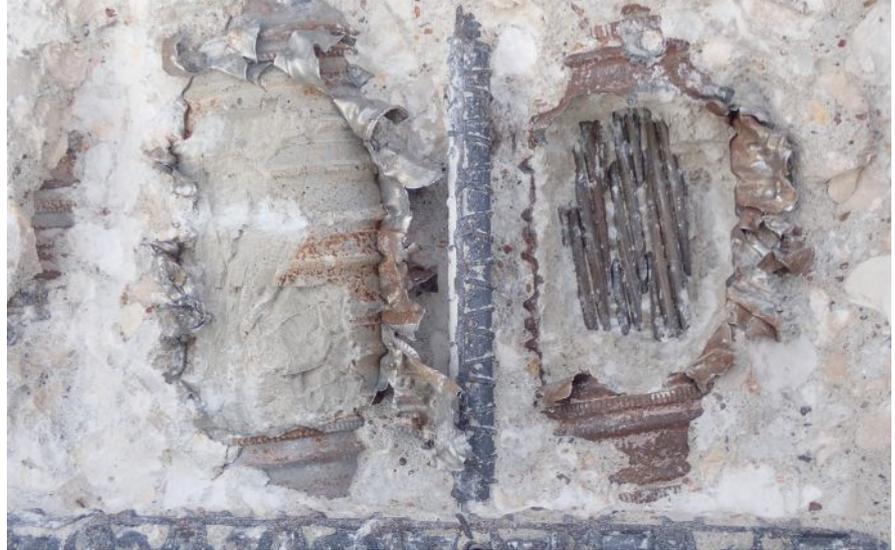
Deck tendon after excavation and opening of ducts for inspection.

The PT tendon survey indicated that the PT system was generally in very good condition. Very few grout voids were detected, and the strands that were uncovered in the deck or box web ducts were in like-new condition. There was some evidence of regrouting, likely to fill voids left during initial grouting. No evidence of PT system distress was observed, except for moderate corrosion of the end anchors where the pourback concrete failed to protect them from the corrosive environment. No distress was observed to be associated with the moisture intrusion at the deck anchorages. It

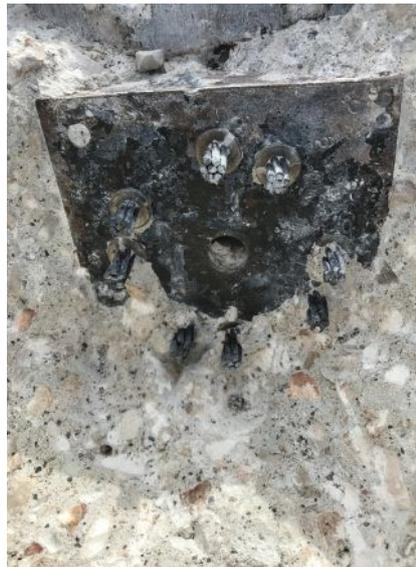
Continuity tendon anchor in deck exposed for inspection.

Photographs from the condition assessment of the main span continuous unit that included visually assessing 100% of the interior and exterior of both box girders; locating post-tensioning (PT) ducts using nondestructive evaluation methods to identify potential grout anomalies; and exposing selected tendons or anchorages for visual inspection and grout sampling. The PT tendon survey indicated that the PT system was generally in very good condition. Photos: Wiss, Janney, Elstner Associates Inc.

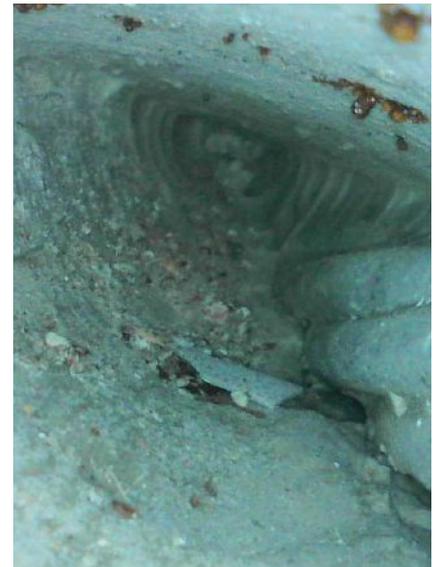
Borescope image of small void in deck tendon near post-tensioning anchor.

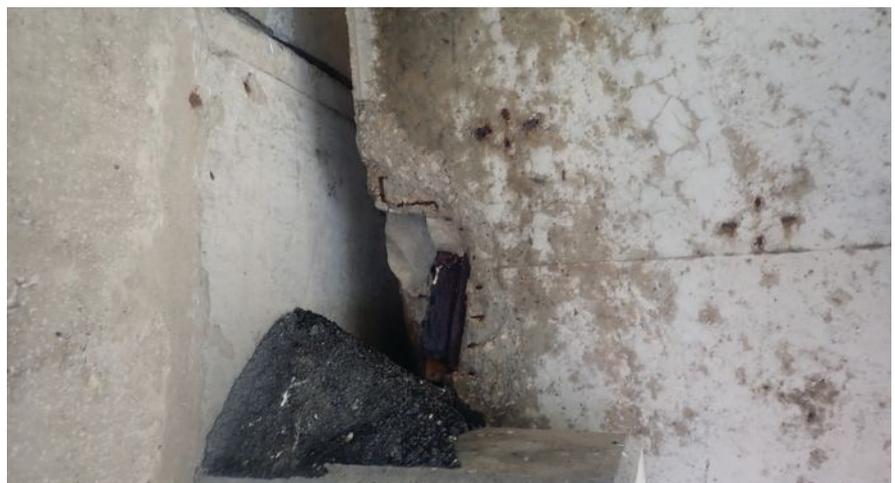
Moderate corrosion of continuity tendon anchor at end of box girder.

- Replacement of the asphalt overlays using a waterproofing membrane or with a polyester polymer concrete overlay
- Spot repairs to the isolated corrosion spalling
- Addition of a water-repellant coating to the exposed box-girder surfaces
- Replacement of the pourbacks at the end tendon anchorages
- Possible addition of a cathodic protection system to the substructure

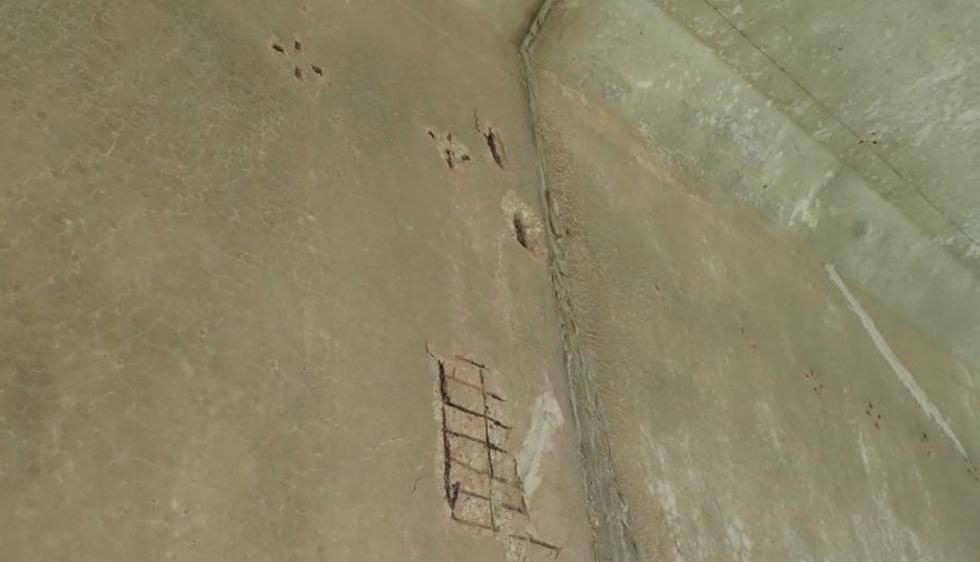
Spalling on the exterior face of the box girder exposed corroded supplemental (not indicated in original plans) wire-mesh reinforcement with insufficient clear cover. Photo: Wiss, Janney, Elstner Associates Inc.

The exterior visual survey identified diagonal cracking in the webs that had occurred during tensioning of the cantilever tendons and had been sealed with epoxy, spalling in the pourback mortar at the end anchorages of the continuity tendons, and isolated surface spalling with exposed reinforcing steel. No distress was observed at the previously sealed web cracks, and spalling that exposed corroded reinforcing steel occurred only at locations where it appeared that supplemental (not indicated in the plans) wire-mesh reinforcement had been installed with insufficient clear cover.
