A Precast Concrete Solution to Preserve Historical Integrity

Rehabilitating the historic Penn Street Bridge

by Michael Urban and Grant Flothmeier, Gannett Fleming Inc.

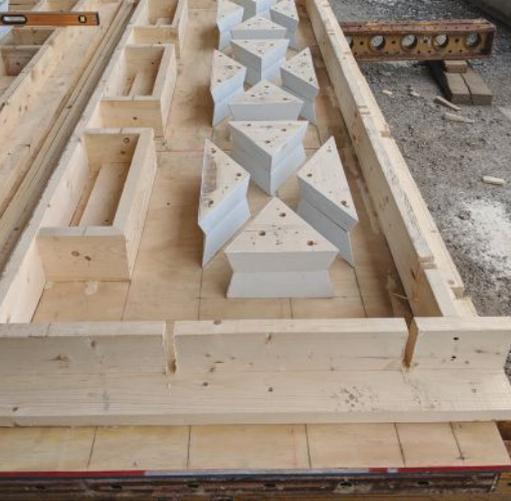
Reusable formwork for a precast concrete railing panel. Slots in end and top forms are for extended J-bars. The panels were cast on site under a span that could be closed to the public. Tarps were hung to control the environment.

During construction, the contractor opted to cast the panels on site, using the space below one of the closed-spandrel spans that could be closed to the public. Tarps were hung to provide the contractor with a controlled environment and enough space to cast several panels at a time. Once casting was completed, the same area was used to store the panels until they were ready for installation.

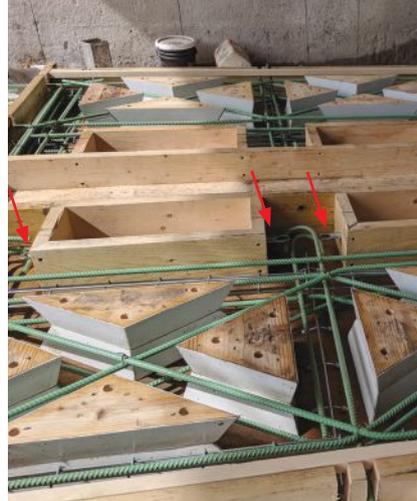
Two panel forms with epoxy-coated reinforcement installed, including J-bars extending from the top and sides of the panels to tie into the cast-in-place posts and rails. Inserts embedded in sides of the panel feet (see arrows) are for installing longitudinal reinforcement to tie panels to the sidewalk reinforcement.

limiting the required support when casting the posts, curbs, and rails led to the addition of "panel feet." The feet were placed directly on the sidewalk such that the panels required only temporary lateral support before the posts, curb, and top rail were cast. Inserts were embedded in the sides of the feet to receive longitudinal reinforcement that tied to hooked reinforcing bars projecting from the sidewalk between the panel feet. The height of the foot was based on the dimensions of the junction box that had to be positioned between the panel feet at certain locations. Epoxy-coated reinforcing J-bars extended from the top and sides of the panels to tie into the cast-in-place posts and rails. The J-bar provided adequate development for the reinforcement to secure the panels in place.

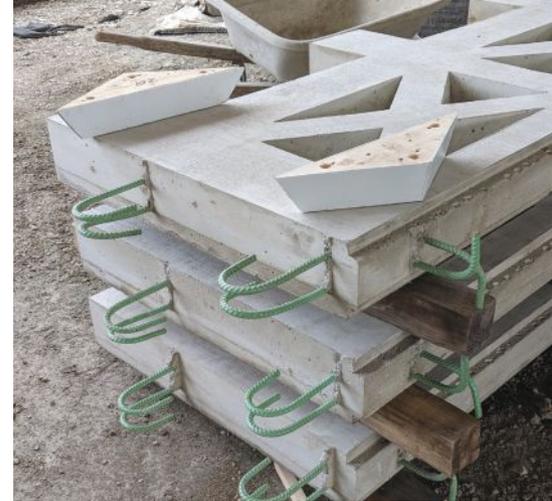
Precast concrete panels ready for erection. J-bars extending from top and sides of panels tie into cast-in-place posts and rails. Pieces of the reusable two-part blockout forms are sitting on the panels.

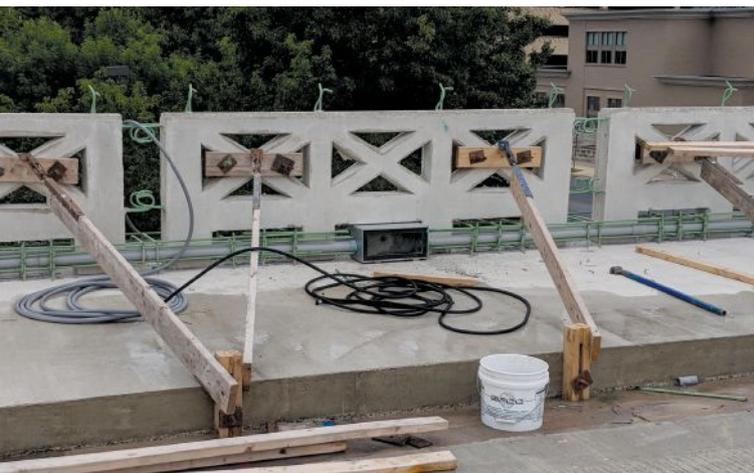
"Panel feet" were incorporated into the design of the precast concrete panels so that the feet could be placed directly on the sidewalk and the panels required only temporary lateral support before casting the posts, curb, and top rail.

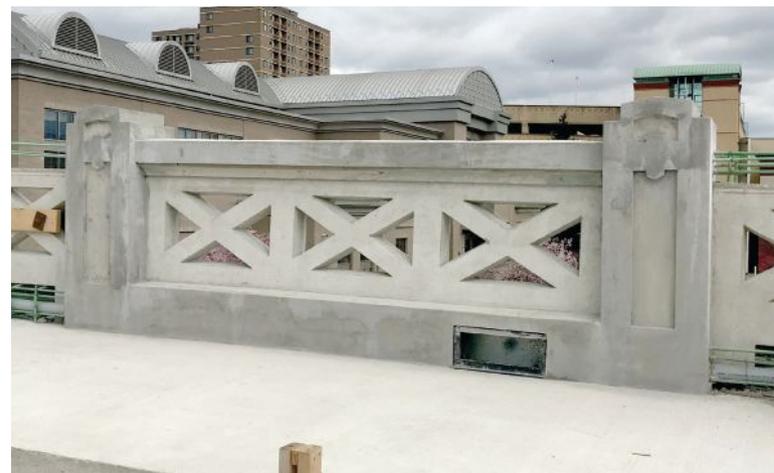
Typical precast concrete panel with cast-in-place posts, curb, and top rail. A conduit and a junction box for bridge lighting are visible.

To eliminate these potential construction issues, the new barriers were designed using a combination precast concrete and cast-in-place system, with precast concrete panels for the X-shaped balustrades designed specifically to minimize construction time and provide a quality finish to the barrier. The panels varied in length from 10 ft 1 in. to 9 ft 3 in. along the length of the bridge, with smaller panels used around the outlooks. Each panel was approximately 3 ft high and 6 in. thick. The posts, curbs, and rails of the barrier were cast in place around the precast concrete balustrade panels to give the barrier its final appearance. This system enabled a high quality of construction, while providing for the conduits and junction boxes and creating a strong connection between the deck and barrier.

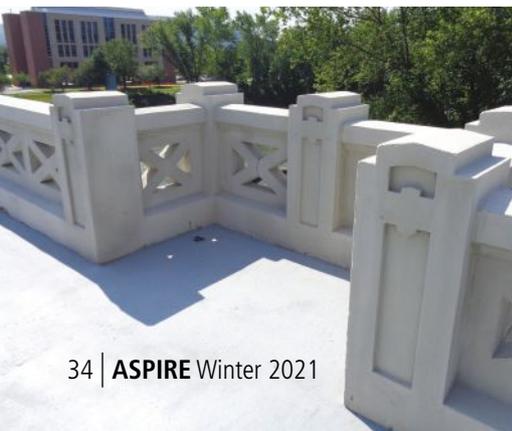
Outlooks at the river piers, which were closed off during rehabilitation in the 1950s, were reconstructed as a part of this project.
