# ANGELES CREST BRIDGE 1

by Jose Higareda, California Department of Transportation

## SINGLE-SPAN, PRECAST, PRESTRESSED CONCRETE SPLICED BULB-TEE GIRDER BRIDGE / CALIFORNIA DEPARTMENT OF TRANSPORTATION, OWNER

**BRIDGE DESCRIPTION:** A simple-span bridge with 208-ft-long, precast, prestressed concrete bulb-tee girders spliced together from three segments at a remote site in the Angeles National Forest

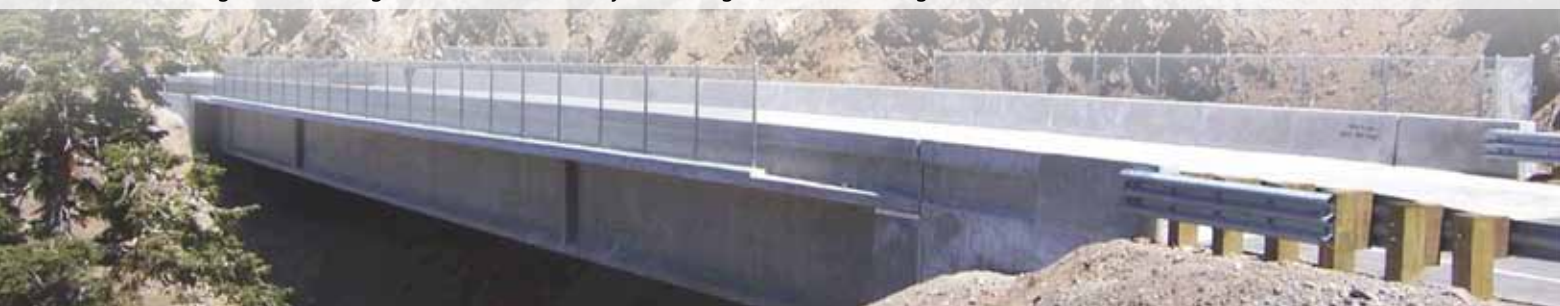
The Angeles Crest Bridge 1 northeast of the city of Los Angeles within the Angeles National Forest. Photos: Caltrans.

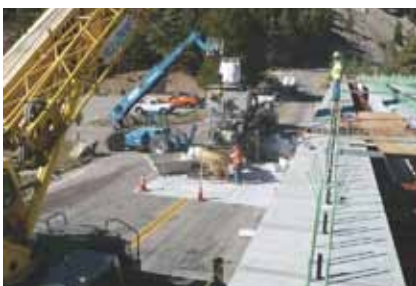
At the staging area less than a mile downhill from the bridge, girder segments were aligned and forms placed for the closure joints.

Here the girders were braced on supports, aligned, and spliced. When concrete in the splices cured to the specified strength, the girders were loaded onto specialized equipment used to move the assembled girders from the staging area to the bridge. A Goldhofer six-line, single-wide hydraulic platform trailer was used to support each end of a girder. A prime mover (tractor) pulled the girders up the hill with 55,000 lb of force. Using hydraulics, the trailers were individually controlled to keep the girders plumb and as level as possible during transport.

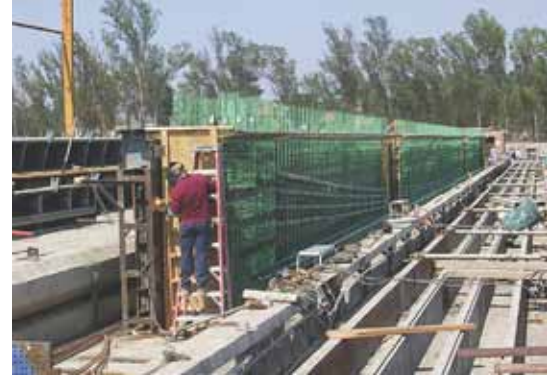
The girder is shown in the Pomeroy casting yard prior to installing the steel side form. All three segments for one girder were cast at one time.

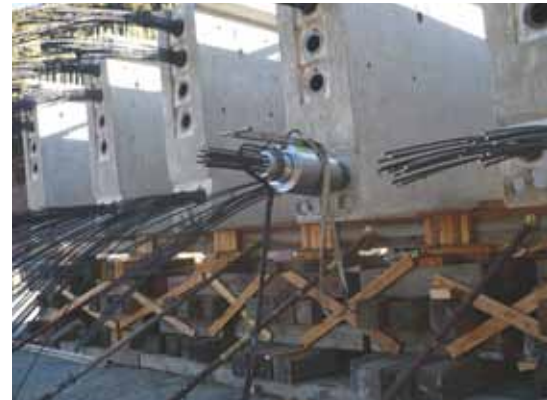
The first stage post-tensioning was done in the staging area. The bottom tendons needed to be stressed simultaneously from opposite ends of the girder to prevent eccentricity.

closure concrete achieved the required strength at the staging area. During the first stage, four of the six ducts per girder were stressed to 2330 kips total. Final stressing took place once the girders were on the abutments and securely braced. The final force was 3560 kips per girder. End diaphragms and intermediate diaphragms were cast after stressing was complete.

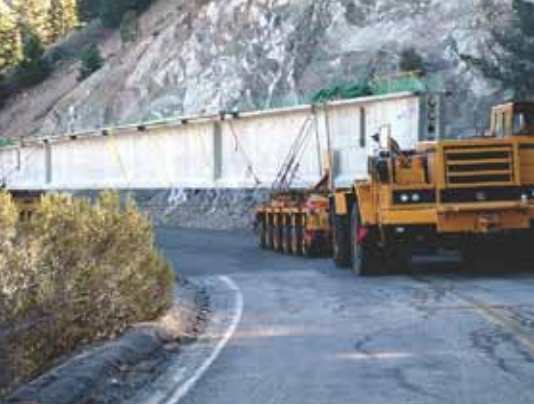
A special tractor and trailer were required to transport the girders from the staging area to the bridge site through several sharp turns.

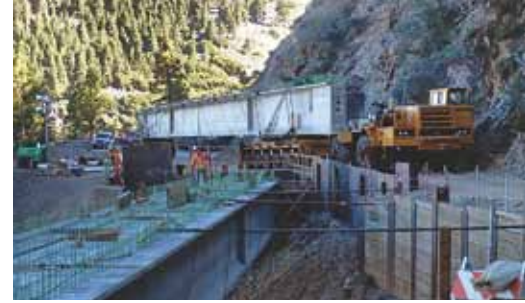
An assembled spliced girder is shown being driven over Abutment 1.

At the bridge site, the abutments were constructed and one end of each partially buried to allow the haul truck to drive over them and move the girders into position near the cranes. The girders were unloaded onto the abutment seats with flanges nearly touching one another. After placing all the girders on the exposed portions of abutments, the buried portion was cleared. Next, the temporary haul road which occupied the same space as part of the abutments and superstructure was removed. Finally, the cranes spaced the girders in their final positions along the abutments.

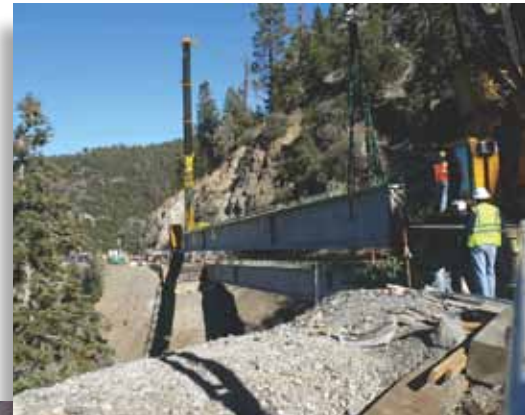
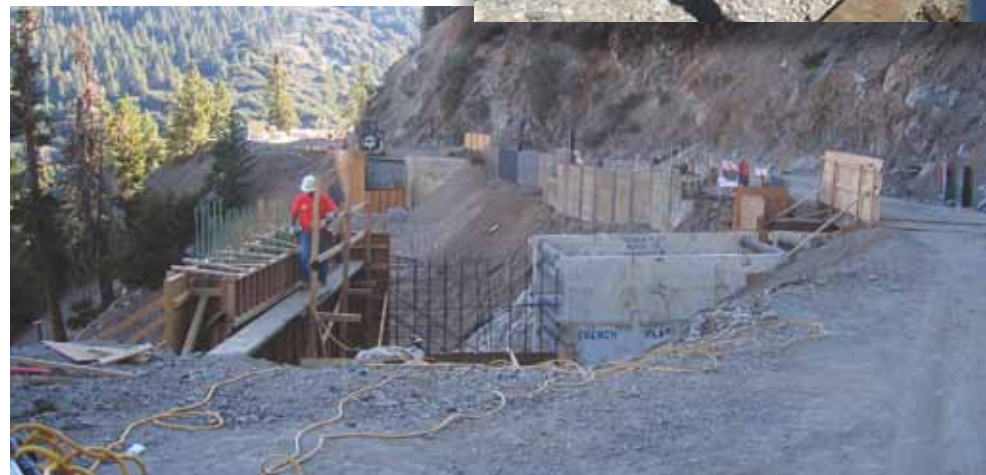
The temporary haul road crosses the uphill end of the abutments to allow delivery of materials including the assembled girders.

The temporary haul road crosses the uphill end of the abutments to allow delivery of materials including the assembled girders. Note the braced forms and bridge over the forms. Once girders were delivered, the road was removed and the full abutment unearthed.

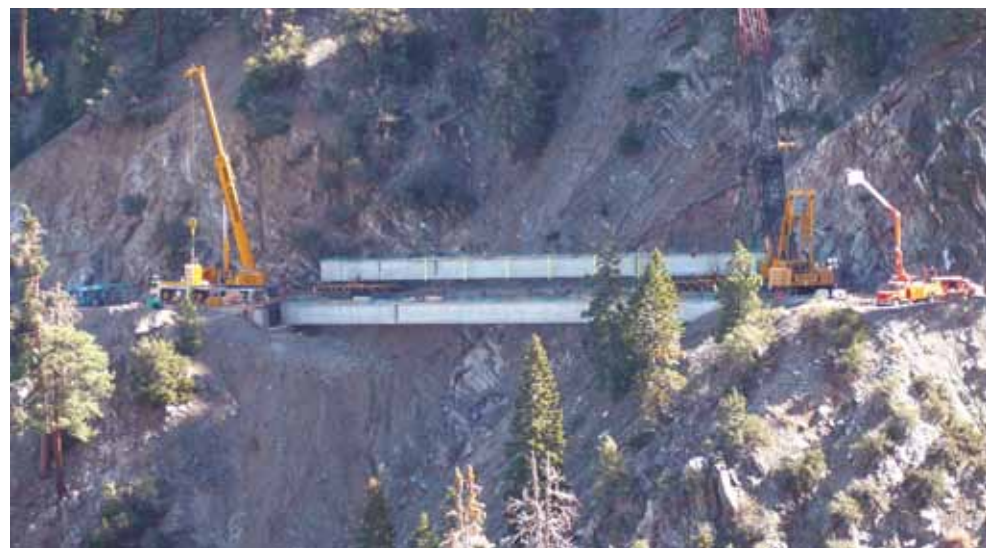
Cranes were positioned over abutments and lifted the girders from trailers that were pulled across the temporary haul road.

Two of the chief concerns were the transportation and erection of the girders. The girders spliced and fully loaded with rigging weigh nearly 180 tons each. PCMAC confirmed that erection was feasible if cranes could be staged at each abutment. It was determined that to install the girders, a 500-ton-capacity hydraulic crane at 91% margin and a 330-ton-capacity conventional crane at 88% margin would be required.
