Bearing Zone Tearing and Spalling in Precast, Prestressed Concrete Girders

by Hugh Ronald, Reynolds, Smith and Hills

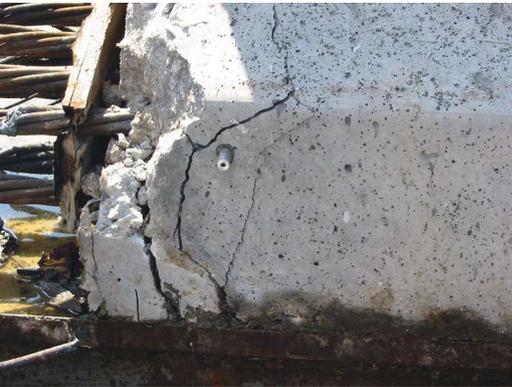
A cracked and spalled girder in the location of the bearing zone for the case of an untreated soffit. All Photos: Lawrence Kahn.

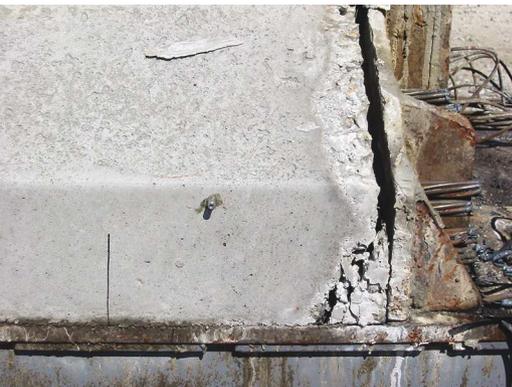
A cracked and spalled girder in the location of the bearing zone. In this case, a Teflon pad was placed between the girder and the soffit.

To address the problem, a number of countermeasures have been employed with varying levels of success. The first countermeasure employed has generally been to lubricate the soffit pan using oil or wax at the ends of the girder (over a distance roughly equal to the strand transfer length), or to place polytetrafluoroethylene (PTFE) or plywood sheets, compression tape, or steel sheets under the bearing zone. The intent is to lower the coefficient of friction between the girder and soffit, thus reducing the magnitude of the tension associated with girder camber and shortening. The table shows that the friction coefficient is reduced from as high as 0.51 on an unlubricated soffit to 0.23 for a wax lubricant. Still, when soffits are lubricated, cracking and spalling are generally not eliminated, but are only reduced in frequency and magnitude.

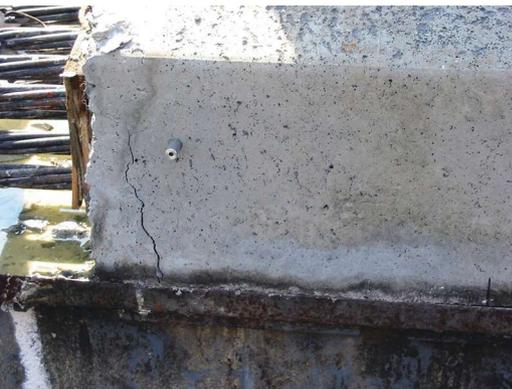
A cracked and spalled girder in the location of the bearing zone where wax was applied to the soffit.

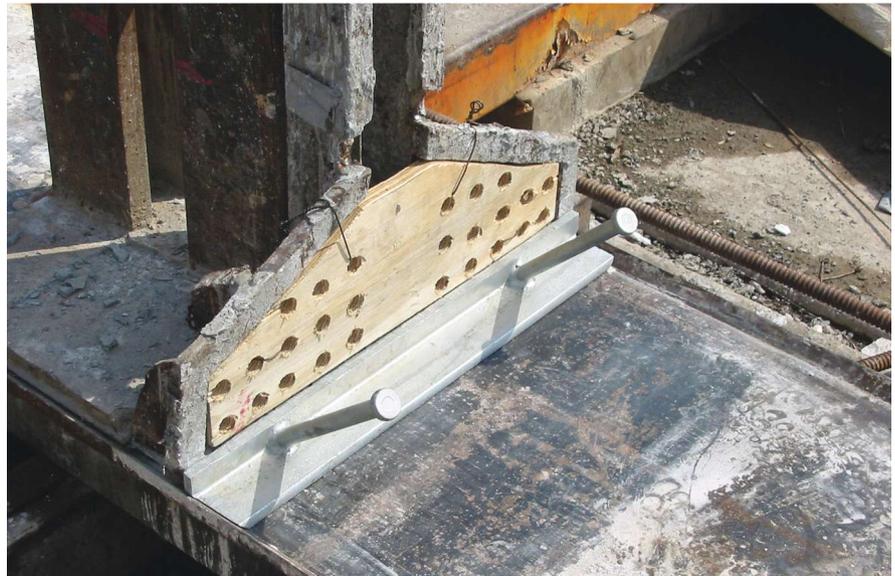
Steel angle positioned to be embedded in girder end.

The second approach has been to embed and anchor steel plates or angles in the bearing zone at the ends of the girder where the knife-edge loading occurs. Use of embedded angles anchored to the girder with headed studs decreases the frequency and magnitude of the cracking and spalling more than use of lubricants alone, but test results show that cracking may still occur. Embedded plates, adequately sized to extend from the end of girder across the bearing zone, have been used successfully to virtually eliminate bearing zone tearing. This detail has been adopted by several owner agencies.
