## CONCRETE CONSTRUCTION

## Precast Replaces Historic Bridge in Glacier National Park

by Linda Josephson, Oldcastle Precast Inc.

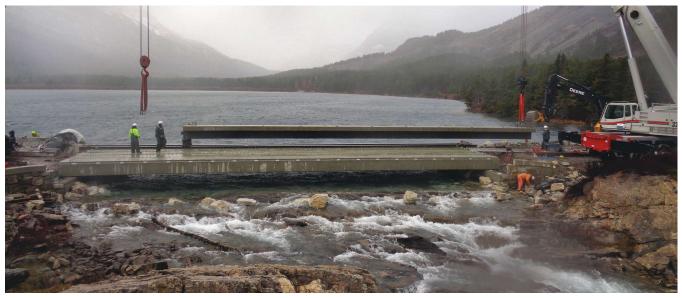
New bridge being installed. Photo: Sam Barchus, Northbank Civil & Marine.

The precast concrete deck consists of six voided slabs that are 85 ft long and 30 in. deep with a 12-in.-deep overhanging sidewalk on one side and a 12-in.-deep overhanging bridle path on the other. These exterior slabs are colored black, so with the overhanging portions it gives the appearance of a slimmer slab than it is, mimicking the 12 in. depth of the old bridge. Five of the voids have 8-in.diameter pipe within them for utility runs.

of two 30-ft 8-in.-long pile caps with curved wing walls. The pile caps are installed just outside the old abutment locations resulting in slightly expanded clearance. Interior piers were eliminated. Otherwise, the new bridge matches the width and location of the old.

The bridge replacement occurred between the close of the hotel in September and the onset of impeding winter weather in the park at an elevation of 4800 ft. To minimize field time to erect, (in addition to precasting the overhangs) pile caps and slabs were trialerected in the precast yard to ensure fit and identify any issues to be mitigated in the plant. Additionally, wing walls were welded to the pile caps before shipment. Even with some delays drilling for the pilings, relatively mild weather allowed the deck delivery to proceed. Driving rain and 55 mph winds at the site made difficult conditions when the trucks arrived. Mercifully, the weather calmed down in a few hours and all pieces were set. The end result is a handsome bridge in a spectacular setting. 🔼
