Rehabilitation and Seismic Retrofit of the North Torrey Pines Road Bridge

by Keith Gazaway, Nathan Johnson, and Mark Creveling, Kleinfelder Inc.

NORTH TORREY PINES ROAD BRIDGE / DEL MAR, CALIFORNIA

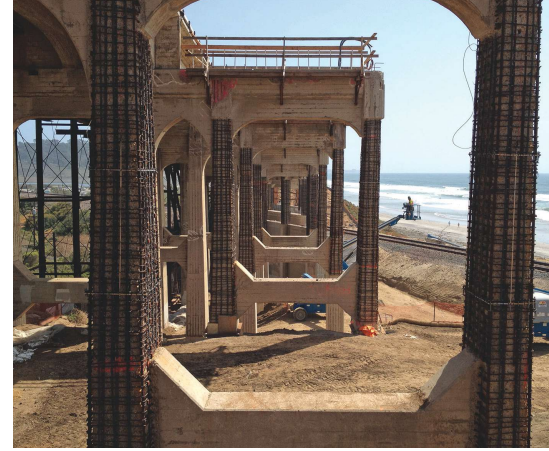
Installed column ties after removal of cover concrete.

- soil densification using compaction grouting to mitigate liquefaction and lateral spreading;
- strengthening columns by removing cover concrete, adding shear reinforcement, and replacing concrete to its original dimensions;
- partial superstructure isolation with sliding bearings to protect stiff skewed bents;
- new deep foundation abutments to help restrain the partially isolated superstructure;
- end-to-end post-tensioning of the precast concrete superstructure to transmit lateral seismic force to select bents and the new abutments; and
- a corrosion protection plan using cathodic protection for elements that will remain in place.

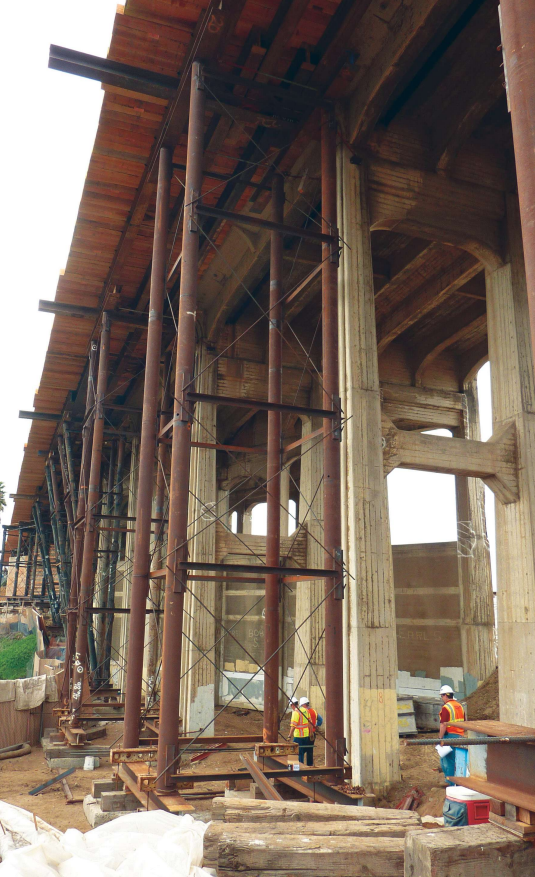
Temporary bridge widening adjacent to environmentally sensitive area.

To allow for the two-lane bridge to remain open to two lanes during construction, the engineering and construction teams developed a temporary steel bridge structure that could be placed on one side of the bridge and moved to the other side in a subsequent stage. The temporary structure was braced laterally against the seismically deficient bridge, which required extensive analysis to ensure safety during construction.

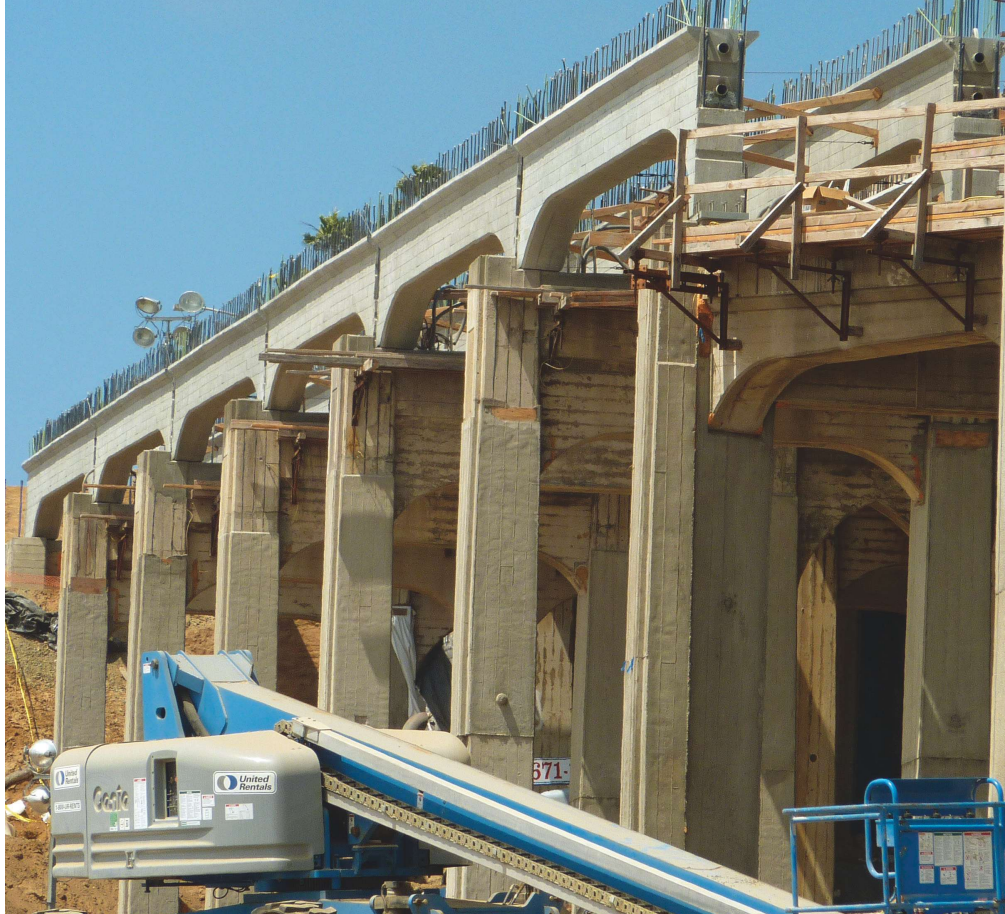
Precast concrete girders erected on rehabilitated substructure.

Precast concrete girders were selected to maintain the railroad's required clearance envelope during construction. The precaster built multiple custom forms to replicate the existing girder dimensions, including end haunches, skews, and surface texture, and the precaster also created a three-dimensional virtual model of each girder to ensure the reinforcement and prestressing would fit perfectly within the forms.
