Impregnation of Post-Tensioning Tendons

A solution for post-tensioning steel corrosion

by David W. Whitmore and Martin R. Beaudette, Vector Corrosion Technologies Ltd.

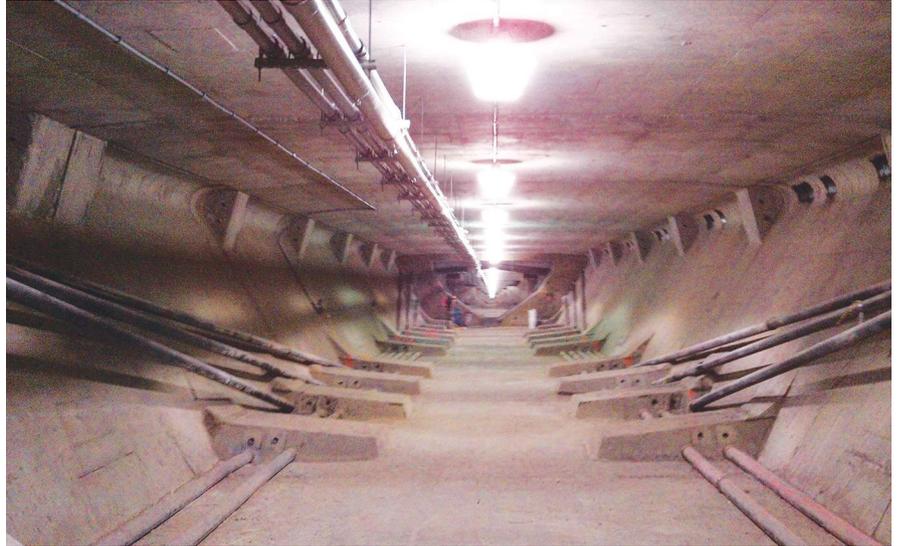
Example of a post-tensioned, box-girder bridge with external post-tensioning tendons. All Photos: Vector Corrosion Technologies Ltd.

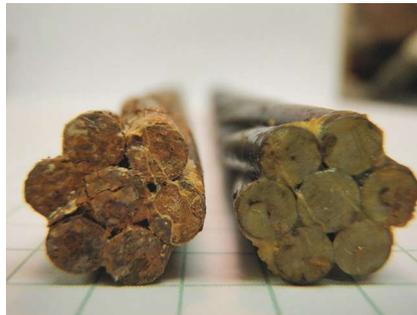
Salt spray testing on untreated and impregnation-treated strands.

The post-tensioning-steel impregnation system has been subjected to a great amount of corrosion testing. Laboratory testing completed to date has focused on determining the qualitative and quantitative corrosion-resistance benefits of the impregnation process. For example, salt spray testing on treated and untreated post-tensioning strand dramatically reveals the substantial corrosion resistance provided by the impregnation material.

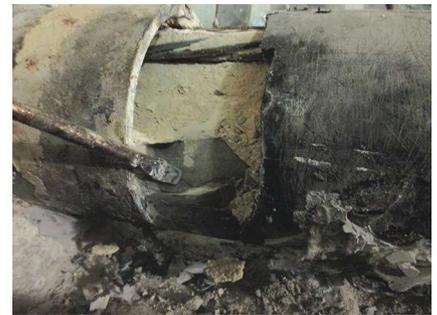
Segregation of grout (light tan is soft and grey is solid) and void at top of tendon.

Grout quality for post-tensioning tendons has been an important consideration for many years because strand corrosion was noted in the presence of grout bleed water and bleed water voids. This concern prompted the development of proprietary cementitious grouts with anti-bleed characteristics.¹ Modern grouts have provided improved performance, but problems have been detected on recently constructed structures including grout voids, segregated grout, soft grout, presence of a high level of sulfates, and chloride-contaminated grout.²

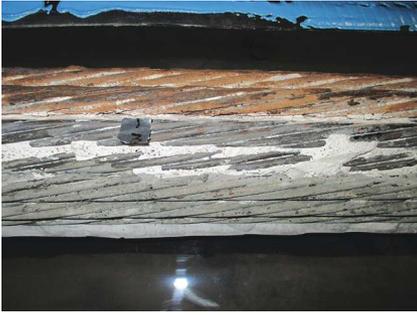
Corroded strands in a bonded post-tensioning tendon.

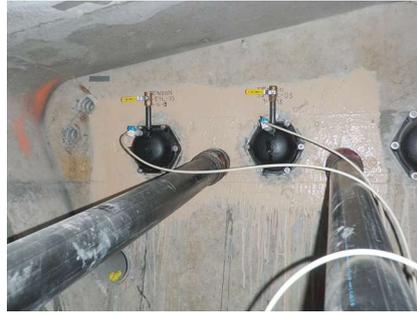
Impregnation of post-tensioning tendon from end anchorage.

Access to the interior of the tendon is made at the grout caps or by an installed port at an intermediate tendon location. After the tendon is air tested and any leaks are

repaired, the impregnation process begins. The impregnation material has been shown to travel as far as 250 ft along the length of a tendon through the interstitial spaces.

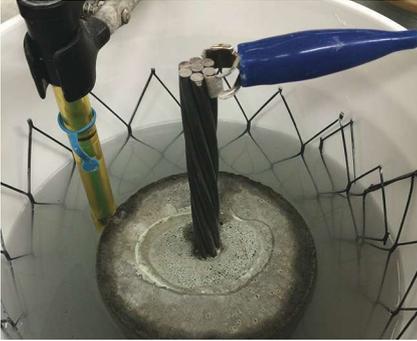
Grouted post-tensioning strand sample undergoing potentiostatic testing.

Potentiostatic testing is a method to produce direct quantitative comparisons between treated and untreated samples in a laboratory setting. The potentiostatic testing completed on impregnated samples produced positive results with a 94.7% reduction in corrosion current in samples with 4.5% grout voids and a 93.1% reduction in corrosion current in chloride-contaminated grout samples. Interestingly, potentiostatic testing on void-free grout samples with and without chlorides shows that the impregnation treated samples had an 81.4% reduction in corrosion current versus the untreated samples.⁶

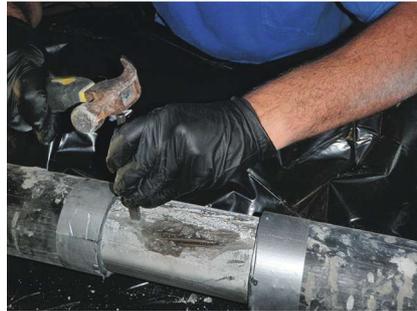
Removal of grout reveals impregnation material present on steel surface and penetration into surrounding grout.

- flow through the interstitial spaces in post-tensioned tendons up to 250 ft from the end or up to 100 ft from an intermediate location,
- leave a corrosion resistant film on exposed steel surfaces, and
- penetrate into the grout for an additional layer of protection surrounding the strands.
