# AUBURN'S MOORES MILL BRIDGE

by Paul Froede, Alabama  
Department of Transportation

### MOORES MILL BRIDGE / AUBURN, ALABAMA

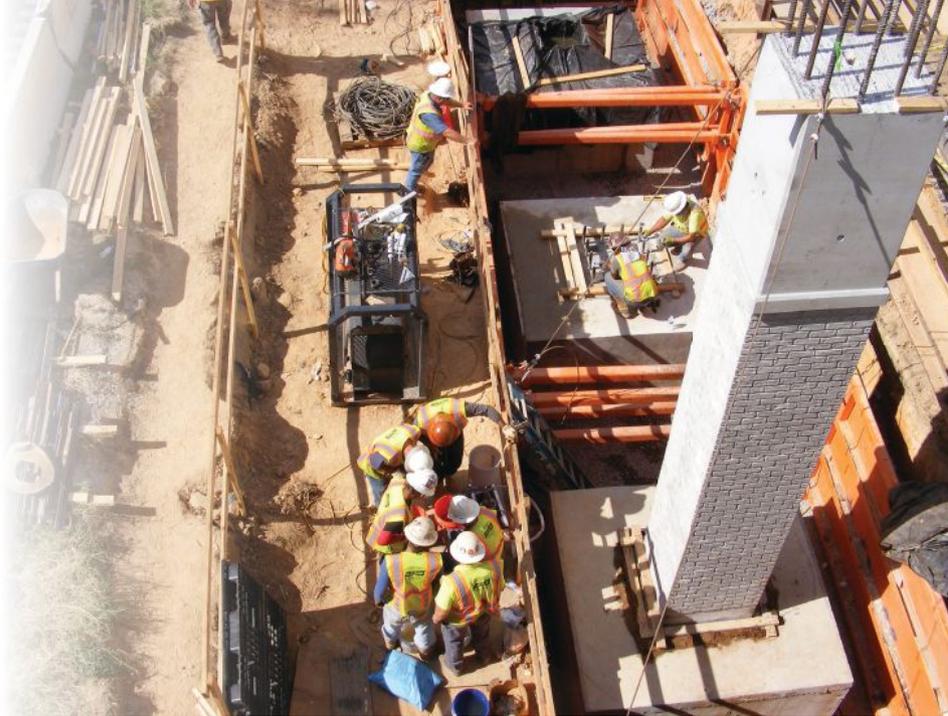
Precast concrete columns for the Moores Mill Bridge, measuring 3 ft 6 in. by 3 ft 6 in. by 19 ft 9 in., weighed over 18 tons each and were installed on cast-in-place footings using a coupler system with dowels. All Photos and Figures: Alabama Department of Transportation.

in Dothan, Ala. The Moores Mill Bridge project presented another opportunity to use ABC methods with large, precast concrete bridge elements. ALDOT has maintained standard drawings of prefabricated bridge systems for use on secondary (county and city) road systems, but those elements are light—weighing less than 2 tons per piece. Precast concrete columns for the Moores Mill Bridge, measuring 3 ft 6 in. by 3 ft 6 in. by 19 ft 9 in., were calculated to weigh over 18 tons each.

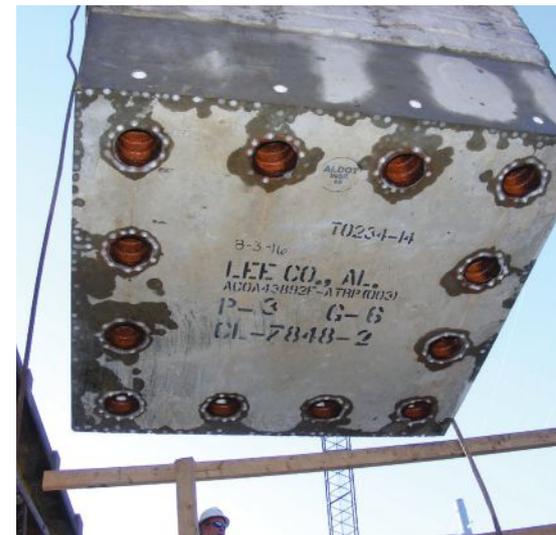
Detail of the precast column base with couplers that connect to dowels in the cast-in-place footing.

The columns were cast vertically, primarily due to the formliner on the sides and the desire to achieve a clean, smooth appearance and ensure faux mortar lines were well formed. The precaster used a plywood template to set coupler locations in the column base; that template was later sent to the contractor, who had matching steel templates made for setting dowel bar positions in the cast-in-place footings. Fabrication of the six columns took about three weeks. Notably, casting the last column took much less time than casting the first because the producer became more familiar with the fabrication setup of these unique columns.

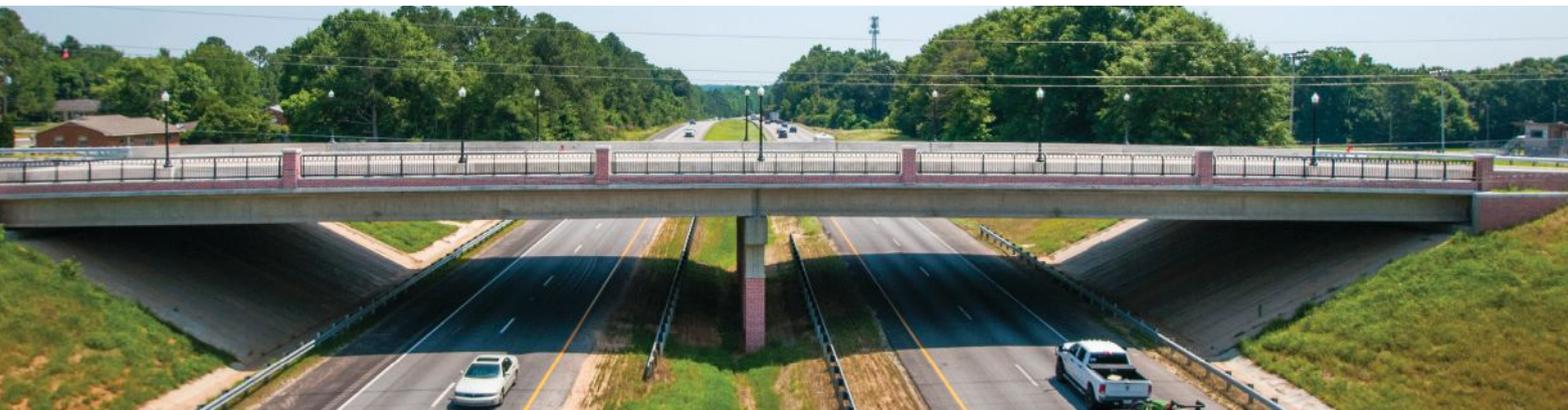
Formliners and staining were used to simulate brick on the Moores Mill Road bridge. Other aesthetic enhancements are the decorative bands on the columns and the chevrons on the bottom surface of the bent caps.

The columns and bent caps were included in the aesthetic enhancements and received special consideration. The cap design incorporates visually pleasing sharp angles because no aesthetic formliners were used in the cap construction. The columns have brick formliners at the bottom and a plain concrete finish at the top. These two distinct sections are separated by a 6 in. decorative band. When determining how far up the column the band should be placed, the designers turned to the Fibonacci sequence/golden ratio, situating the shelf at an elevation 61.8% of the height of the installed column above the ground level.

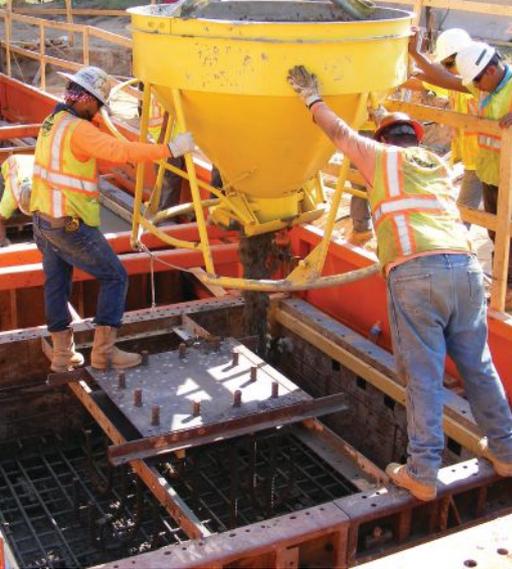
A steel template based on the bar-coupler locations in the precast concrete columns was used to position the no. 11 dowel bars while placing concrete in the footings.

The footings were typical cast-in-place construction, hosting one column each and sitting on nine HP12×53 piles. The steel template based on the bar-coupler positions in the precast concrete columns was used to hold the no. 11 dowel bars in place during concrete placement. It was tack-welded to angle irons to ensure the dowel bars were immobile until after the concrete had cured. The footings were placed and cured according to standard (non-ABC) procedures.

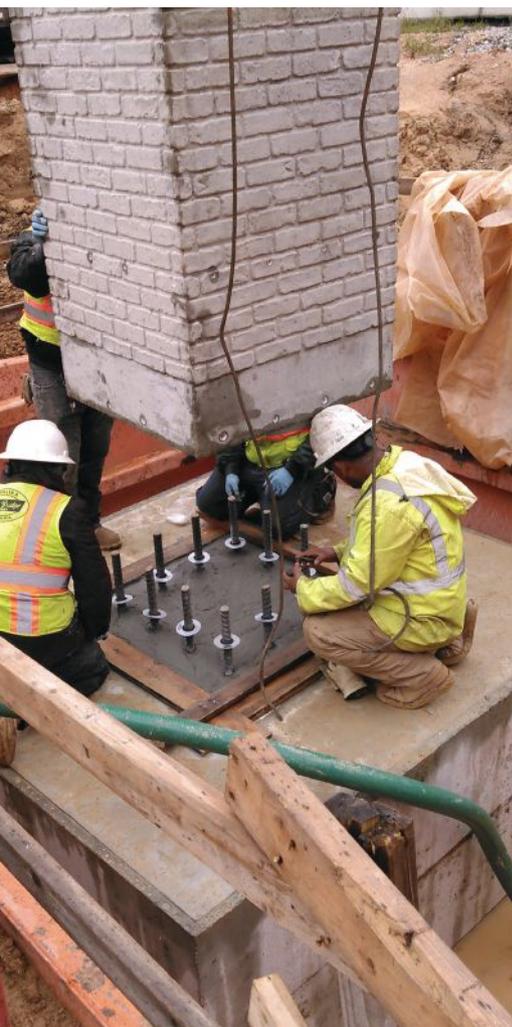
After a dry-fit test of the column on the footing to ensure proper fit of dowel bars and couplers, the grout bed was prepared for final setting of column. Two rows of ports for grouting couplers are visible at the base of column.

1. Keep the footing interface area below the column wet for a minimum of 24 hours.
2. Set shim plates for stability and plumbness.
3. Do a dry-fit test of the column on the footing to ensure proper fit of dowel bars and couplers before preparing the grout bed. Verify shim stack height.
4. Lift the column off the footing, and prepare grout for footing-column interface sealing.

5. Place grout in the defined bed; set the column, and plumb with guywires.
6. Prepare coupler grout according to manufacturer's instructions.
7. Pump grout into the coupler according to manufacturer's instructions.
8. Allow grout to set for 24 hours according to manufacturer's instructions.

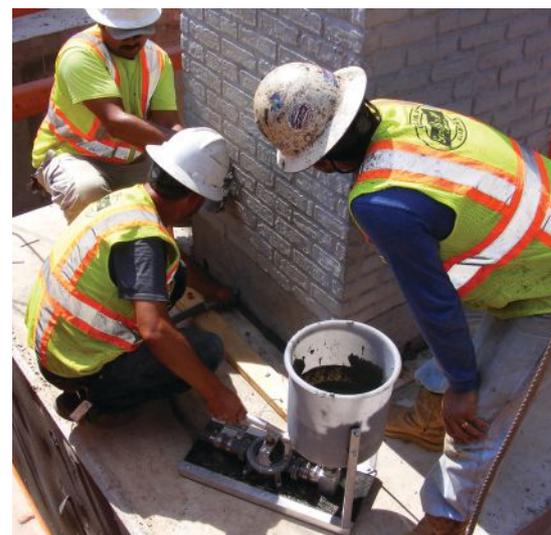
Grout was pumped into the couplers according to manufacturer's instructions, but some locations required a modified approach to address challenges encountered during construction.

Although the erection of the precast concrete columns went as expected, the project team encountered an unanticipated event during coupler grout injection. When the columns were unloaded after transportation to the site, they were left in the horizontal orientation to allow for visual inspection and water cleaning of the couplers. When it was time for installation, the contractor lifted and carefully lowered the column onto the footing—the dowel bars into the couplers—as required in the practice fit-up. The column was then lifted to facilitate grout bed preparation, seal

washer installation, and inspection of the dowel bars. There were no instances of damaged bars noted during these inspections, and no sounds of steel-on-steel rubbing or grinding were heard during lowering. However, when the contractor began injecting the grout in the bottom port of some couplers (less than one per column), the grout pump inexplicably stopped, as if a valve had shut, and no additional flow was possible.

- The affected coupler would allow five pump cycles of grout to flow (it took seven cycles to fill each coupler).
- The issue was not in the pump itself.
- The grout already inserted could be washed out, and water could flow unimpeded through the coupler.
- Running water through the coupler did not improve subsequent grout flow; the pump would stop again after five pump cycles.

The contractor’s solution to the problem was to move the grout insertion tube to the top port, make two complete pumps and then a partial one, and then move the tube to the bottom port and continue pumping. This technique filled the connector, and workers observed grout flowing out of the top port, as required according to the coupler manufacturer’s installation instructions.

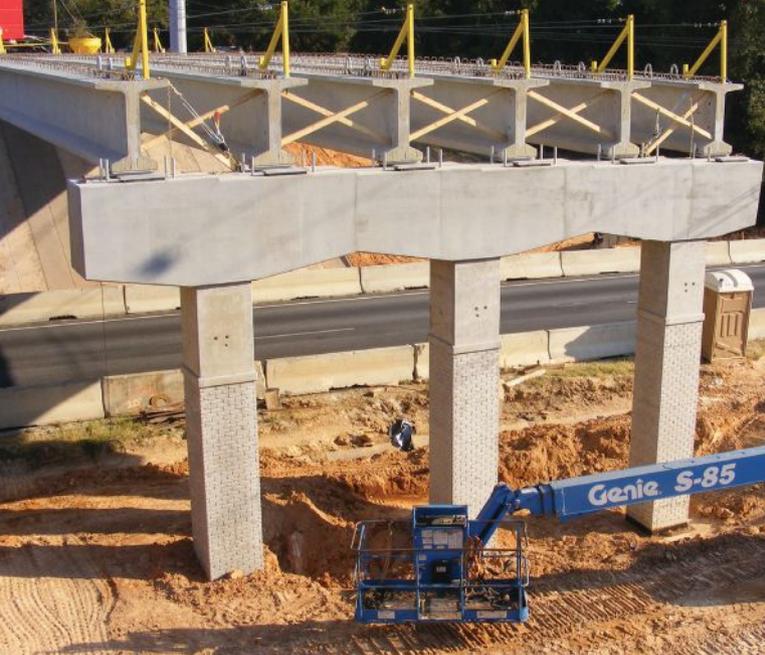
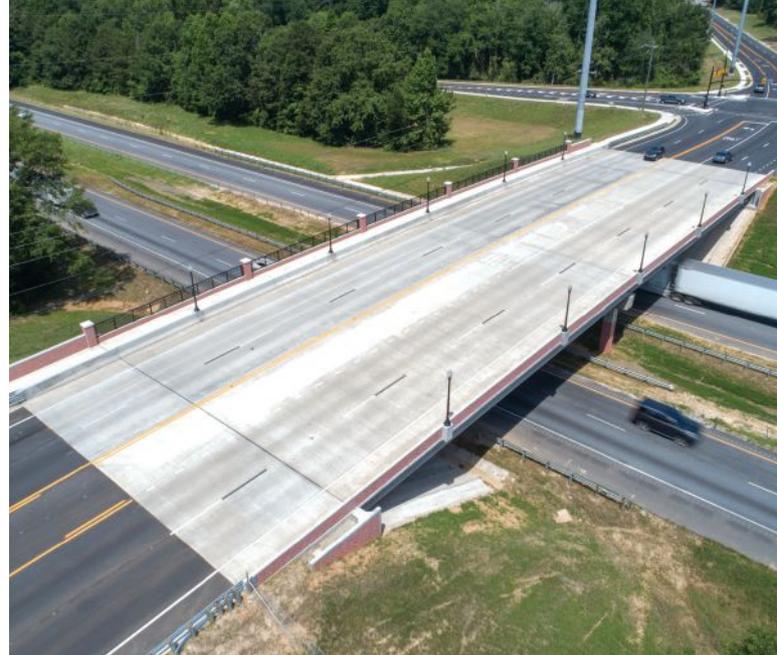
These 54-in.-deep bulb-tee precast, prestressed concrete girders, cast-in-place bent cap, and precast concrete columns were erected during stage 1. The brick formliner and decorative band on the column and the chevrons on the bottom surface of the bent cap were aesthetic enhancements.

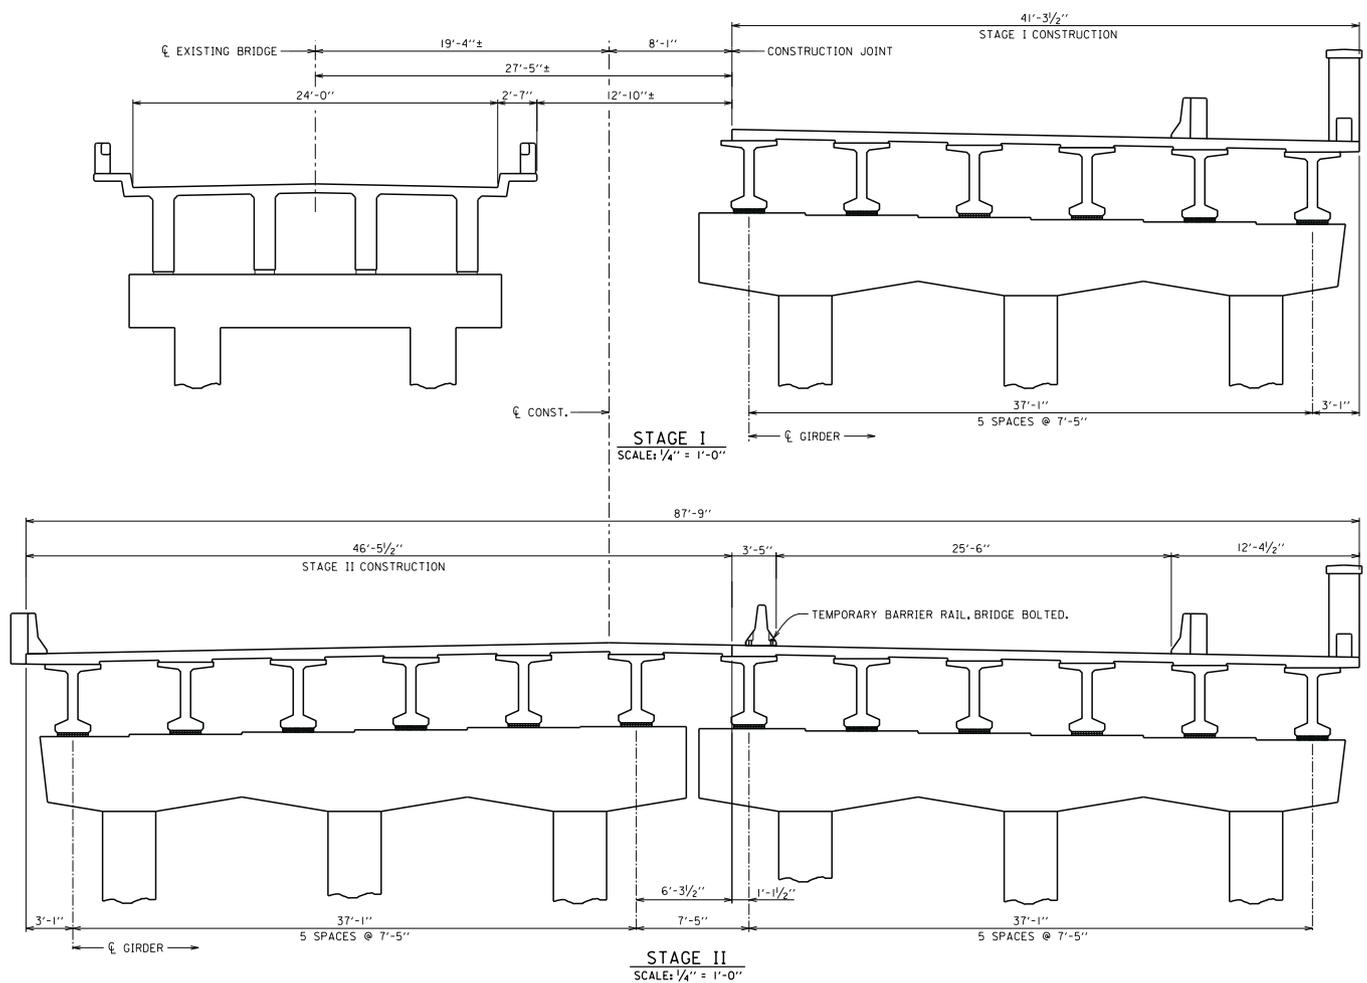
Typical section of the bridge showing stages 1 and 2 of construction. During stage 1, traffic used the existing bridge while two lanes and the shared-use path were constructed to the west. In stage 2, traffic was moved to the new bridge, the existing bridge was razed, and the remainder of the new bridge was built.

Closing the existing bridge to accommodate new construction was not an option, so the new alignment was shifted slightly to the west and the bridge was built in two stages. Stage 1 kept traffic flowing on the old bridge while two lanes and the shared-use path were constructed to the west. Upon completion of stage 1, traffic moved from the old bridge to the completed portion of the new bridge. In stage 2, the old bridge was razed and the remainder of the new bridge built.
