Superstructure Replacement and Widening of the Historic Arch Bridge over Lake Tillery

by John Sloan, AECOM

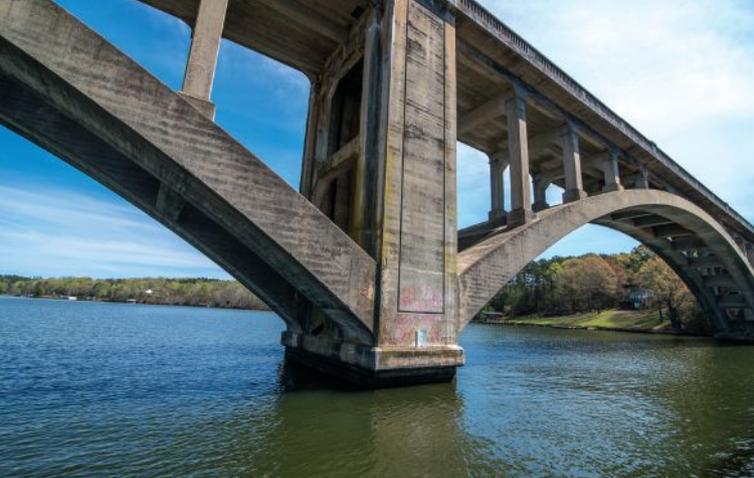
The original open-spandrel arch bridge had a 20-ft-wide deck. Photo: AECOM, courtesy of Byrd's Eye View.

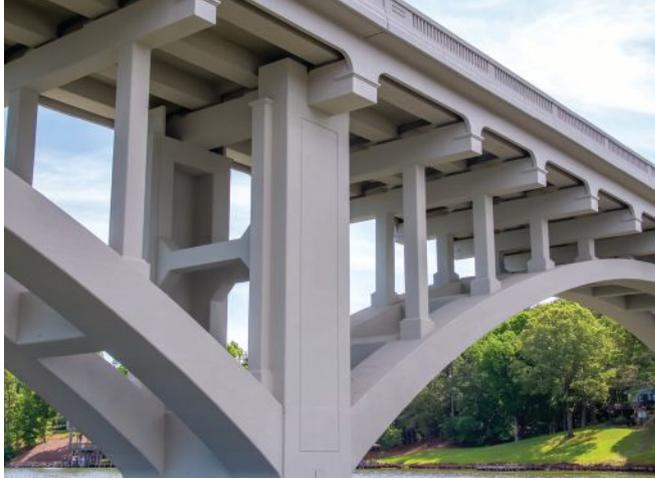
The new superstructure of the rehabilitated bridge has a 36-ft-wide road surface. Establishing continuity of the prestressed concrete box beams from pier to pier before placing the concrete deck mitigated loadings on the arch ribs. Photo: AECOM.

The original superstructure had three reinforced concrete deck girders with steel plate bearings that bore directly on the spandrel bent caps, so this was a very rigid articulation. The superstructure had expansion joints at third points within each arch span, which created high moment demands in the arch ribs below these joints. In the final structure configuration, load was relieved from the arch ribs by establishing continuity of the prestressed concrete box beams from pier to pier before placing the concrete deck. This was achieved by providing continuity reinforcement and closure pours between the box beams over the spandrel bents. In addition, the stiffness of the proposed superstructure was significantly greater than that of the original. Tall elastomeric bearings with a much lower modulus of elasticity than the original steel bearings were used, which created a spring support at each spandrel bent, allowing the superstructure to flex and resist demands while further alleviating the demands

on the arches. Collectively, these items created a greater level of redundancy in the proposed structure compared with the original articulation.
