# Bridge Preservation Program: Maintaining Best Practices

by Rex L. Pearce, Virginia Department of Transportation

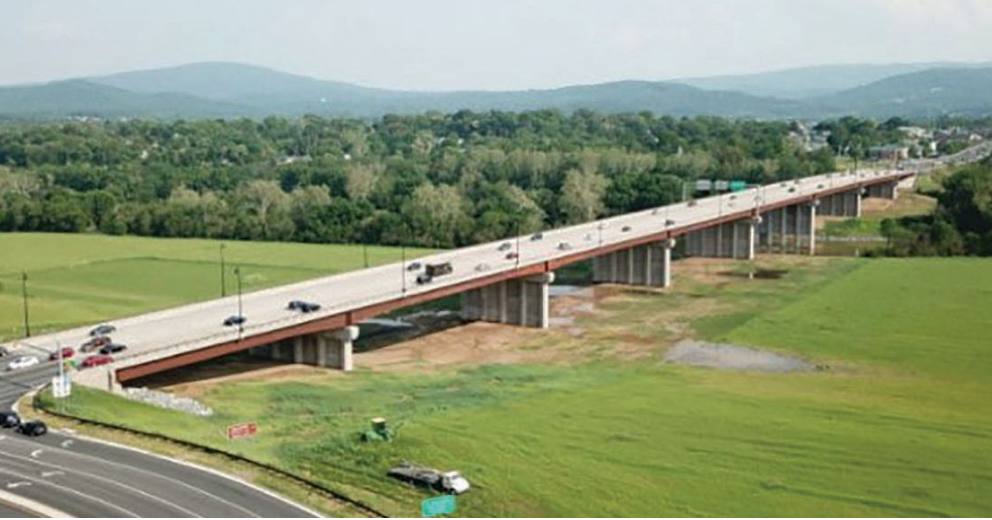
Figure 3. For new construction, continuity and jointless bridge solutions are good options. This bridge has a 1915-ft-long, 100-ft-wide continuous reinforced concrete deck.

For new construction, where possible, an integral-abutment bridge type is best. The Route 340 bridge over the Shenandoah River South Fork pushes the limits of continuity and jointless bridge solutions with its 1915-ft-long, 100-ft-wide continuous reinforced concrete deck (Fig. 3). With deck extensions and jointless Virginia abutment types, it is exemplary of a truly

jointless bridge environment and will likely achieve a century of service life. (For details of the Virginia abutment, see the “Atkinson Boulevard Over CSXT Railroad and Interstate 64” Project article in the Fall 2021 issue of *ASPIRE*.)

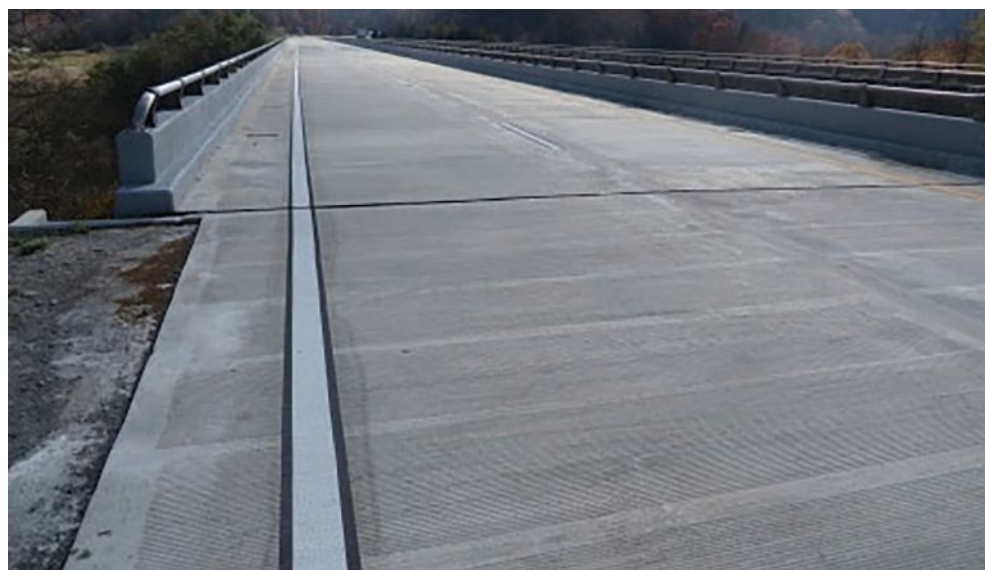
Figure 4. Preservation strategies for this Interstate 64 bridge included bearing reconfiguration to accommodate joint closures, deck extensions, hydromilling, and overlay replacement for a comprehensive jointless solution.

In other cases, the routine “workhorse” bridges that make up the majority of the bridge inventory can be preserved instead of replaced. Preservation of Interstate 64 bridge (Fig. 4) involved bearing reconfiguration to accommodate joint closures, deck extensions, hydromilling, and overlay replacement for a comprehensive jointless solution.
