Widening the Paudèze Bridges with Precast and Cast-in-Place Ultra-High-Performance Concrete

by Walter Waldis and Dimitrios Papastergiou,
Swiss Federal Roads Office

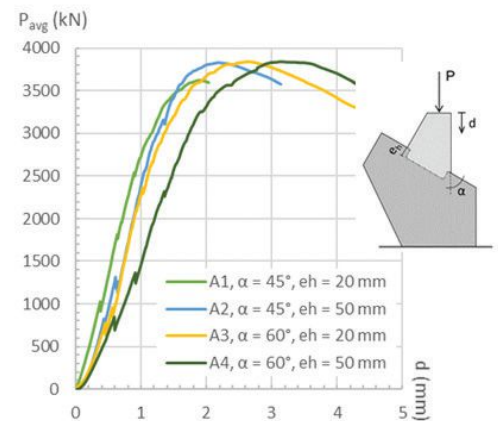
Test results for connections between the lower chord and the box-girder web, and the upper support girder chord and the new deck extension. Figure: IngPhi SA, Lausanne.

- Testing of the connection between the lower chord and the web
- Testing of the connection between the top chord and new part of the deck
- Buckling tests on the struts

The test results for the connections showed large margins compared with the axial design load of around 170 kip.

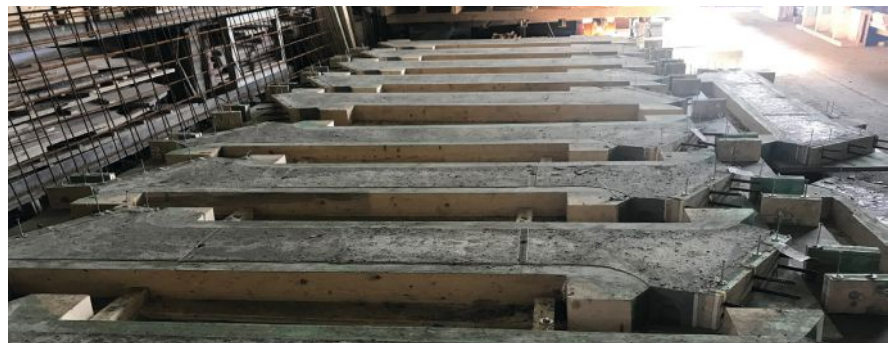
Struts are in their formwork at the precast concrete plant. Four types of forms were required. Photo: IngPhi SA, Lausanne.

The bridge required 816 struts, each weighing 500 lb and measuring 5 in. x 12 in. x 8 ft. The design of the struts was optimized for simple construction.

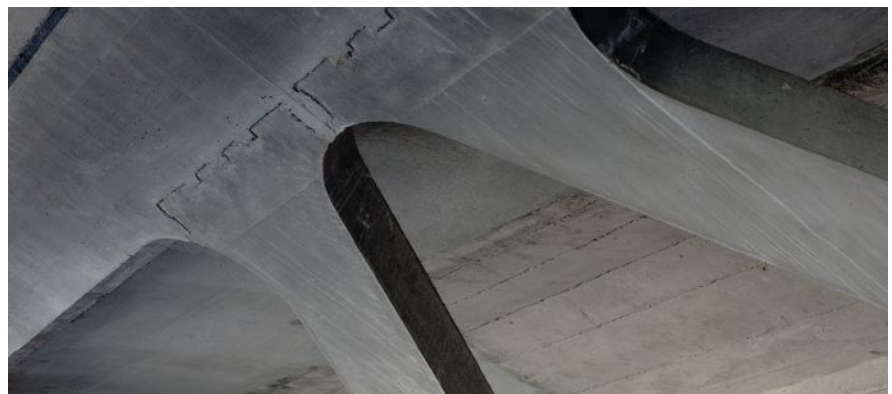
The completed connection of the prefabricated strut to the cast-in-place upper chord shows the adjustability to the geometry that the innovative construction detail allowed. Photo: IngPhi SA, Lausanne.

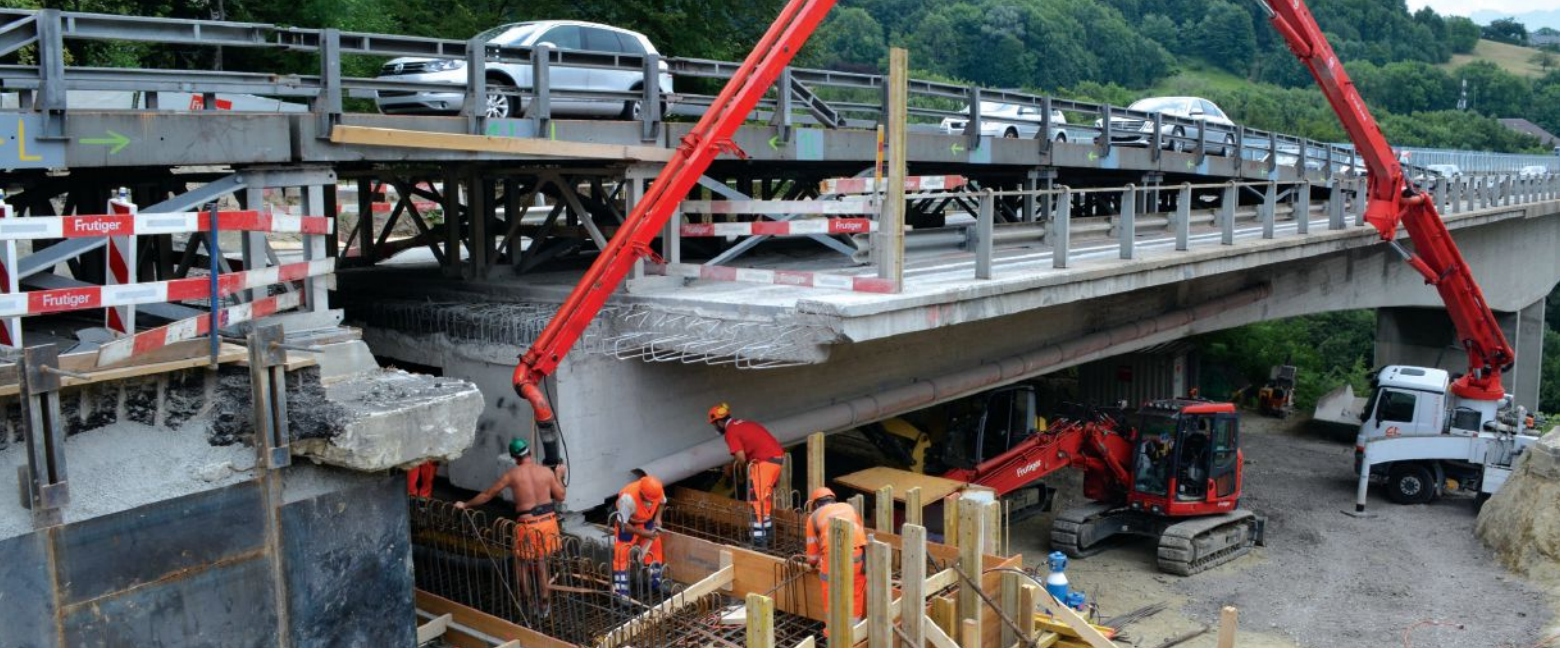
The Swiss Federal Roads Office's temporary steel bridge (flyover) on the deck of the bridge resulted in a 12-ft-long work area across the entire width of the bridge that accommodated 40-mph traffic during construction activities. Photo: IngPhi SA, Lausanne.

During replacement of the abutments and joints, temporary steel bridges (flyovers) were used for two lanes to allow work to continue under them without affecting traffic.

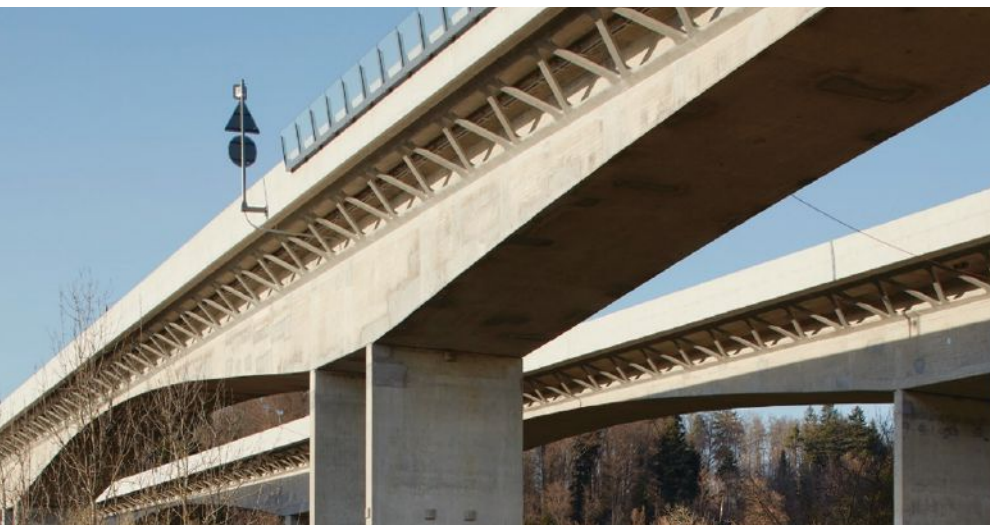
The unique widening and rehabilitation scheme retained the bridges' clean lines and provided a modern aesthetic that preserves the area's cultural heritage landscape. Photo: IngPhi SA, Lausanne.
