Waikoko Stream Bridge Replacement

by David K. Fujiwara, Gary T. Iwamoto,
and Eric Y. Matsumoto, KSF Inc.

BRIDGE DESCRIPTION: 72-ft-long, 21-ft-wide, one-lane single-span through-girder bridge using precast concrete L-shaped girders and deck slabs

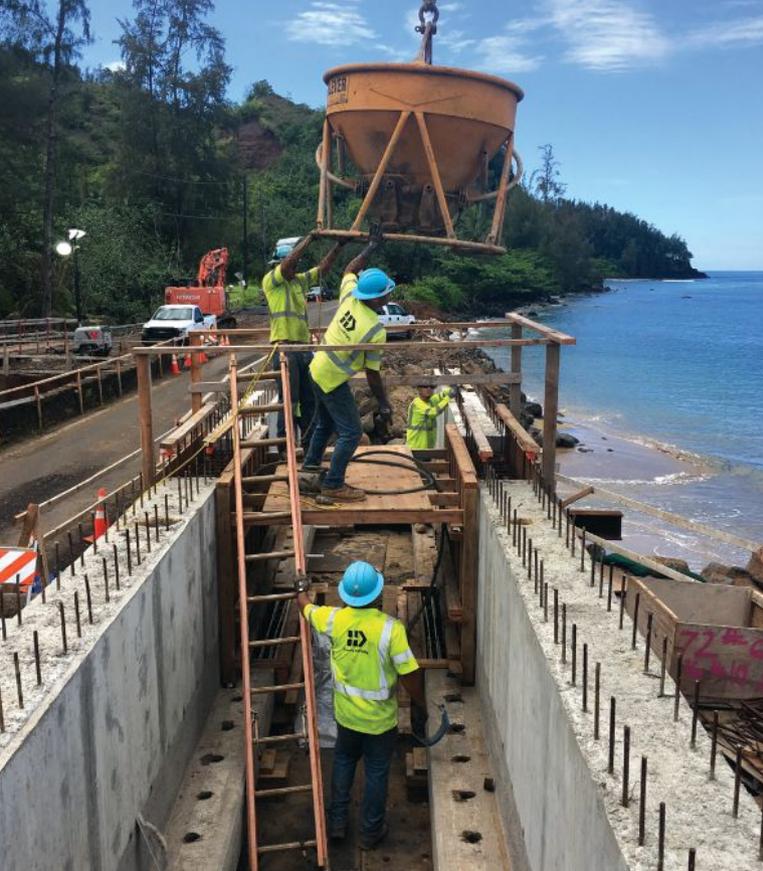
The L-girders were transported to the site in three segments and connected with cast-in-place closure pours on site. Photo: Hawaiian Dredging Construction Company Inc.

allowed full weekend closure period. Two 72-ft-long, L-shaped concrete girders were designed to span the Waikoko Stream. The L-girders were cast in a controlled environment approximately 30 miles from the construction site. Load restrictions on bridges leading to the Waikoko Stream site influenced the decision to cast the girders in three segments (19 ft 4 in., 22 ft 8 in., and 19 ft 4 in. long) with a maximum weight of 17.8 tons each. The L-girder segments were transported to the site and then spliced near the end of the existing bridge.

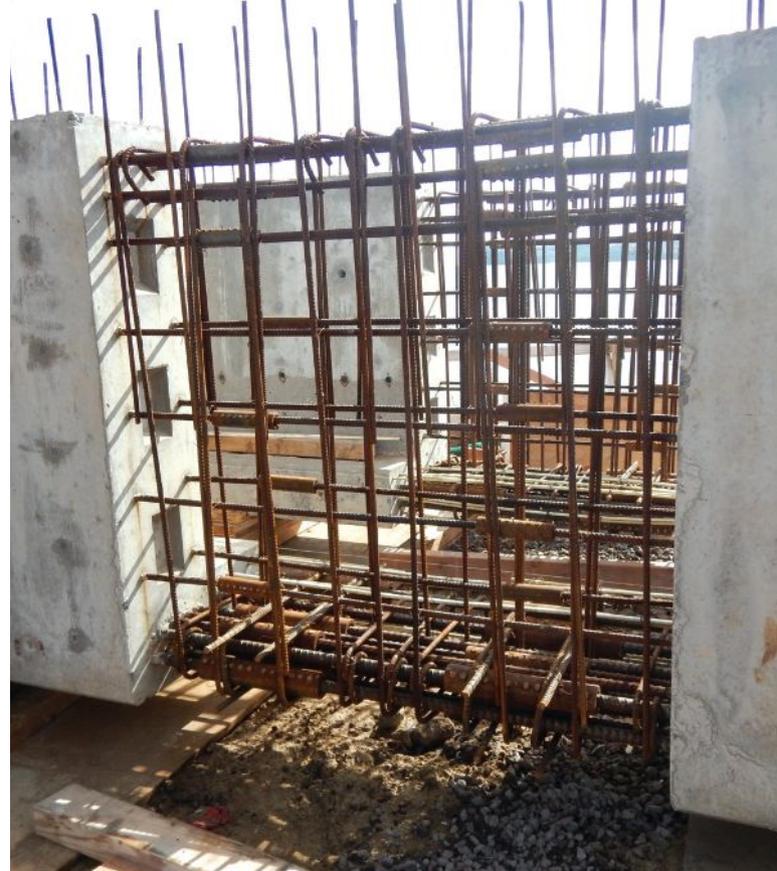
The reinforcement at the two closure pours of the L-girder segments was detailed to facilitate placement of concrete and splicing reinforcement. Note the shear keys. Photo: KSF Inc.

There was limited space at the bridge site to store and splice the girder segments and to maneuver the completed girders. Therefore, the reinforcement at the closure joints was detailed to facilitate on-site placement of concrete and splicing reinforcement.

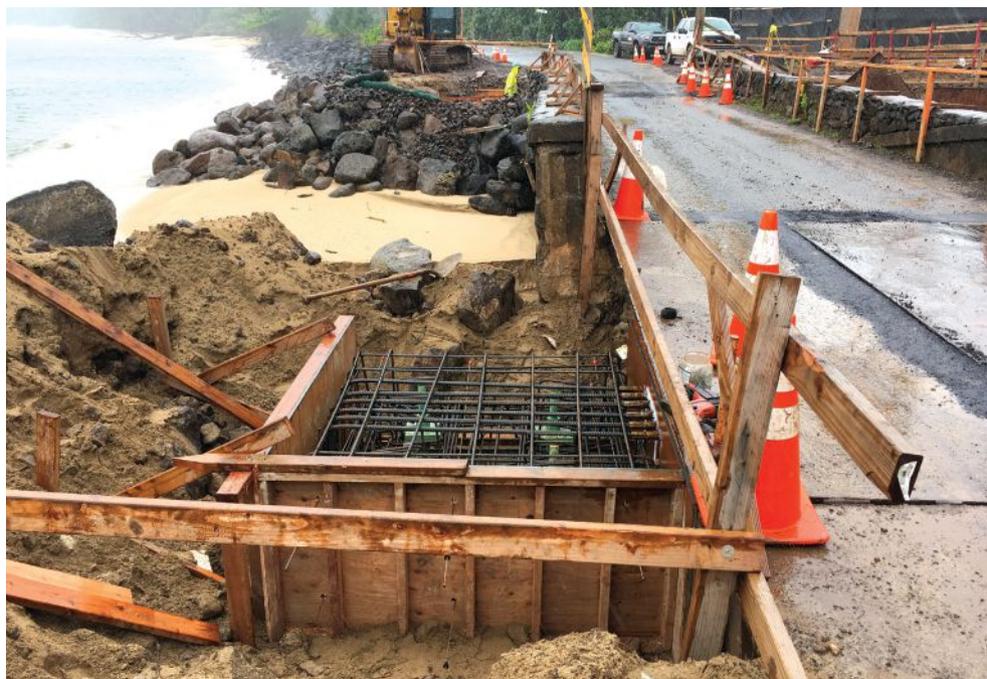
The substructure was installed before the full closure of the roadway. Photo: KSF Inc.

Micropiles were installed near the four corners of the existing bridge to support the new structure. Equipment for the micropile installation was situated such that roadway traffic would not be disrupted. Abutment caps and grade beams were constructed with cast-in-place concrete. The precast concrete components were then delivered to the site. The L-girder segments were spliced on a sliver of land along the roadway near the bridge. Precast concrete slabs were strategically stacked to facilitate placement.

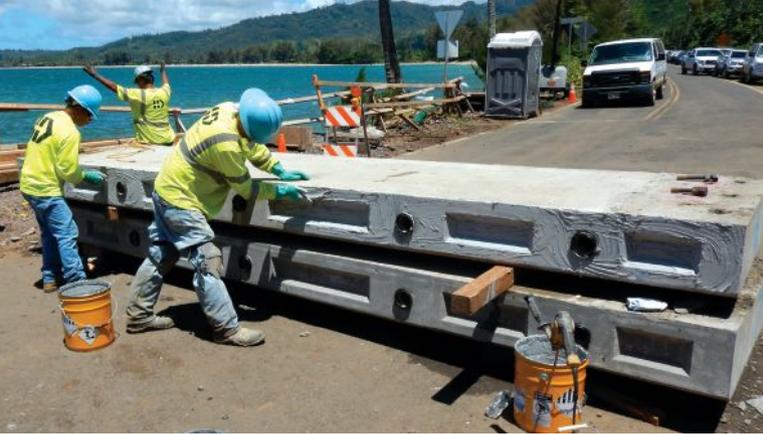
Slow-set epoxy paste adhesive was applied to the joint faces of the precast concrete slabs before erection. The slow-set epoxy was used to ensure that there was adequate time to set and post-tension the slabs. Photo: KSF Inc.

A separate crew prepared the precast concrete slabs by cleaning the ducts and edges of the components, installing seals for the ducts, and applying slow-set epoxy paste adhesive to the joint faces of the slabs. After the slabs were set, the post-tensioning bars were installed, corrosion-inhibiting amine carboxylate powder was blown into the ducts, and the bars were tensioned. As the slabs were squeezed together, excess epoxy oozed out of the joints and was subsequently removed. Upon completion of the post-tensioning, the ducts were grouted. After losses in the post-tensioning, there should be approximately 320 psi of compressive stress in the slabs. Post-tensioning was used to provide a better product with fewer long-term maintenance requirements.

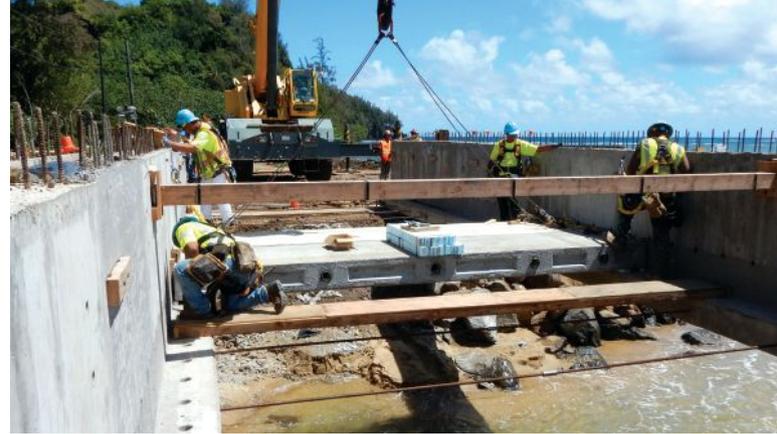
Bracing is in place between the L-shaped girders while the precast concrete slab segments are set. Photo: Hawaiian Dredging Construction Company Inc.

and compression struts were placed near the tops of the girders to resist the rotation of these components due to the eccentric loading from the slabs. Extruded polystyrene foam was placed on the girder ledges to temporarily support the slabs. The thickness of the foam was varied along the girders based on calculations that accounted for girder deflection and the final grade.

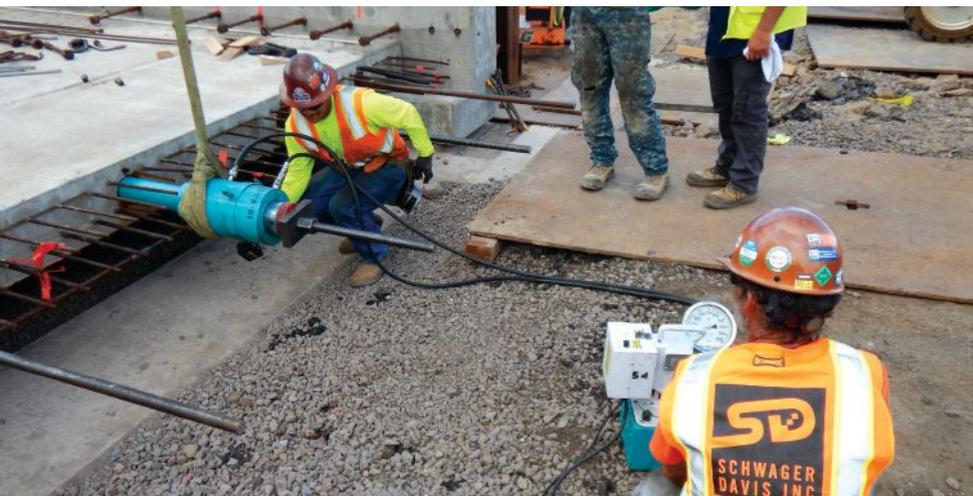
After the slabs were set, the longitudinal post-tensioning bars were installed and tensioned. Photo: Hawaiian Dredging Construction Company Inc.
