PROJECT

The Falls Bridge: A Historic Location Reimagined

by Dr. Harold Walton, HNTB Corporation

FALLS BRIDGE / BLUE HILL, MAINE

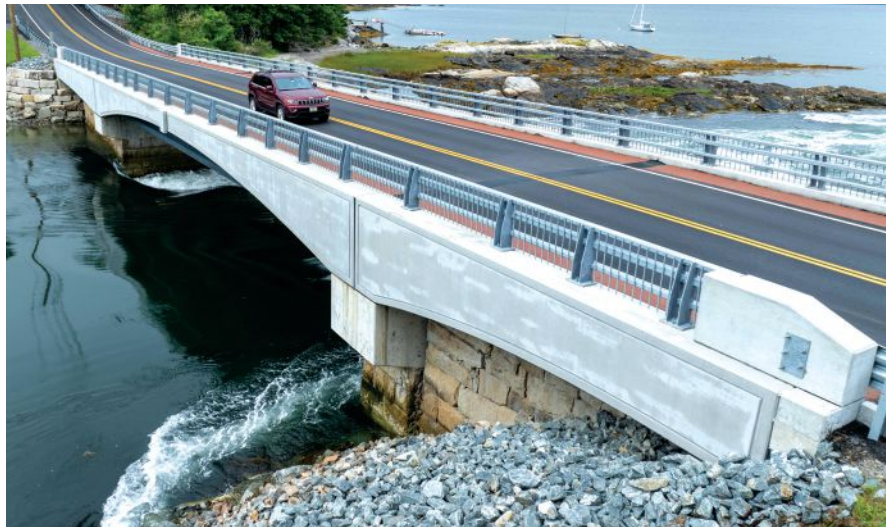
The new precast concrete superstructure and rehabilitated concrete abutments showcase a combination of historical preservation and architectural features that highlight the iconic beauty of the reversing falls and the site. Photo: Maine Department of Transportation.

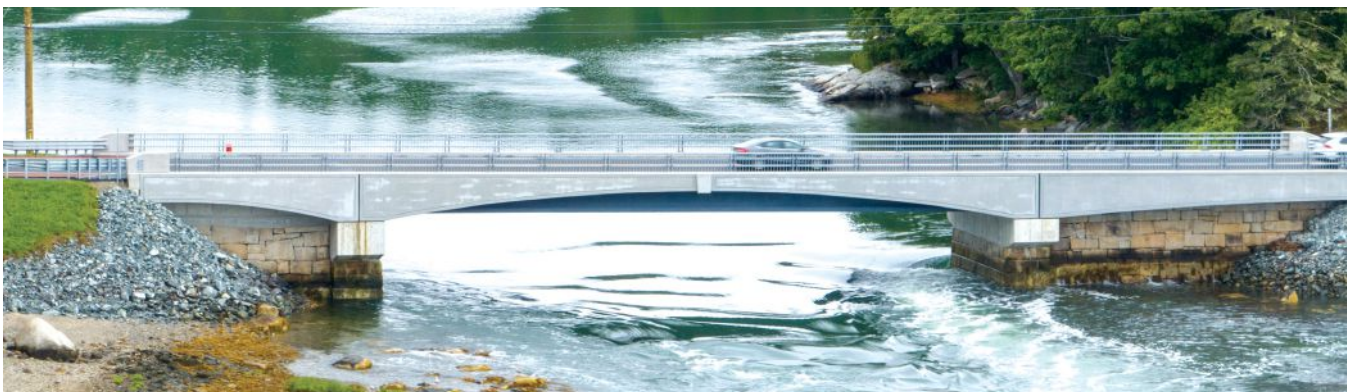
Aesthetic features such as a picketed crash barrier and radiused fascia panels with pencil-line insets create visual appeal for the new superstructure while also improving the safety of the roadway with unobstructed driving sight lines. Photo: Maine Department of Transportation.

replacement preserved the historic stone-faced abutments and approach walls, maintained the hydraulic characteristics of the reversing falls, and minimized the amount of challenging in-water work. Aesthetic enhancements included a crash-compliant decorative steel railing with pickets, pedestrian-friendly stamped and colored pavement on the shoulders, and concrete fascia panels with a bottom radius and accompanying reveal. Inspired by the old bridge, the precast concrete fascia panels give the new superstructure an arched appearance, emulating structural support. Reinforcing bars embedded into the concrete fascia panel are cast into the concrete curb to provide a durable, concealed connection.

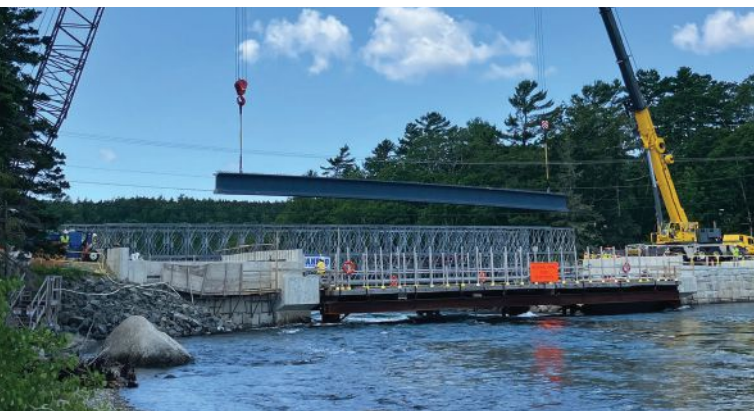
A prestressed concrete Northeast bulb-tee exterior girder is erected for the main span. The girders were treated with a pigmented protective coating to create a visual contrast with the uncolored concrete fascia panels. Photo: Maine Department of Transportation.

The American Association of State Highway and Transportation Officials' *AASHTO LRFD Bridge Design Specifications*³ does not provide guidance for designing prestressed concrete with stainless steel prestressing strands. The NEBTs were designed in accordance with guidance developed by the Florida Department of Transportation (FDOT) in its Structures Design Bulletin 21-02.⁴ The minimum 1.4% strain at rupture of Grade 240 ASTM A1114 stainless steel strand is low compared with the minimum 3.5% strain at rupture of Grade 270 ASTM A416⁵ carbon steel prestressing strand; therefore, strength design was performed using the strain-compatibility method with nonlinear

stress-strain behavior of the strand and concrete strength modifications to the Whitney stress block. Based on the FDOT design bulletin, the flexural resistance factor to be used for a tension-controlled stainless steel prestressing strand girder is 0.75, rather than the 1.0 flexural resistance factor for a typical tension-controlled carbon steel strand reinforced prestressed concrete girder. Typically, carbon steel prestressing strands are pretensioned up to 75% of f_{pu} (specified tensile strength) during fabrication; for this project, pretension of the stainless steel strands was limited to 65% of f_{pu} as based on the FDOT bulletin. The beams were fabricated with fifty 0.62-in.-diameter strands in the bottom of the beam and four strands in the top of the beam. All strands are straight, and no strands are debonded.

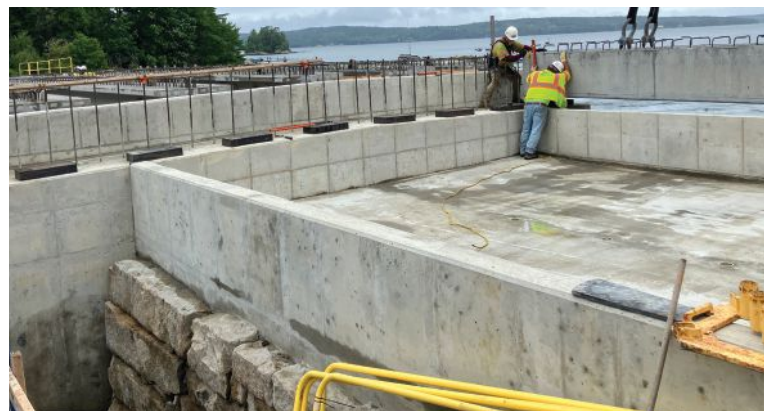
Precast concrete beams for the south approach span are installed over a concrete slab and concrete extension walls that cap the dry-laid granite retaining walls. The prestressed concrete bulb-tee girders of the main span are visible in the background. Photo: Maine Department of Transportation.

The existing dry-laid granite causeways of the 1926 bridge were constructed for a 20-ft roadway and were too narrow to support the 30-ft roadway leading up to the new superstructure. The new roadway is carried by approach spans that span the causeways with center-to-center bearing span lengths of 53 ft 9 in. (north approach) and 30 ft 3 in. (south approach). Supported by the existing abutments and by new concrete

grade beams, the approach spans each consist of eight butted 2-ft 7-in.-deep by 4-ft 0-in.-wide reinforced precast concrete beams with 5-ksi concrete design strength supporting an 8-in.-thick cast-in-place concrete topping slab. The approach beams are conventionally reinforced with Grade 100 high-chromium, low-carbon steel meeting the requirements of ASTM A1035. No prestressing was used in the components of the approach spans. The contract gave the contractor the option of fabricating the nonprestressed concrete components.

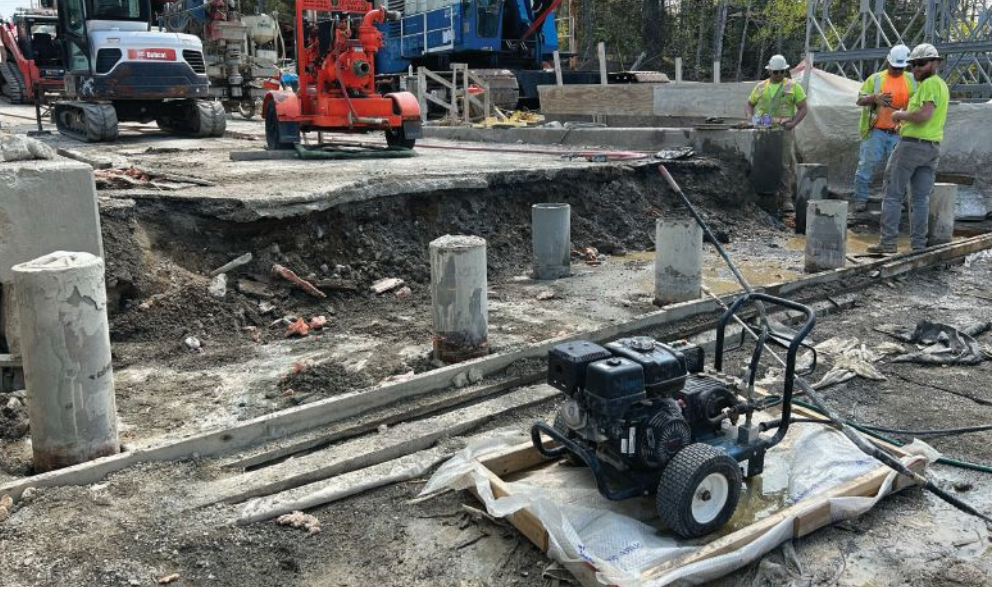
Crews cored 14-in.-diameter holes in the south abutment before installing micropiles. Coring through the stone and concrete abutment was specified as a nonpercussive, low-energy method of creating holes with a low risk of damaging the facing stones at the abutment. Micropiles were installed through the precored holes, and this underpinning provides an alternative load path if the soil-supported abutment is undermined. Photo: HNTB.

The gravity abutments from the 1926 bridge were rehabilitated to support the proposed superstructure. Bedrock is shallow at the site, and exposed bedrock outcrops are prevalent adjacent to the north approach causeway and in the channel. Borings taken through the abutments indicated that the north abutment had been founded on cleaned bedrock while portions of the south abutment had been founded on native till soils. To mitigate future settlement and undermining, the south abutment was underpinned with micropiles. Eight micropiles, each with an 11.875-in.-diameter casing and a no. 18 central reinforcing bar, were installed in 14-in.-diameter cored holes in the south abutment. The annulus around the micropile casing was tremie-grouted with a permeating grout. The grouting process also served to permeate and fill nearby holes, voids, and wide cracks within the existing abutments.

The approach spans are supported on one end by the rehabilitated abutments and on the other end by micropile-supported, cast-in-place concrete grade beams installed beyond the limits of the existing stone retaining walls.
