Rapid Repair of Prestressed Concrete Bridge Beams

by Dr. Rudolf Seracino, Dr. Gregory Lucier, and J. Kendon Gann, North Carolina State University, and Nicholas Pierce, North Carolina Department of Transportation

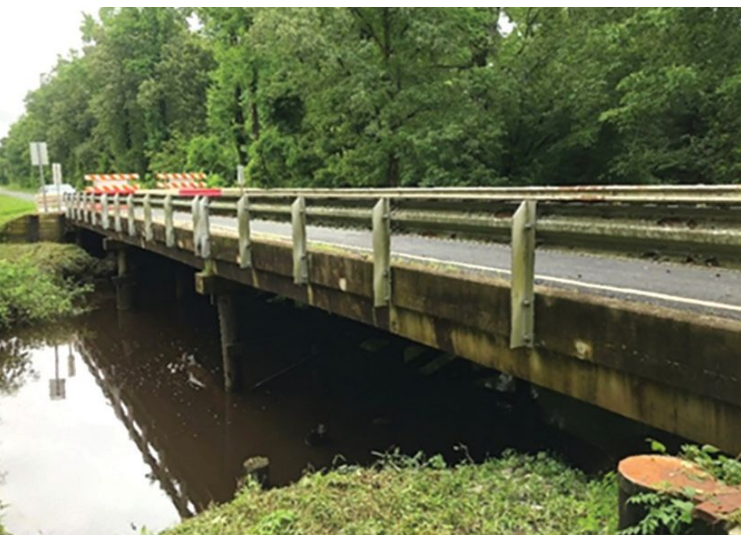
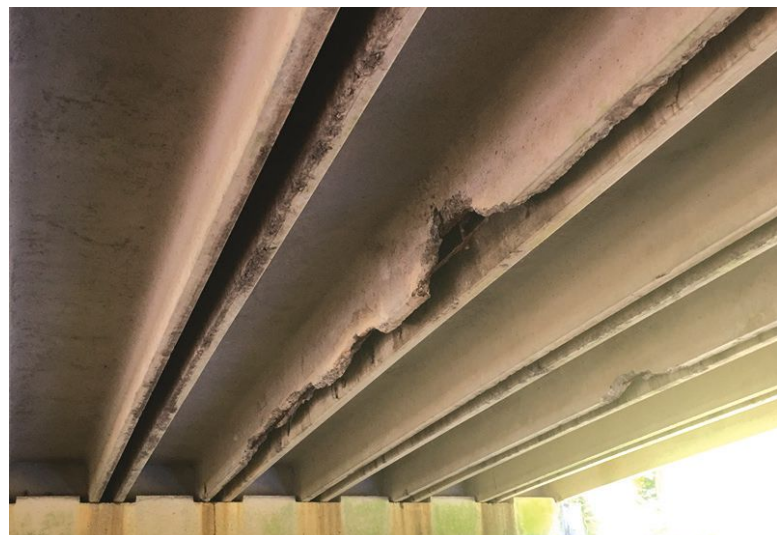
One such example was Bridge 810003 in Sampson County, N.C. This three-span, prestressed concrete C-channel bridge was built in 1955 and was closed following a biennial inspection in May 2020. **Figure 1** shows the Sampson County bridge, which exhibits deterioration typically experienced by C-channel beams, where corrosion of the steel strands leads to spalling of the thin concrete stems, further exposing

Figure 1. The C-channel bridge in Sampson County, N.C., which was closed to traffic in May 2020, exhibits typical deterioration experienced by C-channel beams. All Figures: North Carolina State University.

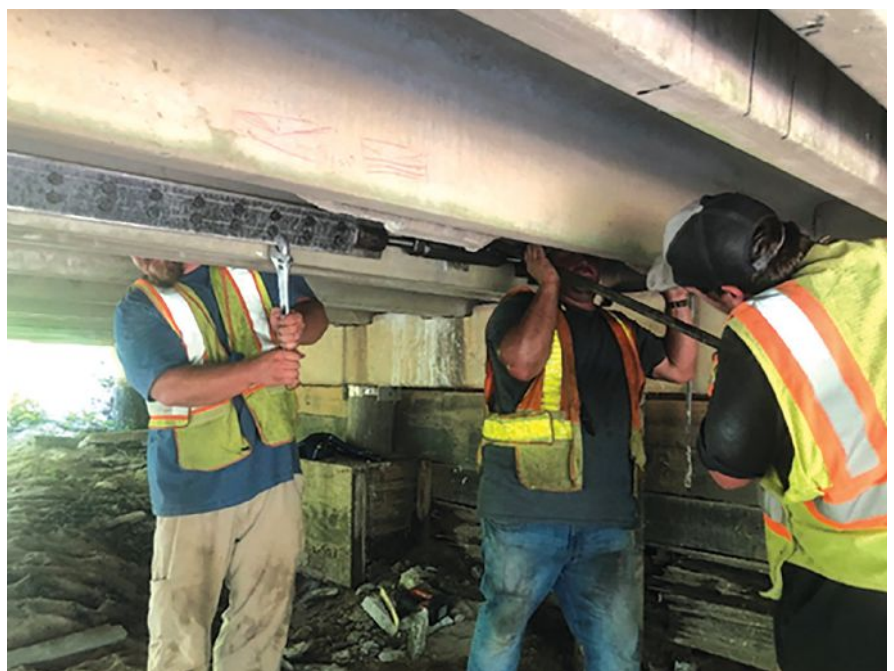
Figure 3. A North Carolina Department of Transportation maintenance crew prestresses a fiber-reinforced-polymer plate by tightening a turnbuckle on the Sampson County bridge.

The repair is a cost-effective alternative that can be installed in hours by NCDOT maintenance crews, and the bridge may be reopened immediately after installation. **Figure 3** shows an NCDOT maintenance crew installing the system on the Sampson County bridge. **Figure 4** shows the system in place on the Sampson County bridge, which was reopened to traffic in November 2020.

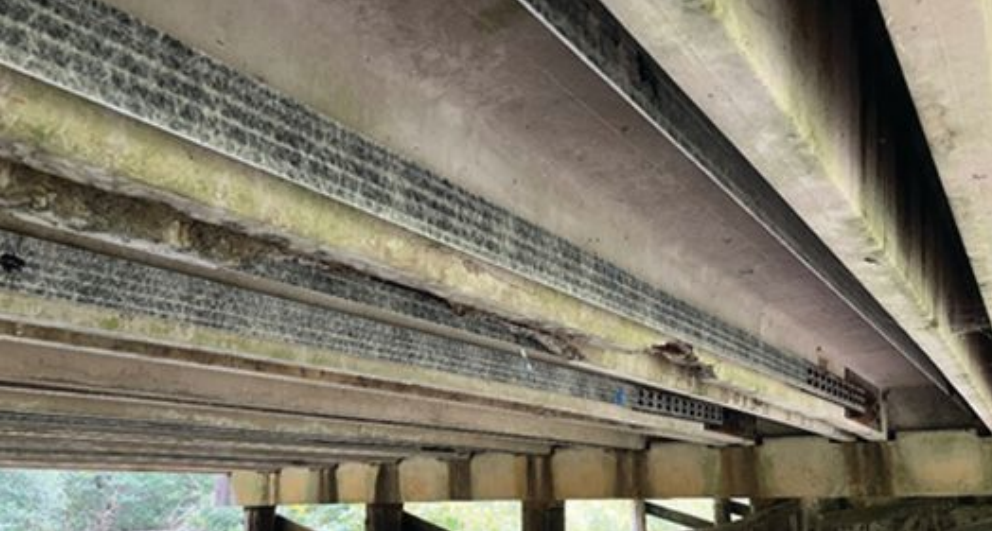
Figure 4. Completed installation of the repair system before the reopening of the Sampson County bridge in November 2020.
