PROJECT

West Sammamish River Bridge

City of Kenmore, Washington

by Kevin S. Kim and Hana D'Acci, Jacobs, and John Vicente, City of Kenmore

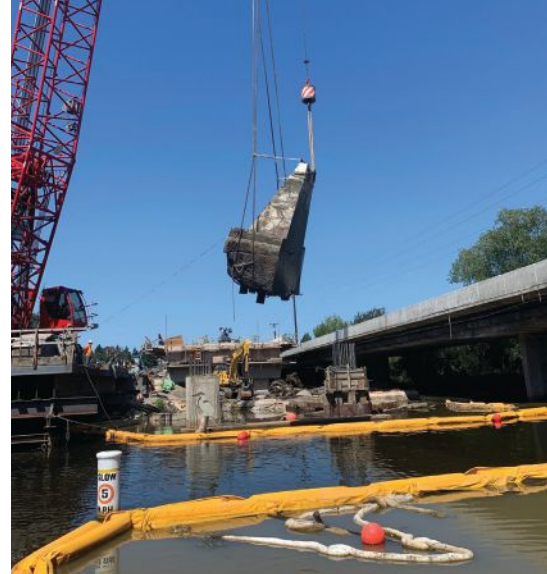
In two cases, removal of the existing concrete foundation required that sections be cut in half. Photo: City of Kenmore.

- Removing existing bridge foundations.** As-built plans of the original 1938 bridge were a close match for what was discovered in the field, but removing the structures proved to be extremely difficult. A local specialty contractor pumped the sediment from below the concrete foundations and exposed the supporting timber piles. Once the piles were

exposed, divers threaded lifting cables underneath the foundation sections. While the cables were suspended from a crane, the divers used underwater chainsaws to cut the existing pilings. When the pilings were all cut, the crane lifted the existing concrete foundation out of the river, which was dangerous and time-consuming work. The

four foundations weighed between 140,000 and 200,000 lb each. Two of the foundations were so heavy that they exceeded the capacity of the cranes and could not be lifted without first being cut in half vertically. The contractor worked extended hours during the in-water work window to complete the foundation removal.

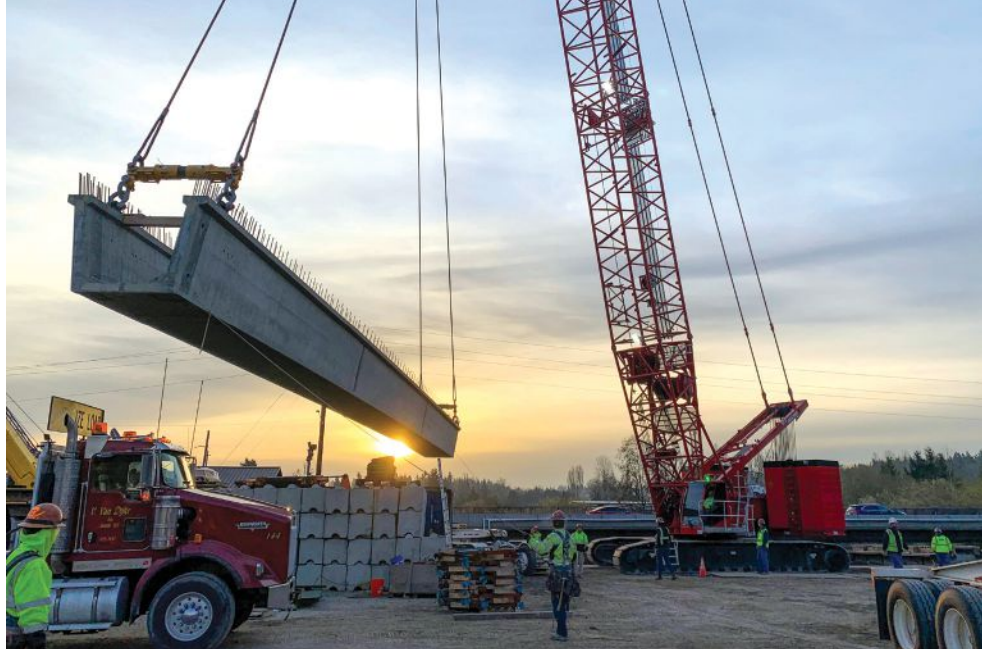
Installing one of the precast, prestressed concrete tub girders. The typical girder is 110 ft long and weighs 165 kip. Photo: Jacobs.

River Bridge structure would be visually compatible with the existing bridge, the team decided to use precast concrete “tub-shaped” girders (WSDOT UF60G5) and the same span arrangement as the remaining northbound bridge. As such, two girder lengths were used on the project; span 2 had a girder length of 140 ft with a weight of 210 kip, and the other four spans had 110-ft-long girders weighing 165 kip. This aspect of the design not only expedited construction but also minimized impacts on environmentally sensitive areas.

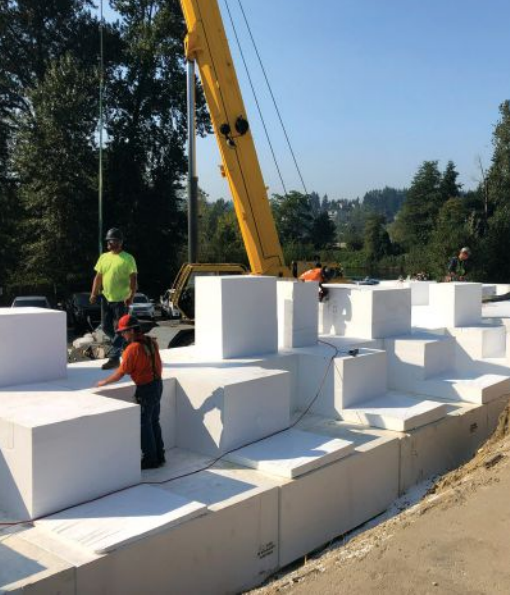
At the roadway approaches, geofabric blocks are placed over traditional gravel materials to mitigate settlement of the highly compressible peat layers. Photo: City of Kenmore.

- **Geofoam blocks to mitigate settlement.** The bridge corridor is underlain by highly compressible peat layers, which are prone to settlement. To mitigate long-term settlement due to new roadway approaches at each end of the bridge, the design team recommended using geofoam blocks for the roadway subgrade instead of gravel. The geofoam blocks are extremely lightweight but structurally adequate to support the roadway without inducing any long-term settlement along the corridor. Use of geofoam blocks over the traditional gravel materials substantially shortened the construction duration.

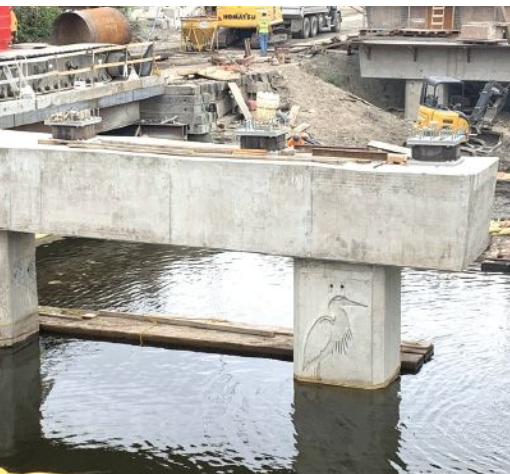
Seismic isolation bearings—rubber bearings with lead cores—reduce the seismic demand on the concrete columns and foundation. Great blue herons are featured on the pier columns because the Sammamish River is a major habitat for the species. Photo: Jacobs.

achieve that goal, the latest technology was used to account for climate change, seismic conditions, and the day-to-day needs of the structure over the long term. Given the earthquake risks at the bridge location, seismic resiliency was an important component of the work. To accommodate seismic design requirements for a 1000-year design seismic event and to reduce the seismic demand on the concrete columns and drilled shafts, the design team used seismic isolation bearings to support the bridge superstructure. Although seismic isolation bearings are typically used on complex structures or seismically vulnerable older bridges, the design team specified them for this structure because they are suited for the presence of liquefiable soil layers, which would cause lateral spreading, and for short column heights that could not withstand the seismic displacement demands. A rubber bearing with a lead core was selected for its cost effectiveness and ease of installation.

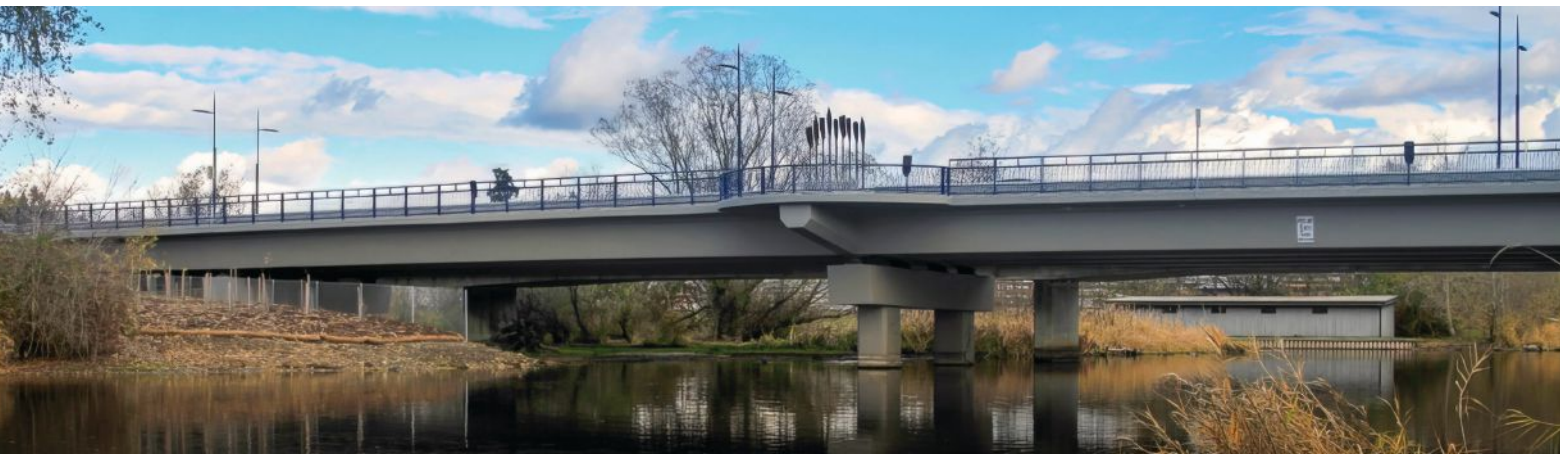
Nine vertical “oars” at the overlook on the West Sammamish River Bridge multiuse path delineate its position and importance
Photo: Jacobs.

Finally, the nine vertical “oars” of the monument on the multiuse path provide a vertical element that further delineates the position and importance of the overlook. The lightweight and simply patterned pedestrian railing offers a transparent horizontal feature that doesn’t compete with the visual prominence of the overlook or interfere with travelers’ views from the bridge.
