New Mexico

by Kimberly Coleman, New Mexico Department of Transportation

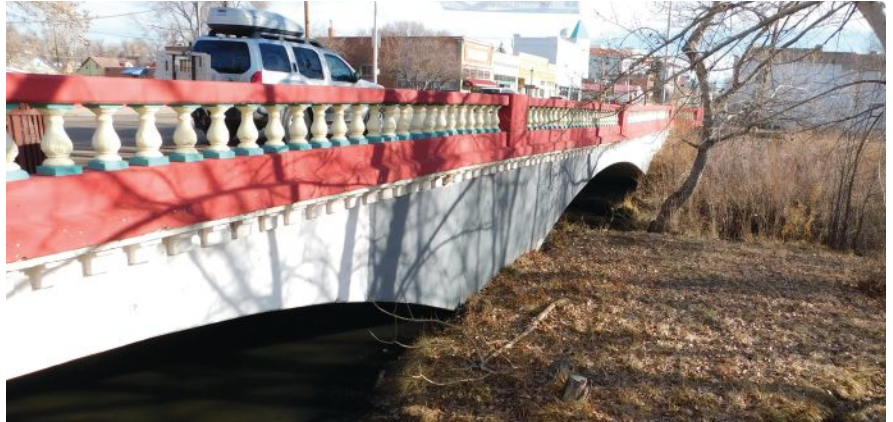
Figure 1. New Mexico's oldest concrete arch bridge carries Bridge Street over the Gallinas River in Las Vegas, N.Mex. It was built in 1909 and is still in service today. Photo: New Mexico Department of Transportation.

One of New Mexico's oldest in-service concrete bridges is a locally owned concrete arch in central Las Vegas, N.Mex., built in 1909

(**Fig. 1**). This bridge carries Bridge Street over the Gallinas River, which is part of the historic Santa Fe Trail. Even though this bridge has been in service for over 110 years, it is still in fair condition—truly an example of concrete performing to its best advantage!

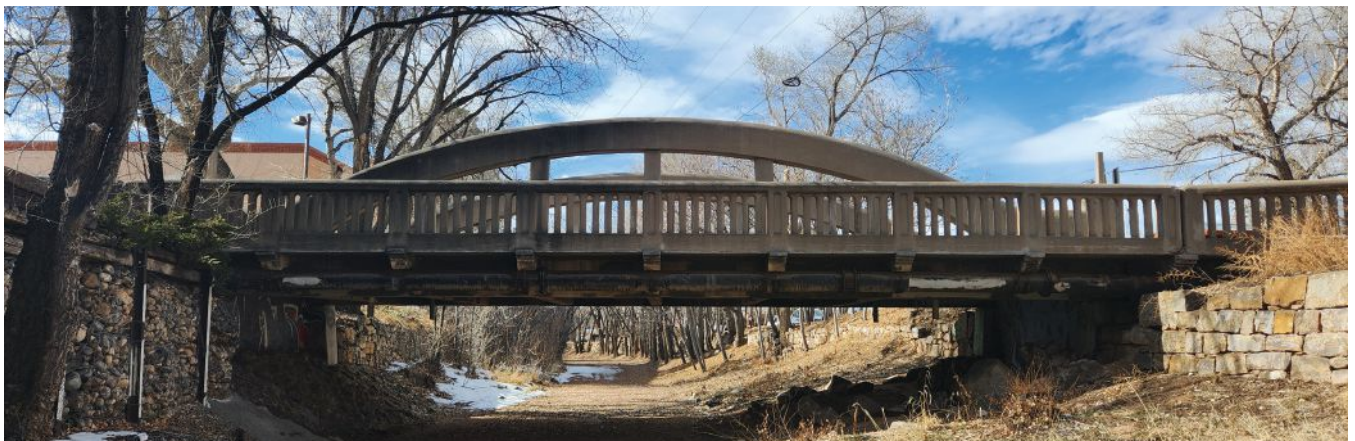
Figure 2. One of New Mexico's oldest bridges carries Grant Avenue over Arroyo de Las Mascaras in the heart of Santa Fe. The concrete through-truss bridge, dubbed the "Rainbow Bridge," was built in 1920. Photo: New Mexico Department of Transportation.

Another of New Mexico's oldest bridges is in the heart of Santa Fe. This concrete through-truss bridge, dubbed the "Rainbow Bridge," was built in 1920 and carries Grant Avenue over Arroyo de Las Mascaras (**Fig. 2**). This bridge is load posted at 10 tons, but it is still in fair condition and is still performing its intended function.

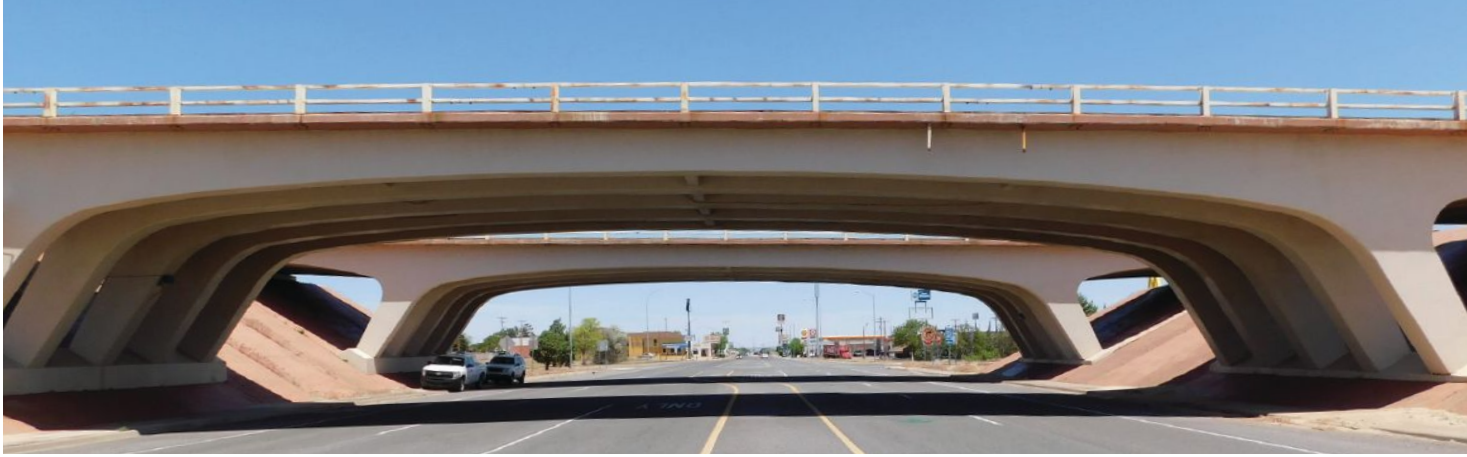
Figure 3. Two of the New Mexico Department of Transportation's concrete K-frame bridges carry Interstate 40 in Tucumcari, N.Mex. There are eight K-frame bridges in the state. Photo: New Mexico Department of Transportation.

New Mexico's multispan, rigid K-frame structures represent an unusual type of reinforced concrete bridge (**Fig. 3**). NMDOT owns six of these bridges, four of which were built in 1980 and 1981 and are in satisfactory condition. Two were built in 1990 and are in good condition. NMDOT looks forward to many more years of use from these bridges.

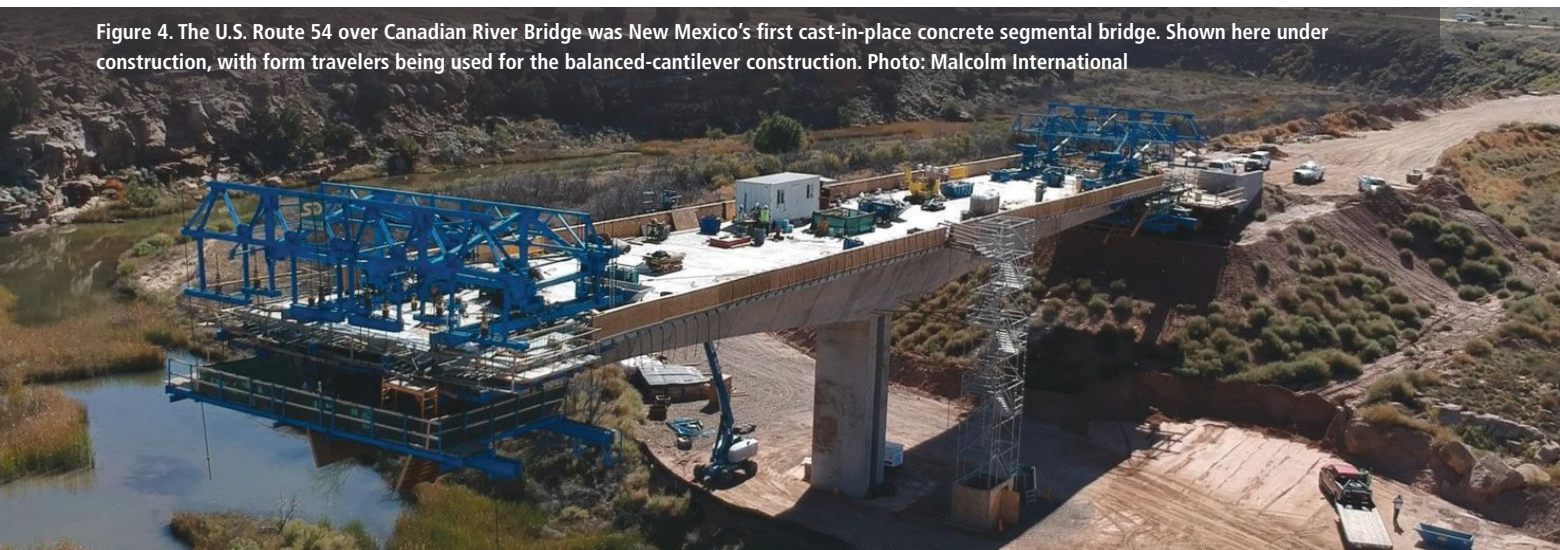
Figure 4. The U.S. Route 54 over Canadian River Bridge was New Mexico's first cast-in-place concrete segmental bridge. Shown here under construction, with form travelers being used for the balanced-cantilever construction. Photo: Malcolm International

In 2021, construction was completed on NMDOT's first cast-in-place concrete segmental bridge, U.S. Route 54 over the Canadian River in Logan, N.Mex., featured in the Winter 2021 issue of *ASPIRE*[®] (**Fig. 4**). This bridge type was selected because it could be constructed from above, thus surmounting environmental constraints caused by wetlands and endangered fish species in the Canadian River below. The bridge, which was opened in June 2021, was awarded the 2021 American Segmental Bridge Institute's Bridge Award of Excellence and the 2022 American Council of Engineering Companies' Grand Conceptor Award.

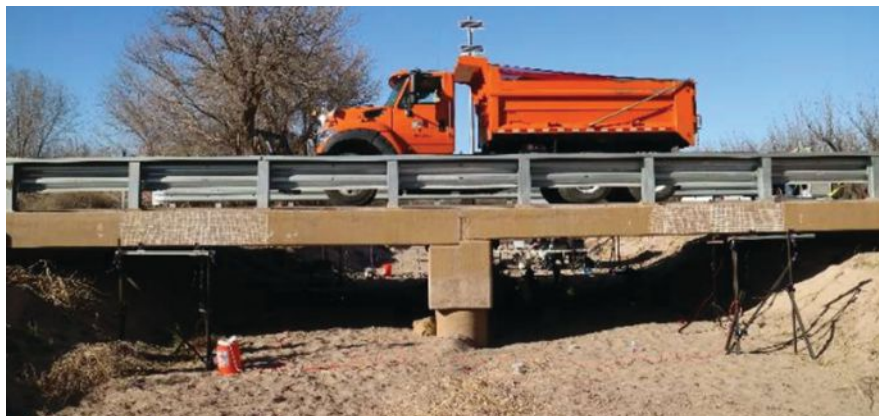
Figure 5. Load testing on the NM 186 over La Union Main Canal. This is the New Mexico Department of Transportation's first use of ultra-high-performance concrete (UHPC) for a prestressed concrete girder bridge. One span of the two-span bridge used UHPC, and the other span used a conventional concrete mixture. Photo: New Mexico Department of Transportation.

The bridge was instrumented with internal and external strain gauges and load tested several times to establish a baseline for future testing and provide comparisons between the behavior of the two concrete types (**Fig. 5**). In Phase IV, NMSU undertook development and testing of nonproprietary UHPC mixtures for joints and overlays. A 1-in.-thick UHPC overlay concrete was

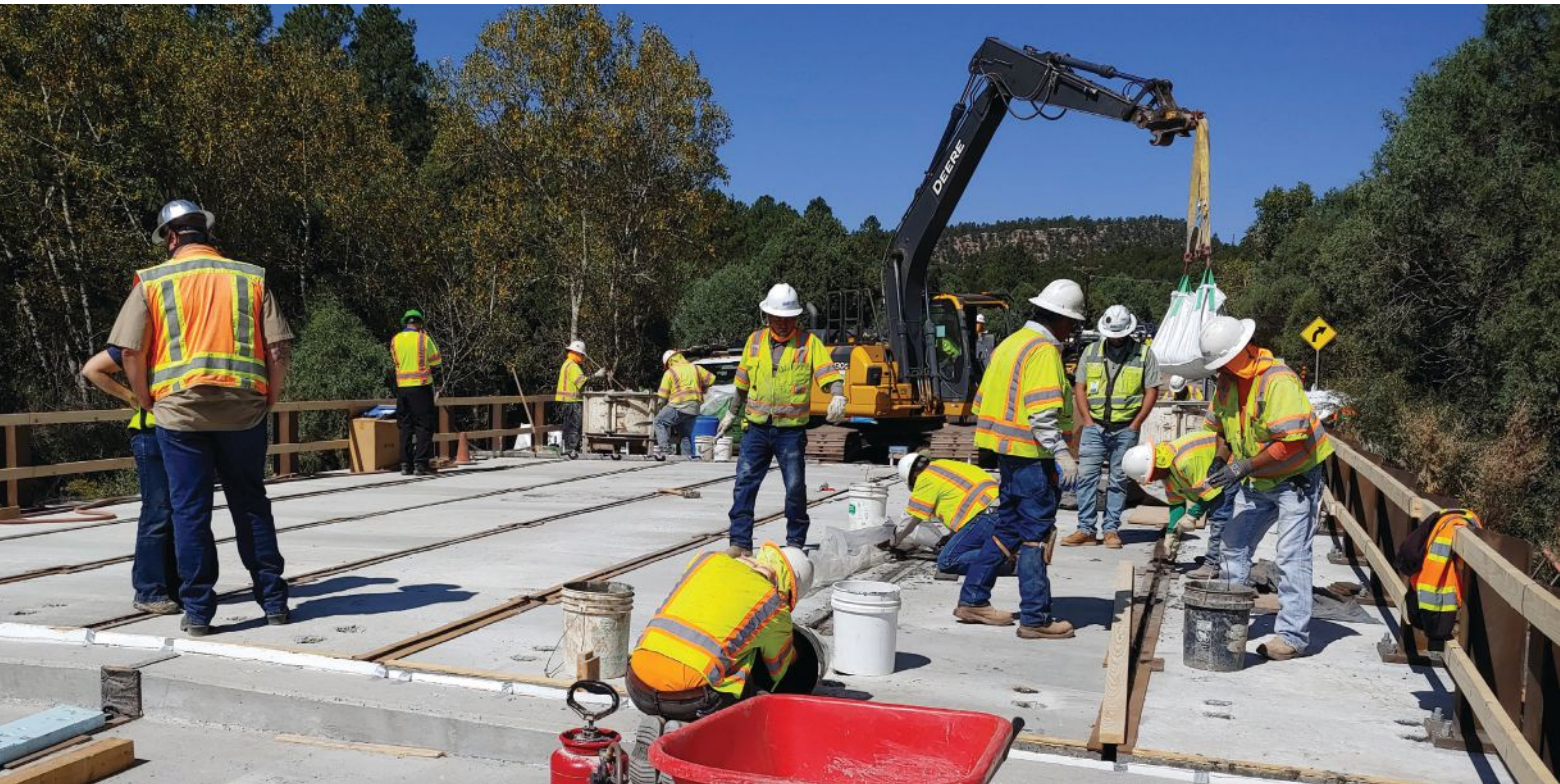
Figure 6. Installation of ultra-high-performance concrete joints on the NM 50 over Glorieta Creek Bridge. Photo: New Mexico Department of Transportation.

As NMSU's research on nonproprietary UHPC was progressing, NMDOT used proprietary UHPC mixtures on several other projects: one UHPC deck overlay and four precast concrete bridges with UHPC closure joints. New Mexico's most recent precast concrete bridge with UHPC closures is NM 50 over Glorieta Creek. In the 2023 PCI Design Awards, it received the All-Precast Concrete Solution award and an honorable mention for Bridge with a Main Span under 75 ft (**Fig. 6**).

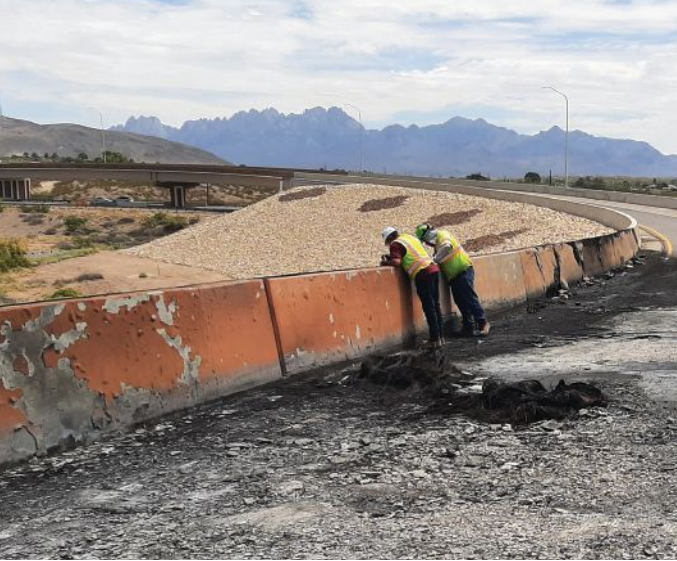
Figure 7. In July 2023, a fuel tanker truck overturned and burned, resulting in fire damage to a concrete bridge deck and barriers. The fire-damaged concrete was repaired or removed and replaced. The structure was reopened five months later. Photo: New Mexico Department of Transportation.

A recent emergency occurred on an interstate flyover ramp in Las Cruces, N.Mex. On the evening of July 11, 2023, a fuel tanker truck tipped on its side, catching fire and spilling burning fuel near the departure abutment. It burned for approximately 80 minutes, causing explosive spalling and strength loss to the deck, concrete bridge rail, and downslope wingwall (**Fig. 7**). NMDOT's emergency repair contractor used hydrodemolition to remove the fire-damaged concrete and recast or patch the damaged components. Repairs were completed and the bridge was reopened to traffic on December 13, 2023.

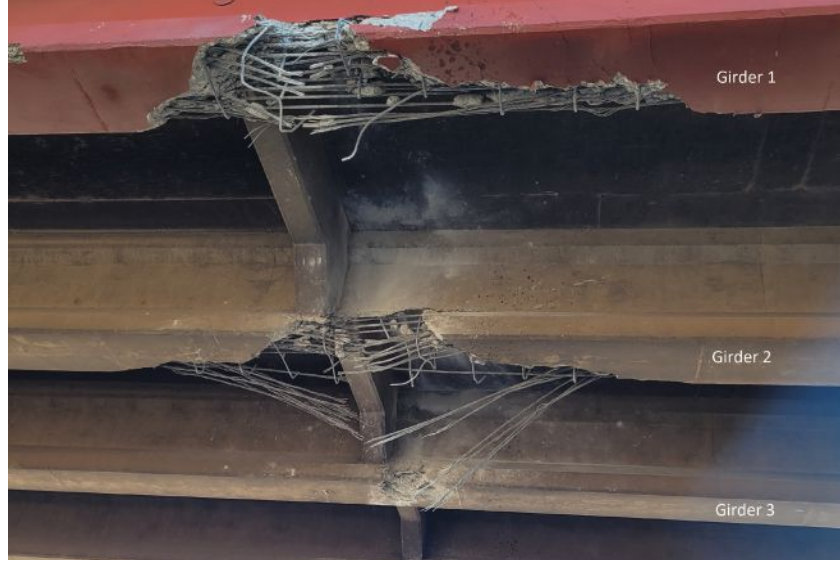
Figure 8. In October 2022, the NM 129 overpass over Interstate 40 was hit by an excavator and all strands were severed on two of the five prestressed concrete girders. One lane was immediately closed and remains closed. Construction to replace the damaged span is anticipated to begin in late 2024. Photo: New Mexico Department of Transportation.

Another source of significant damage has been vehicular collisions with girders. The resiliency and redundancy of concrete girder bridges allow many of these damaged girders to be repaired. NMDOT has used strand couplers, cementitious patch materials, and sometimes carbon-fiber wrap to quickly put the damaged girders back into serviceable condition. However, some damages defy repair. In October 2022, the NM 129 overpass over I-40 was hit by an excavator, which severed all strands on two of the five girders over the eastbound lanes

(**Fig. 8**). NMDOT staff immediately closed the lane carried by the two damaged girders, and the bridge is still restricted to one lane in this span. A design project is currently underway to replace the damaged span, with construction anticipated to begin in late 2024.
