Experimental Evaluation of Overheight Impact Damage and Repair Effectiveness in Prestressed Concrete Bridge Girders

by Dr. Mohamed A. ElGawady, Dr. Haitham AbdelMalek, Francis Ashun, Dr. Mohanad Abdulazeez, and Dr. Ahmed Ghenni, Missouri University of Science and Technology, and Dr. Ahmed Ibrahim, University of Idaho

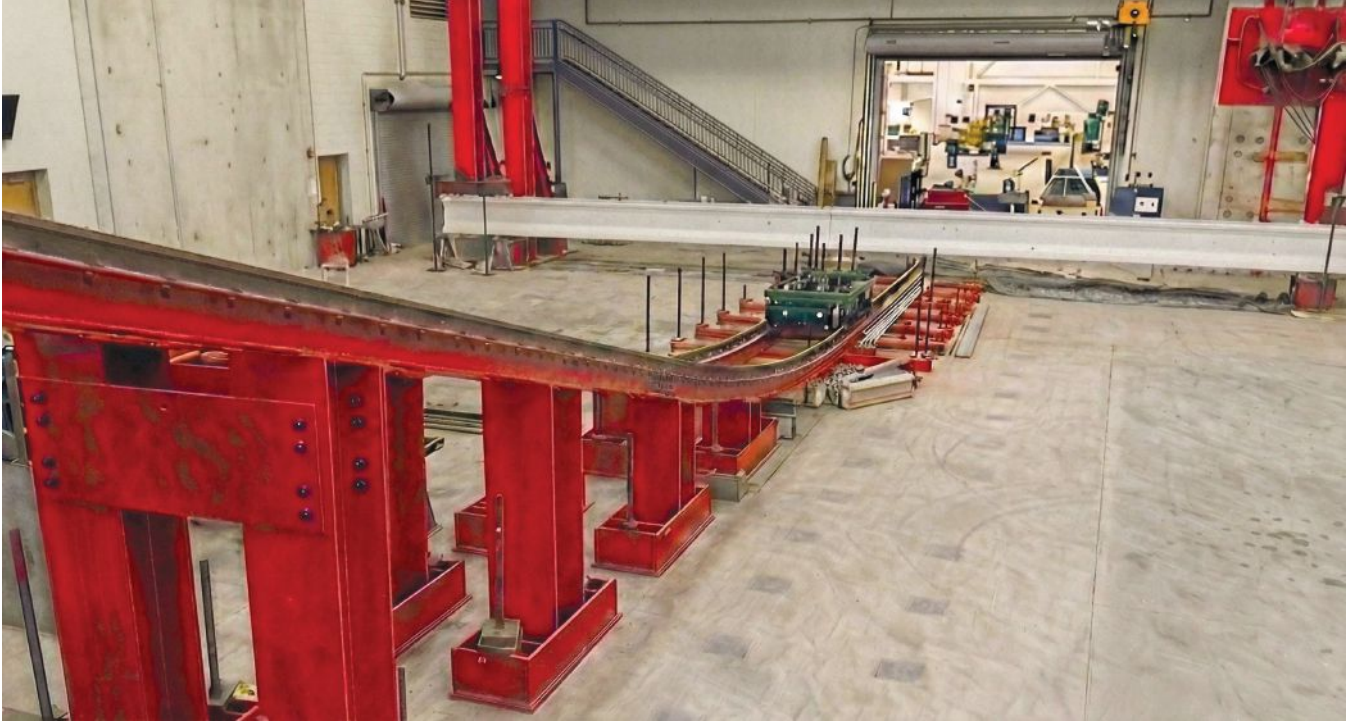
Figure 3. The impact bogie is ready to be released for impact testing of a girder specimen.

Lateral impacts were delivered using a purpose-built impact simulator consisting of a 60-ft-long elevated steel track, of which a 22-ft length was flat and 38 ft was inclined (**Fig. 2** and **3**). The impact bogie had an empty weight of 2800 lb and was designed to withstand the AASHTO LRFD specifications' equivalent static force of 600 kip. The steel frame—measuring 7 ft by 3 ft—was configured to accommodate removable concrete slabs for weight augmentation. A steel bumper at the front contained load cells for measuring the impact force. During this experimental program, up to three 1400-lb concrete slabs were installed. With three slabs installed, the total bogie weight reached 7000 lb. The

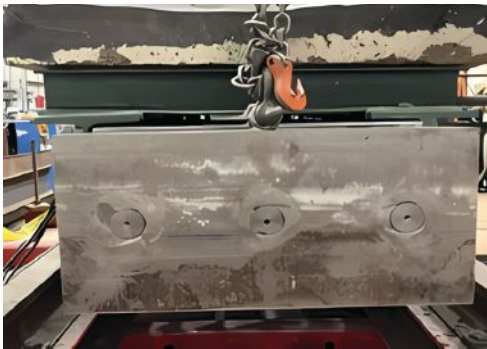
Figure 4. Impactor shapes: flat head (top) and fork head (bottom). These impactors simulate typical tractor trailer and oversized equipment impacts, respectively.

bogie, which was equipped with interchangeable impactor heads, served as the surrogate vehicle, providing repeatable kinetic energy under gravity-driven acceleration. A flat head simulated distributed contact consistent with trailer header-bar engagement, and a fork-shaped head reproduced concentrated, asymmetric contact representative of specialized equipment or offset strikes (Fig. 4). In all tests, the impactor head

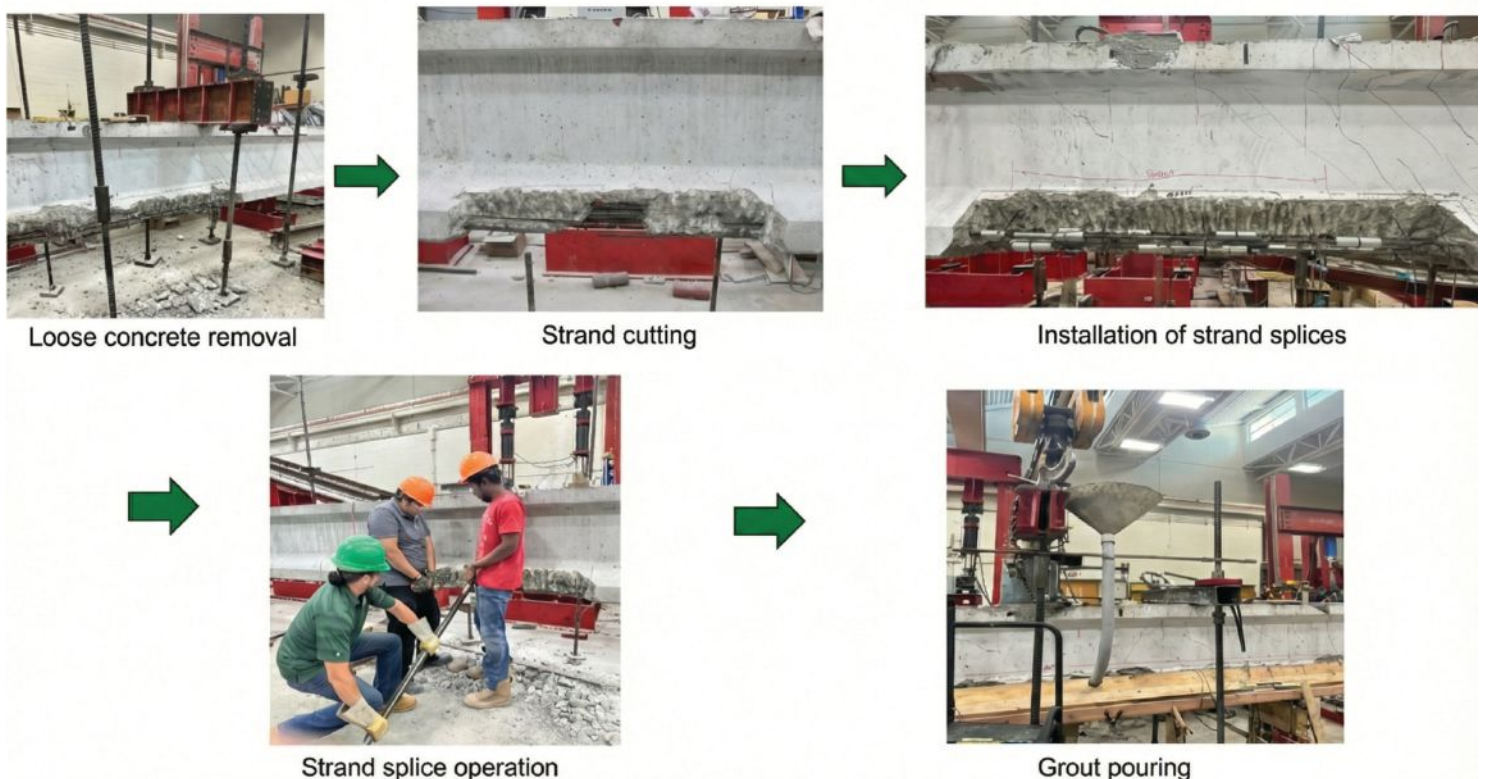
Figure 6. After the girders were impact tested, these steps were taken in the strand splicing repair.

Two repair strategies were experimentally evaluated for restoring flexural capacity after overheight impact-type damage: mechanical strand splicing using a proprietary system and externally bonded carbon-fiber-reinforced polymer (CFRP) composites. The strand-splicing program investigated four girders with strand losses between 17% and 33%. Repairs followed a consistent field-relevant sequence, including

- concrete removal and strand exposure,

- staggered splice installation,
- reintroduction of effective prestress by tensioning to approximately 70% of strand yield,
- patching with high-strength non-shrink grout with an average design compressive strength of 10,200 ksi, and
- epoxy injection into diagonal cracks along the web to restore stiffness and limit crack reopening (Fig. 6).

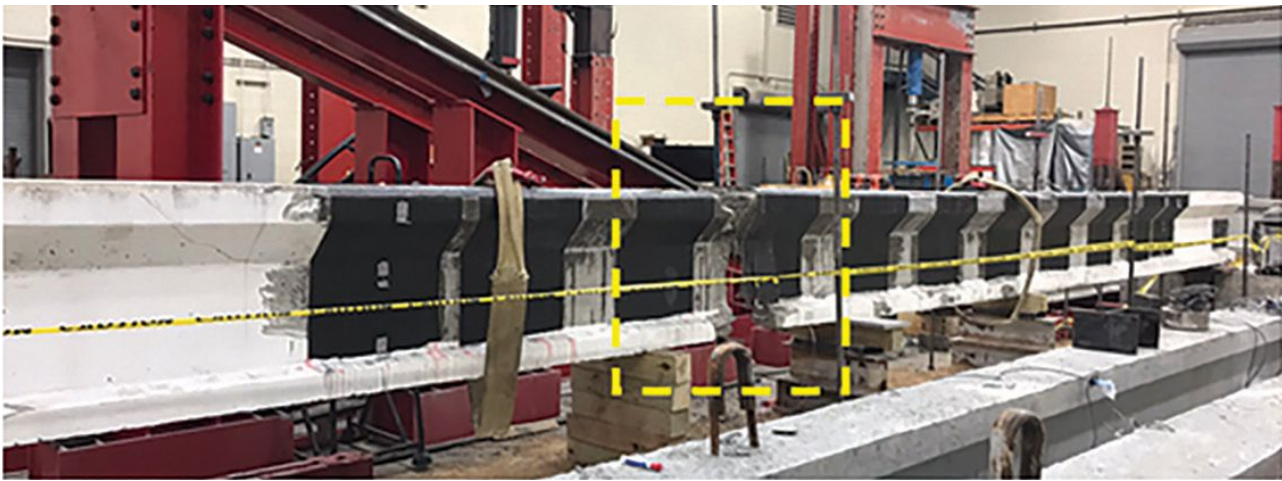
Figure 7. Failure of the carbon-fiber-reinforced polymer (CFRP) repaired girder; only the CFRP-repaired specimens were tested upside down.

confirm that a CFRP system can restore and even increase flexural strength for moderate damage levels, provided that anchorage and bond quality are properly controlled; however, the repair may shift the failure mode from ductile flexure to anchorage-controlled brittle behavior.

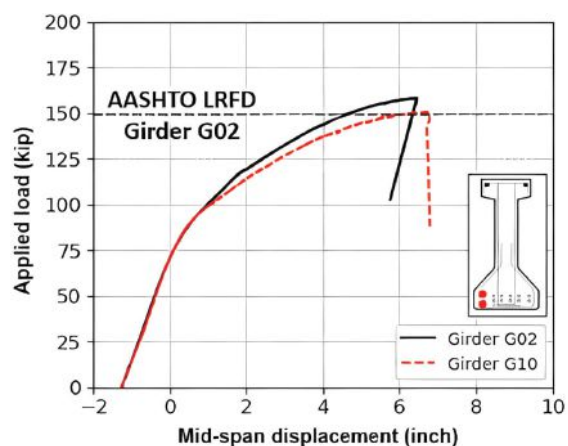
Figure 8. Force-deflection curve of repaired girder G08 (33% strand loss with carbon-fiber-reinforced polymer strengthening) and undamaged control girder G02.

strand loss. No strand splicing was done as part of this work. A wet layup system designed in accordance with the American Concrete Institute's *Guide for the Design and Construction of Externally Bonded FRP Systems for Strengthening Concrete Structures* (ACI PRC-440.2-17)⁵ was installed with longitudinal plies (individual layers of fiber reinforcement) on the soffit and U-wrap anchorage to mitigate debonding. Successful performance required thorough surface preparation, including crack injection, patching, corner rounding, and appropriate surface roughness. Pull-off testing⁶ indicated excellent bond quality, with failure occurring within the concrete substrate rather than at the interface or within the CFRP system. Under four-point bending, both CFRP-repaired girders exhibited brittle failure initiated by U-wrap rupture followed by longitudinal ply debonding (**Fig. 7**). Despite the brittle failure mode, strength restoration was substantial: the 17% damage girder and the 33% damage girder exceeded the control girder's strength by 23% and 16%, respectively (**Fig. 8**). These results
