# North Carolina

North Carolina continues to invest in infrastructure while exploring innovative construction and repair methods to extend the lifespans of concrete bridges.

by Nicholas Pierce, Aaron Earwood,  
and Tyler Rogers, North Carolina  
Department of Transportation

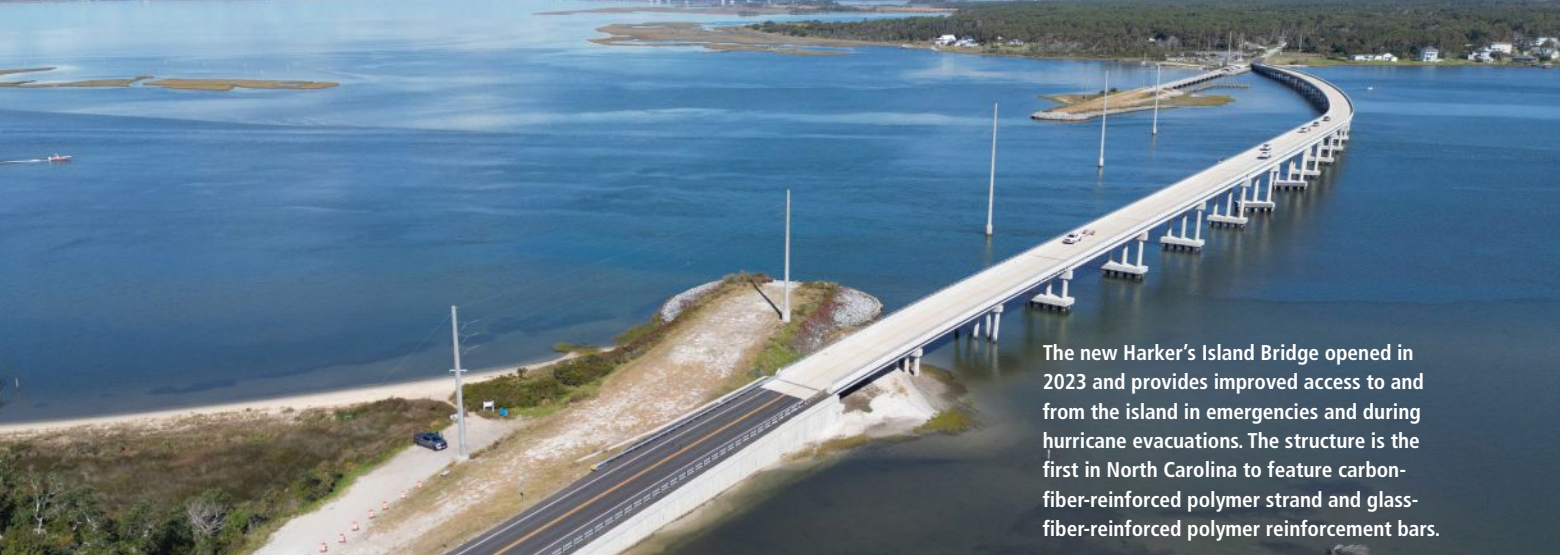
The new Harker's Island Bridge opened in 2023 and provides improved access to and from the island in emergencies and during hurricane evacuations. The structure is the first in North Carolina to feature carbon-fiber-reinforced polymer strand and glass-fiber-reinforced polymer reinforcement bars.

The Harker's Island Bridge replacement project was the first bridge entirely reinforced with FRP reinforcing bars and prestressing strand in North Carolina. (For more information on this project, see the Fall 2023 issue of *ASPIRE*®). Given the success of the Harker's Island project, NCDOT has specified FRP reinforcement on other projects, including a bridge replacement over the Alligator River in the Outer Banks region.

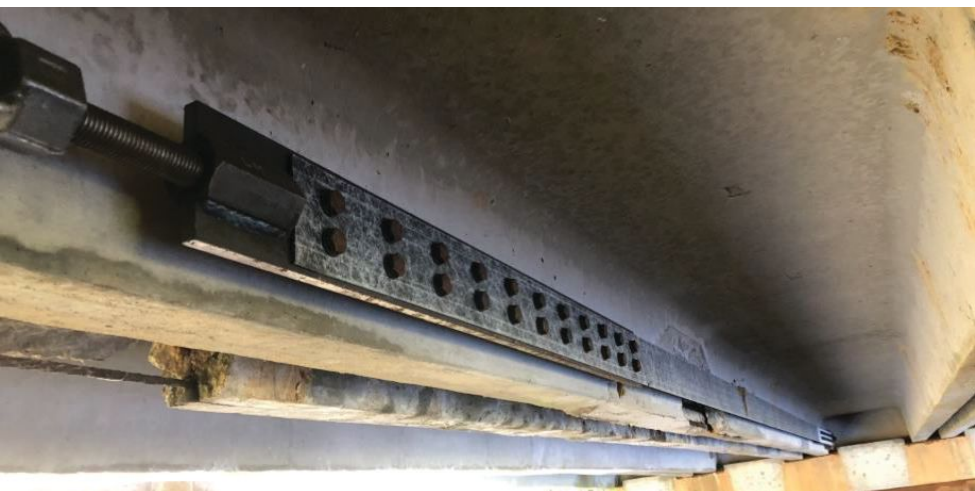
**Sampson County Bridge No.3 is the first North Carolina example of a retrofit application using the prestressed, mechanically fastened, fiber-reinforced polymer system. The repair of six beams was completed in five days, and the bridge reopened immediately after installation of the repair.**

In November 2020, six channel beams on Sampson County Bridge No. 3 were retrofitted with the prestressed MF-FRP system as a temporary solution for a deteriorated structure. The bridge is a three-span prestressed concrete channel structure built in 1966 across Branch Six Run Creek, and the retrofit was designed to restore prestressing forces lost due to corrosion of internal steel strands. The cost-effective repair allowed the bridge to be reopened immediately; the bridge’s condition was then continuously monitored until the structure was replaced. The new bridge opened to traffic in 2023.

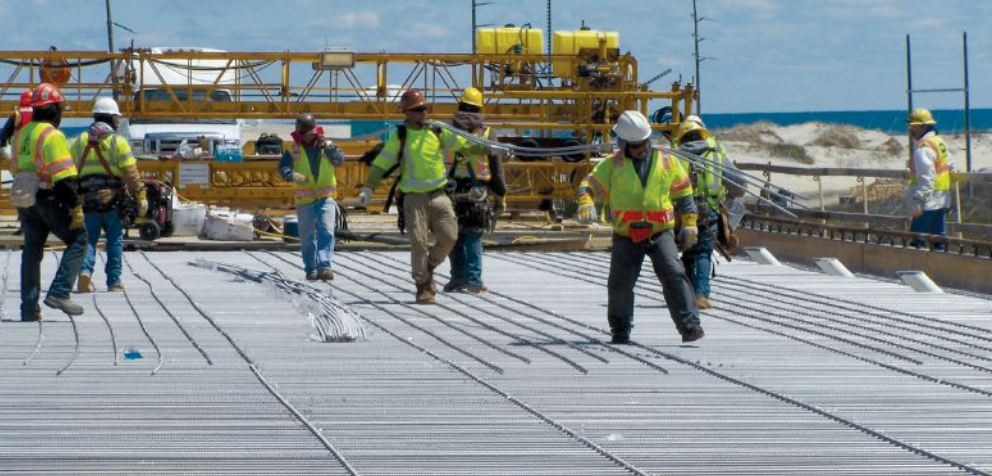
The Marc Basnight Bridge is designed to resist corrosion in the harsh saltwater environment of coastal North Carolina. To meet the 100-year service life, the design team chose stainless steel reinforcement for the cast-in-place concrete deck.

the first time in North Carolina, stainless steel was used in place of traditional carbon steel reinforcement, specifically in the cast-in-place concrete bridge deck and the post-tensioning bars. In conjunction with the stainless steel reinforcement, advanced concrete mixtures and precast concrete components were used to help achieve the design goal of a 100-year service life. The concrete mixture proportions used for the Marc Basnight Bridge were selected for maximum durability against saltwater exposure. Calcium nitrite corrosion inhibitor coupled with supplementary cementitious materials, including fly ash, slag, and silica fume, decrease the permeability of the concrete and help delay the onset of corrosion in the steel reinforcement.

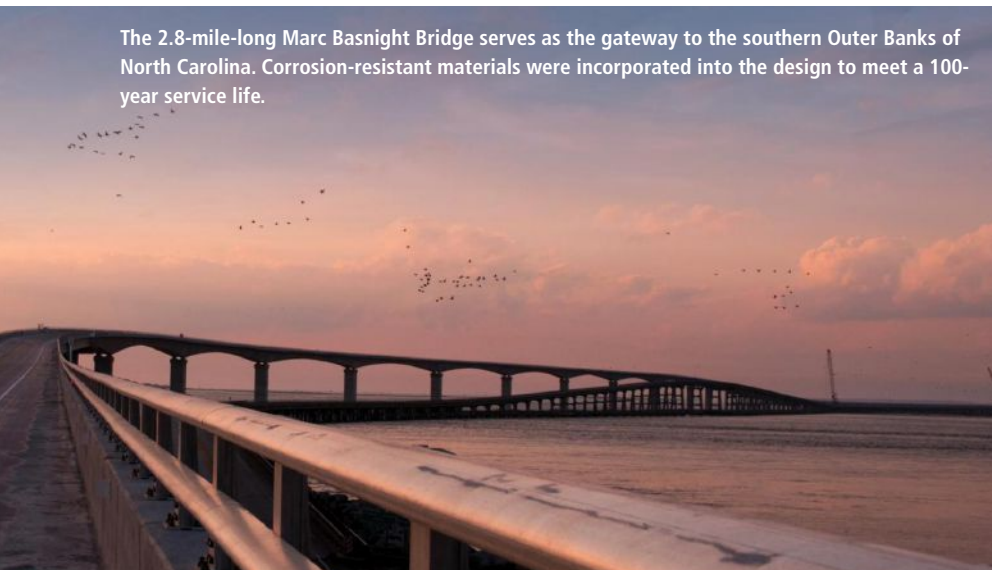
The 2.8-mile-long Marc Basnight Bridge serves as the gateway to the southern Outer Banks of North Carolina. Corrosion-resistant materials were incorporated into the design to meet a 100-year service life.
