# **When Concrete Isn't Concrete: Preserving the Dry Canyon Bridge**

by Rebecca Burrow, Oregon **Department of Transportation**

In 2017, nearly a century after it was constructed, the Dry Canyon Bridge on the scenic Historic Columbia River Highway underwent its first major rehabilitation, which included repairs to low-strength concrete, realkalization of the superstructure, application of a cementitious render, and an experimental deck overlay. With the completion of these repairs, it is expected that the bridge will have another 100 years of service life under the Oregon sun.

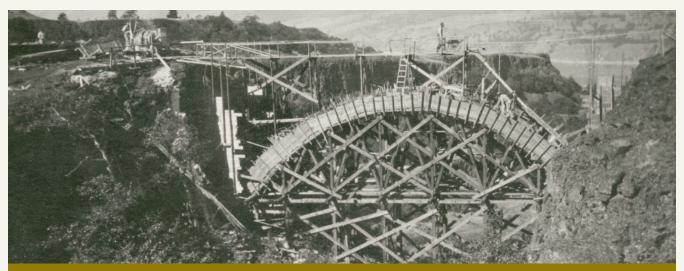
The Dry Canyon Bridge was constructed over the winter of 1920-1921, before highway construction had reached this remote location in the Columbia River Gorge. The timber for the falsework and formwork was brought in by mule train. Photo: Oregon Department of Transportation Bridge Engineering Section.
