Inspection and Repair of a Fire Damaged Prestressed Girder Bridge

RICHARD STODDARD, Washington State DOT, Olympia, WA

IBC-04-17

DAMAGE INSPECTION REPORT 12/12/02

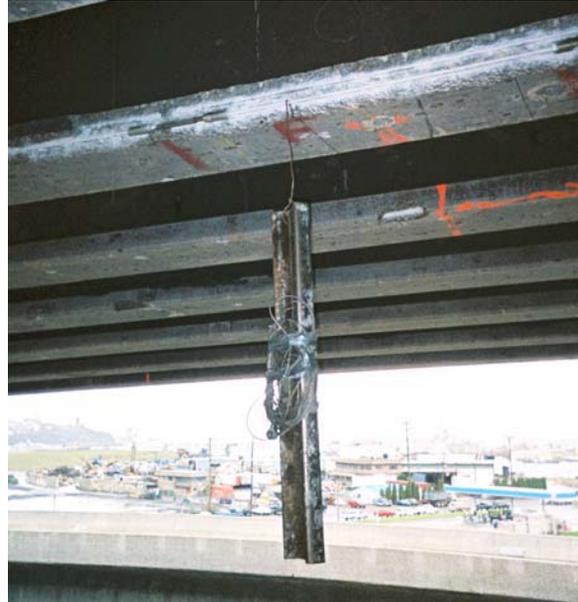
Photo 6. Deflection Test Dead Weight

Prior to removing samples of prestressing strands for material testing, a simple deflection test was performed to calculate the prestressing force remaining in the exposed strands. The deflection tests were conducted on exposed strands with exposed lengths varying from 8 feet to 14 feet. The tests were conducted before the strands were cut and after the cable replacement splices were tensioned. Cable deflections were induced by hanging a 4 foot piece of rail provided by the BNSF Railroad. The rail and the attachment cable provided a dead weight of 173.3 pounds.

The deflection tests were performed 40 feet above the ground and there was concern about the accuracy of the measurements. The actual location of vertical support points for the exposed strands could extend into the concrete, the displacement measurements could be affected by random placement of the calipers, and the overall accuracy could also be affected by error in the dead weight. Based on these concerns, it was concluded that the span length measurements were accurate to within 2 inches, the dead weight was accurate to within 0.1 pound, and the deflection measurements were accurate to within 0.001 inches. Combining all of these possible measurements errors produces a 3% change in the calculated tension. Additional errors may be present in this method but it is believed that the field test had a

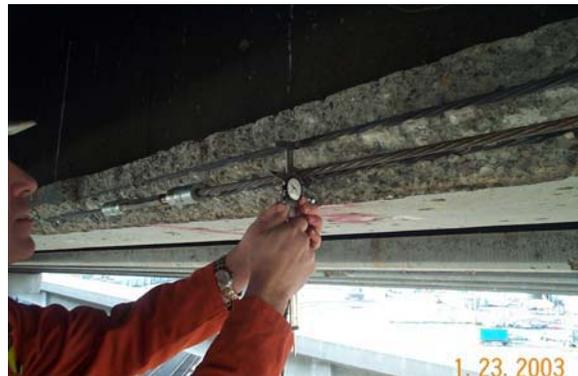
Photo 7. Deflection Test Measurement

The cable deflections were measured multiple times by two inspectors using a dial reading caliper with an accuracy of 0.001 inches. The readings were averaged to provide a deflection for the tension calculation. The exposed span length for the deflection test was measured between the points at which the strands re-entered the concrete.

probable accuracy of 5% and was certainly accurate to within 10% of the actual tension force. Figure 7 shows the calculations used in the deflection tests.

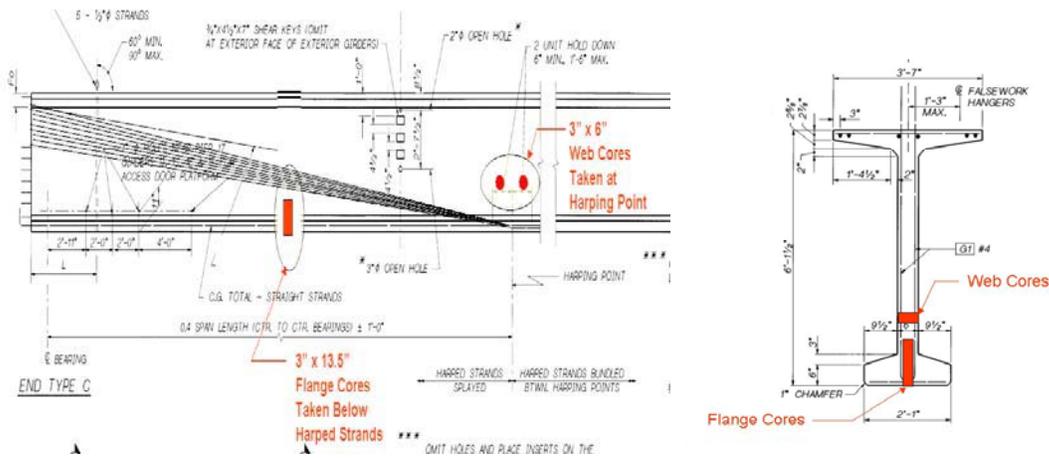
Figure 9. Concrete Coring Located to Avoid Prestressing Strands and Rebar

Concrete core samples were removed from eighteen locations in the webs and bottom flanges of six girders in Span 8. Vertical cores measuring 3 inches in diameter by approximately 13½ inches deep were removed from ten locations in four girders. Eight of the vertical cores were taken from the hot zone in Girders 8A, 8F, 8G, and 8N. Two vertical cores were taken from in the coolest heat zone of Girder 8E, which was near Pier 8. Eight horizontal cores measuring 3 inches in diameter by 6 inches deep were taken in the hot zones near mid-span of Girders 8A, 8E, 8F, and 8N.

Core No. A2-V-B: Outer 2 inches poor condition (±700°F-900°F); remainder appears sound.

Core No. F1-V-B: Outer 1 inch fair condition (up to ±200°F); remainder appears sound.

Core No. G2-V-B: Outer 3½ inches fair condition (up to ±500°F); remainder appears sound.

Core No. N2-V-B: Outer 2 inches poor condition (up to ±700°F); 6-9 inches fair condition (up to ±500°F); remainder of concrete appears sound.
