Segmental Bridges: Case Studies and Lessons Learned

by Chris Davis, Scott Greenhaus, Eric Sommer, and Bob Sward, Structural Technologies; Bob Gensel, Pullman Services; Craig Finley and Jerry Pfuntner, COWI

Case Study: West Seattle High-Rise Bridge Emergency Repairs

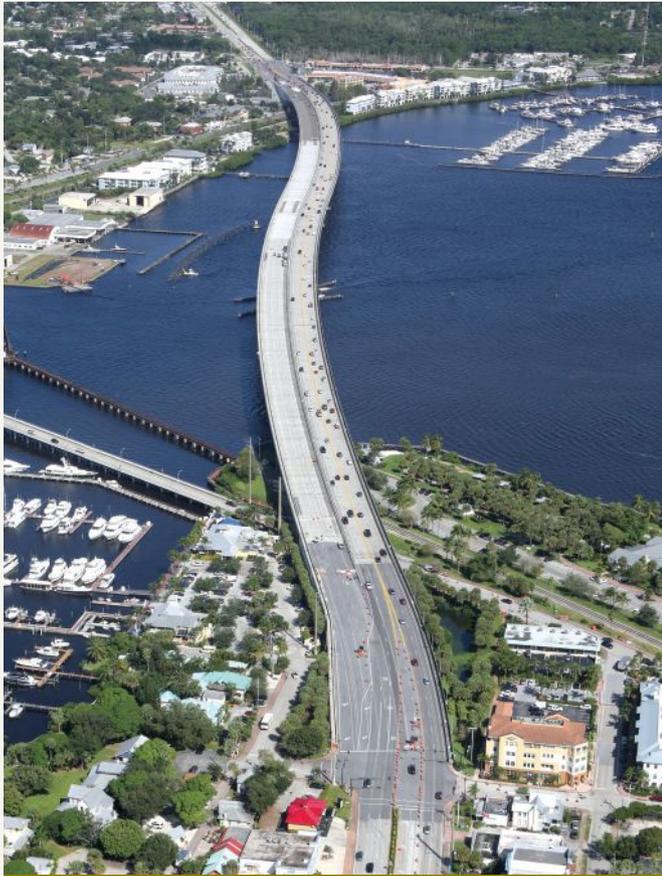
In June 2020, the Florida Department of Transportation (FDOT) closed portions of the bridge to address emergent repair needs identified during a routine inspection. Cracking was discovered in the bottom slab of southbound span 1 over Dixie Highway, and out of an abundance of caution, both bridges and Dixie Highway were immediately closed to traffic.

North- and southbound traffic on the northbound Roosevelt Bridge during repairs to the southbound bridge. Photo: Florida Department of Transportation and Cardno.

The initial crack was discovered on June 16, 2020; emergency shoring was in place by June 26; and the northbound bridge reopened to traffic on June 27. Dixie Highway was reopened on July 3 after being realigned to clear the emergency shoring system.

FDOT began the design for the repair of the bridge and initiated an emergency contracting process for the repairs. For the first time in FDOT history, the agency selected the construction manager/general contractor (CMGC) method of project delivery. This contracting method leverages early contractor involvement to assist with design and repair methods, expediting project completion and reopening of the structure.
