# Creating a Neighborhood Icon

by Jeff Parker, David Evans and Associates Inc.

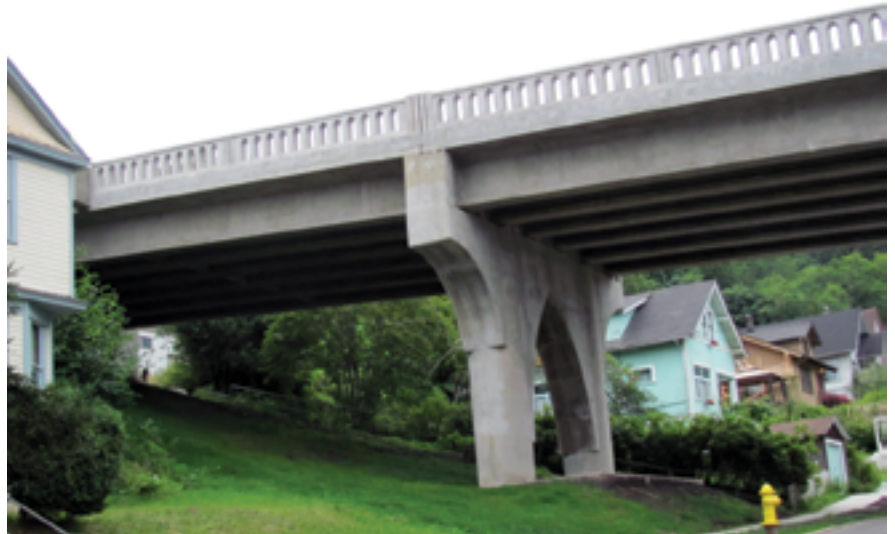
*The two-span bridge has a decorative railing consistent with the appearance of the historic neighborhood. All photos: David Evans and Associates Inc.*

The new bridge is a two-span, 180-ft-long concrete structure with a decorative railing that retains the character and aesthetic charm consistent with the appearance of the historic neighborhood. The bridge features drilled shaft foundations, cast-in-place concrete columns and abutments, precast, prestressed concrete deck bulb-tee beams, and soldier piles. The approach fills use retaining walls with cast-in-place concrete fascias. Perhaps most important, the bridge incorporates 42-in.-high rails and sidewalks being used twice daily by the neighborhood's schoolchildren.

Astoria is the oldest U.S. settlement west of the Rocky Mountains. The bridge-design detail complements the historic neighborhood. The design was subject to the approval of the Historic Landmarks Commission, which ultimately presented the city with an award for the design.

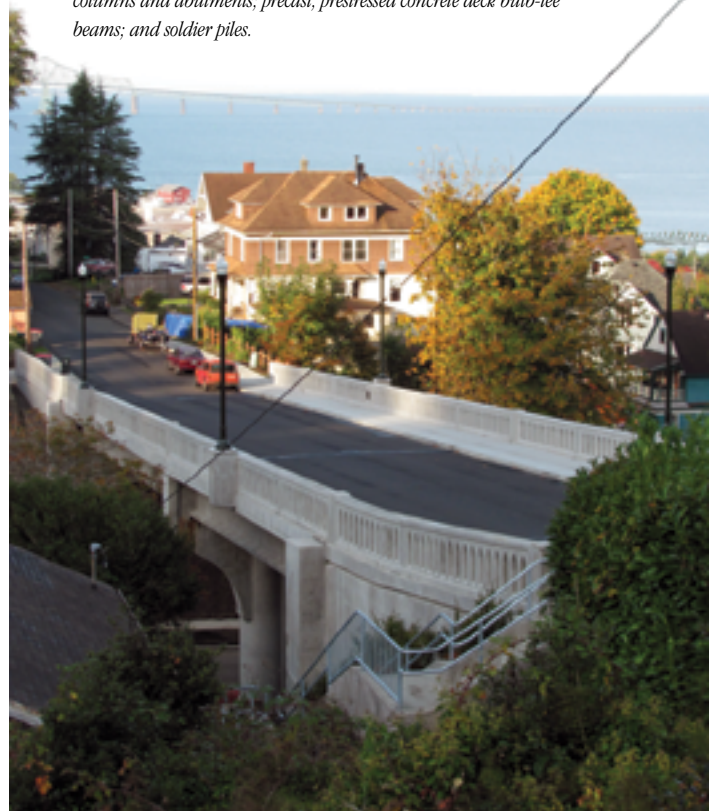
*The bridge features drilled shaft foundation; cast-in-place concrete columns and abutments; precast, prestressed concrete deck bulb-tee beams; and soldier piles.*

The bridge design incorporated techniques to account for continual ground movement. A 30-in. hole was opened around the bridge columns, on the uphill side of the landslide, and filled with bentonite-modified soil. As the earth moves, these holes start to collapse toward the columns, but the bentonite flows around the columns without placing a lateral load on them.
