1st Street Bridge over Los Angeles River

Preserving a historical monument

Murray Morgan Bridge

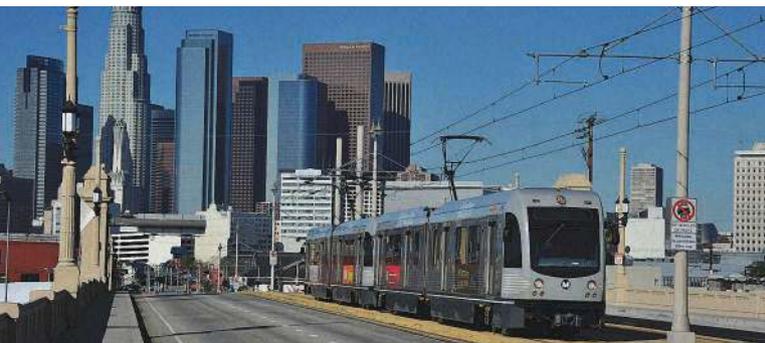
Completed bridge with the Los Angeles skyline. All Photos: Atkins North America.

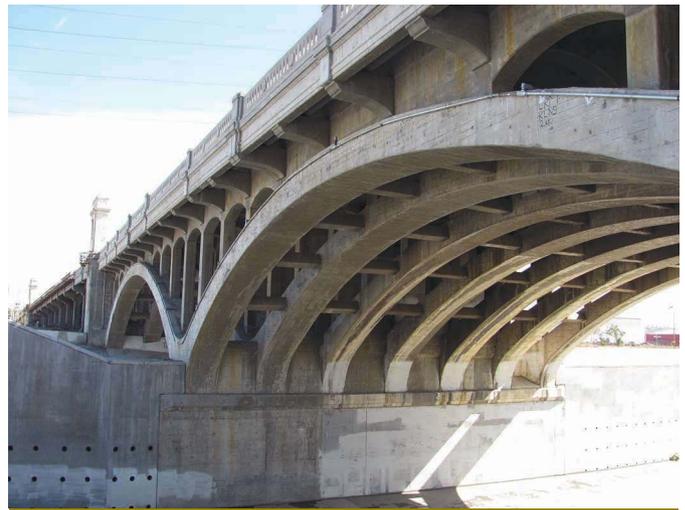
Bridge arch spans across the Los Angeles River.

In keeping with the neo-classical architecture, the widened north side of the bridge was built with the same aesthetics as the original bridge. The bridge portion over the Los Angeles River consists of two identical deck arch spans on a central pier with pylons at each end. The graceful open spandrel arch has vertically curved concrete arch ribs with equally spaced vertical columns supporting floor beams and a deck slab. The girders have cathedral arches and the exterior girders have ribbed overhangs. The spandrel columns, which are part of the arches above the river, are arched in shape and highly decorative.

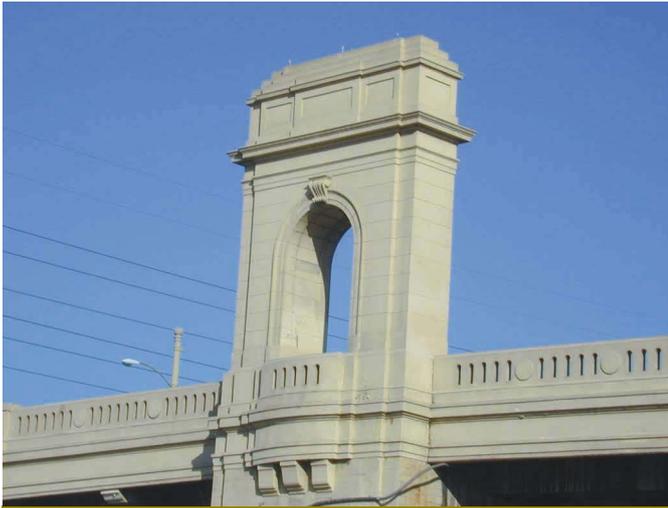
Triumphal arch.

At the ends of the arches and at three other locations, massive 200,000-lb masonry blocks in the shape of Roman triumphal arches rise above the river piers. Behind the piers are projecting balconies with benches. The plain frieze is finished with an architrave cornice. The structure is heightened above this entablature with a wide panel bearing plain incised rectangles, finally surmounted by stepped rows of narrow horizontal blocks.

Five massive, 200,000-lb masonry triumphal arches were wire cut from their bases and carefully relocated to the widened portion by crane. The contractor used a special lifting apparatus for this purpose. The triumphal arches were then bolted to their new pedestal bases using 18 vertical and four horizontal high-strength rods.

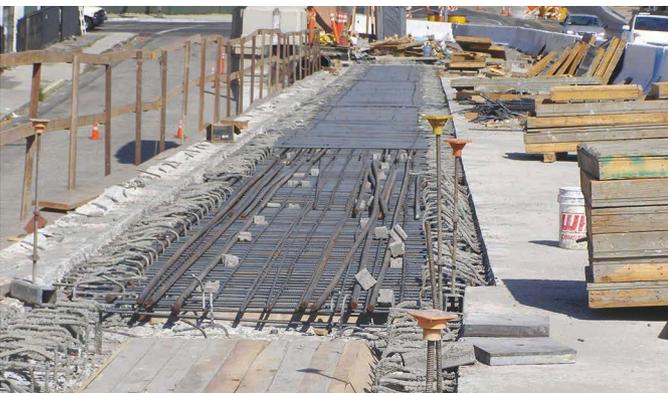
Tee-beam strengthening.

At the west and east approaches, the additional live load was resisted by increasing the sectional properties and resistance of the structural elements underneath the train tracks. Two reinforced concrete tee-beams were strengthened by removing and rebuilding a thicker deck with additional reinforcement. Concrete was also added at the beam stem within the bay. At the arch span, a waffle slab was used with the sole purpose of distributing the train loads directly to the top of the arch beams.

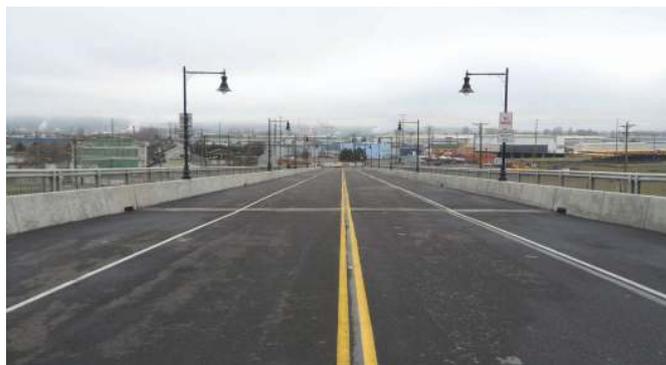
Murray Morgan Bridge port approach looking east – final deck and lane configuration.

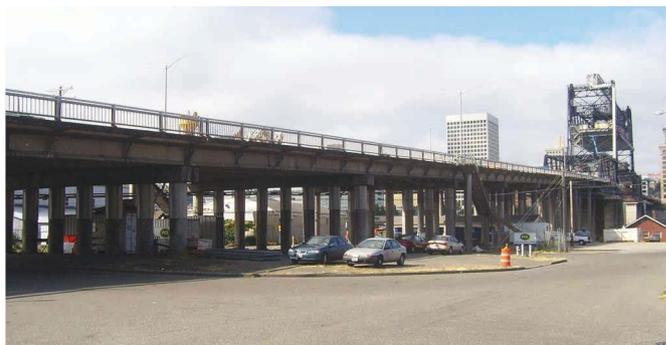
Murray Morgan Bridge port approach looking southwest.

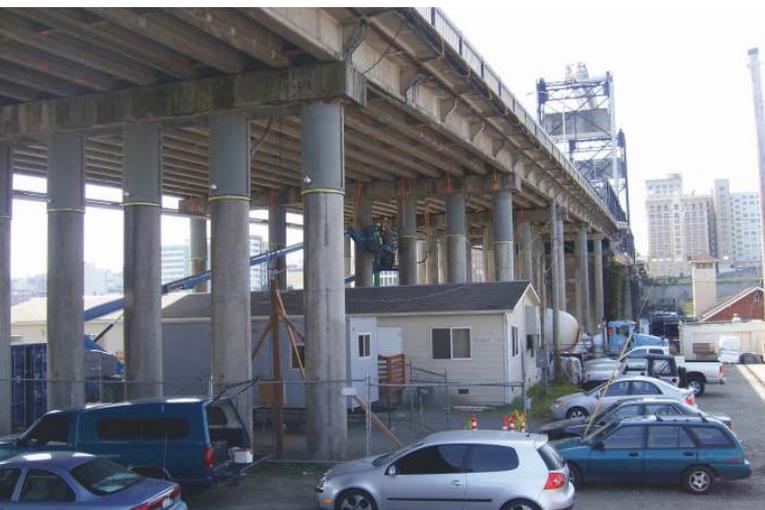
Murray Morgan Bridge port approach with repairs to the tops of the columns in place. All photos: David Evans and Associates Inc.

The design-builder developed a unique solution within the boundaries of the project's performance specifications to repair the hollow precast, prestressed concrete columns of the substructure. The solution utilized a two-component, rigid polyurethane system of poured structural foam to support the interior faces of the hollow concrete columns, while the exterior faces were repaired and encapsulated. The 2-lb density foam had a compressive strength of about 0.3 ksi when fully cured and sufficiently supported the interior faces of the

hollow columns during construction. The structural foam also increased confinement capacity of the columns in the plastic hinge zones, which improved the seismic response of the structure.
