# Using Standard Repair Procedures to Streamline the Repair Process for Prestressed Concrete Members

by W. Cabell Garbee II and Jason L. Civils, North Carolina Department of Transportation

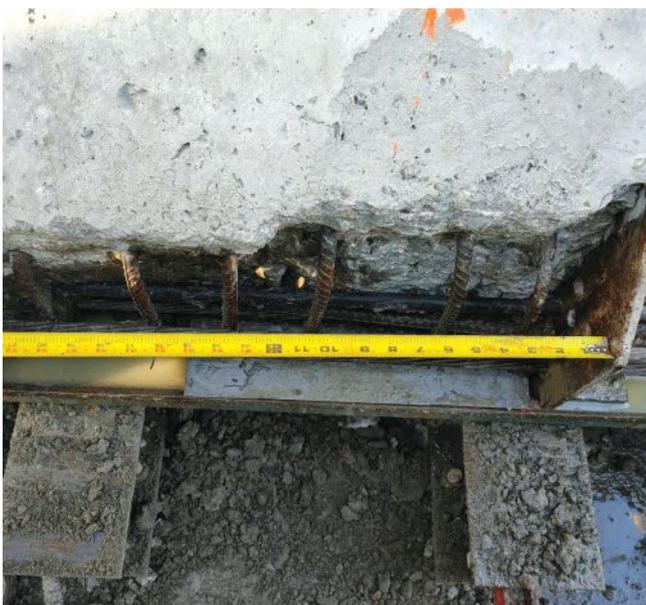
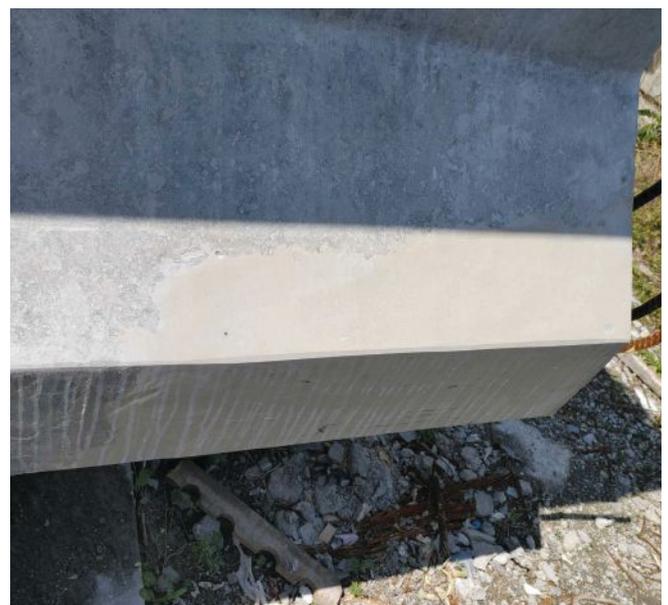
Void in the bottom flange at the end of a girder observed after form removal (left). Completed repair of void after finishing (right). A high-modulus, two-component structural epoxy adhesive that was mixed with oven-dried sand was used for the repair, which was similar to North Carolina Department of Transportation Standard Repair Procedure, but on a larger scale. All Photos: North Carolina Department of Transportation.

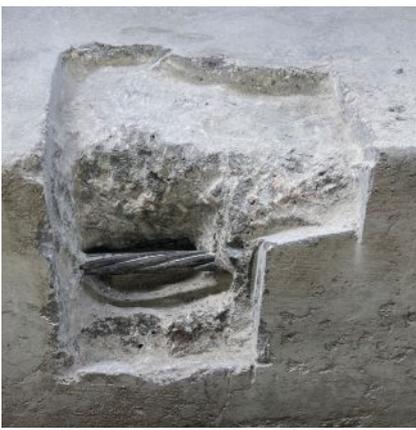
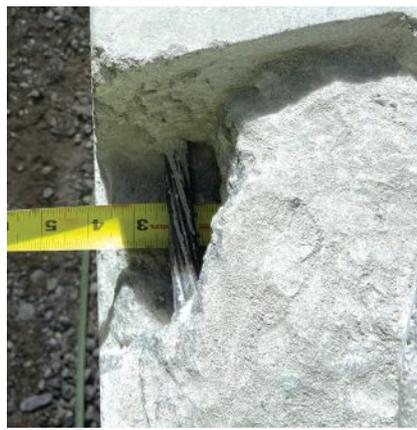
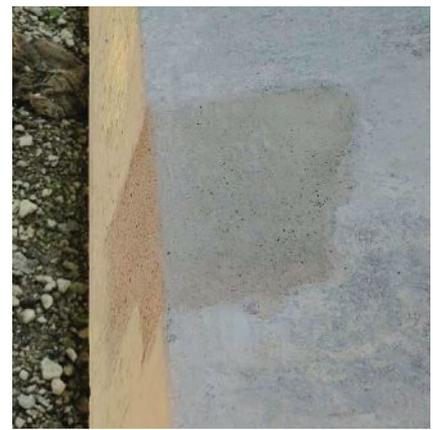
Photos of the preparation and repair of a defect at the corner of the bottom flange of a prestressed concrete girder. The left photo is a close-up of the area prepared for repair by removing unsound concrete from the void area and squaring the edges. The center photo is an overhead view of the same area to be repaired where concrete has been chipped out behind the strand. The right photo shows the completed repair. An on-site North Carolina Department of Transportation (NCDOT) inspector documents the defect, is present during the repair, and, if satisfied, approves the repair. This defect is similar to one of the NCDOT Standard Repair Procedures, but it is deeper than the limit so the Materials and Tests Unit inspector needs to document the defect. That documentation, along with the producer's detailed repair procedure, is then submitted as a nonconformance report to the Structures Management Unit for review and approval.
